Collision between *Petunia Seaways* and *Peggotty* on the River Humber 19 May 2016

SUMMARY

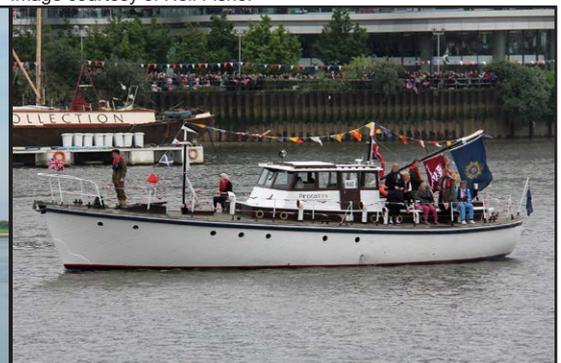
As *Petunia Seaways* continued on its voyage, *Peggotty*'s crew were shocked but uninjured. *Peggotty*'s upper structure had been seriously damaged, and as the skipper began to gather his belongings together he saw that the forward cabin space had water seeping up through the deck. At 0454 *Peggotty*'s skipper called VTS and advised that the launch had been 'brushed by a ferry' and that *Peggotty* was taking on water and required assistance. During the resultant VHF conversation, the VTSO established that *Peggotty*'s own bilge pumps were working but not able to cope with the volume of water ingress, and that its position was just north of the Middle Burcom buoy. At 0457:38, encouraged by the buyer's representative, the skipper called a "Mayday" on his VHF as *Peggotty* began to sink by the bow.

Peggotty was a historic launch and of sound construction when built. However, at the time of the accident the launch was over 70 years old and it had not been subjected to a structural survey for at least 20 years. It is without doubt that *Peggotty*'s wooden hull failed in the collision with *Petunia Seaways*. As no direct source of water ingress was visible, it is likely that the launch's planking failed along the upper limit of the lower hull's fibreglass coating, leading to catastrophic damage and making the loss of the launch inevitable.
