MARINE ACCIDENT
INVESTIGATION BRANCH

SAFETY DIGEST

**Lessons from Marine
Accident Reports
1/2017**

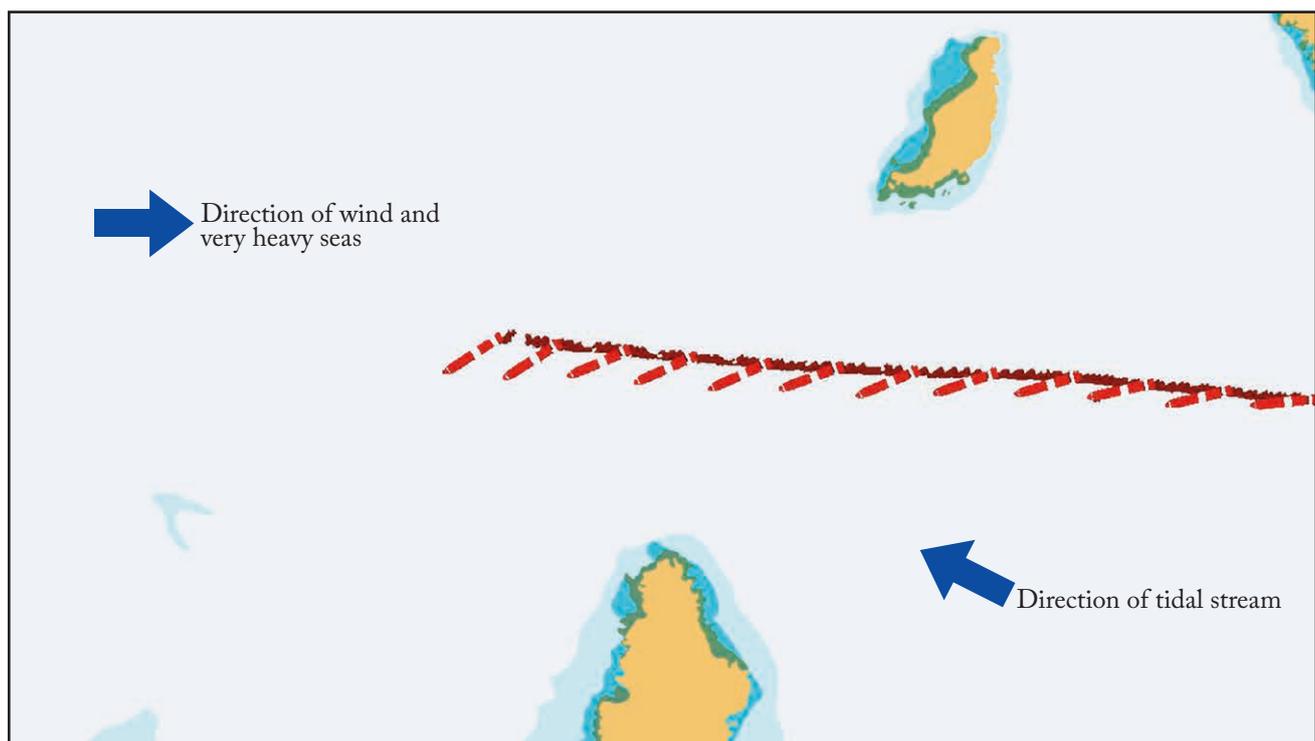
Figure 1: Vessel's track showing headings through the water (vessel shown 10 times actual size)

As the vessel approached the channel, the weather deteriorated and gale force winds were opposing the strong tidal stream; this was creating treacherous conditions that were dangerous for small vessels. On entering the channel, it is evident from AIS evidence that the bridge team slowed the vessel down, almost certainly to reduce the risk of pounding or ploughing as they headed into the dreadful sea conditions (Figure 1). Due to the direction of the tidal stream, it is also evident that course alterations were required to maintain a safe navigational track over the ground. However, these course changes had the effect of placing the large sea increasingly on the vessel's beam.

When close to the area of worst sea conditions, the vessel capsized and remained afloat upside down for a considerable period of time; none

of the crew survived. The alarm was not raised until about 25 hours later when the upturned hull was spotted by a passing ferry (Figure 2). The accident had gone unnoticed because: the capsizing was so rapid that there was insufficient time for the crew to call a "Mayday", the EPIRB almost certainly became trapped and did not float free, and the AIS transmissions ceasing was not observed ashore.

1. Passage planning is critical for every voyage; it needs to take into account all potential hazards and should include abort plans where necessary. In this case the ship entered the extremely hazardous channel at the very worst time of maximum opposing wind and current, creating the fatal sea conditions. Options were available to seek shelter or avoid the area. However, the decision to press ahead with the voyage resulted from poor passage planning, a likely under-estimation of the environmental conditions, over-confidence in the vessel's sea-keeping capability and an unwillingness to alter across the sea after the recent experience of a dangerous cargo shift.

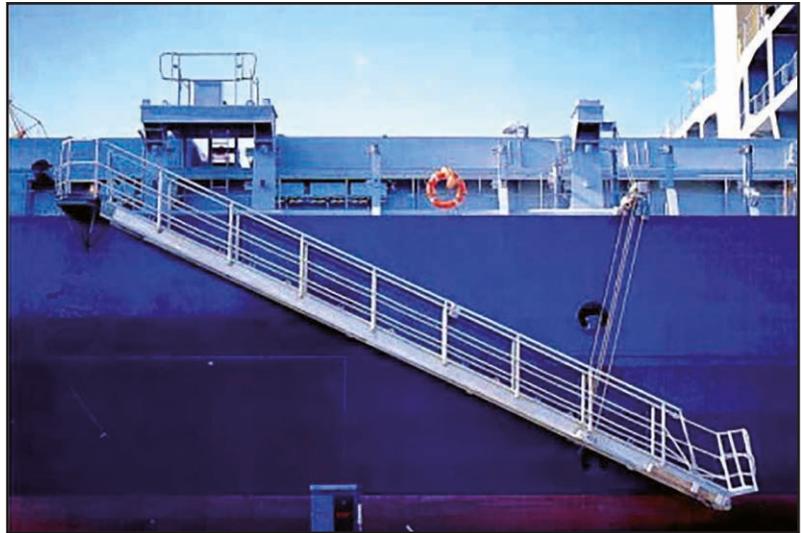
Figure 1: Similar arrangement of accommodation ladder

The turntable at the top of the accommodation ladder was secured to the platform with a bolted central pivot pin, and was supported by two sets of roller bearings.

Upon investigation it was found that the failure of the accommodation ladder was due to the corrosion of the central pivot pin, which had caused the turntable to detach from its support platform (see Figures 2 and 3). In addition, the turntable's roller bearings were completely rusted and had seized solid. The surrounding metal structure of the platform was also wasted due to corrosion.

1. Accommodation ladders and their supporting platforms are often located in areas exposed to the weather. They are particularly vulnerable to salt water spray, which can accelerate metal corrosion if not adequately protected.

2. The importance of routine preventative maintenance is clearly demonstrated in this incident where three crew members were badly injured. It is very easy to miss out that one inspection or maintenance routine, particularly if at first glance the equipment looks in good condition, and proper inspection or maintenance would be difficult and time consuming. However, as in this case, looks can be deceiving, and the more accessible, well painted topsides of the turntable masked the poor condition of the structure beneath.

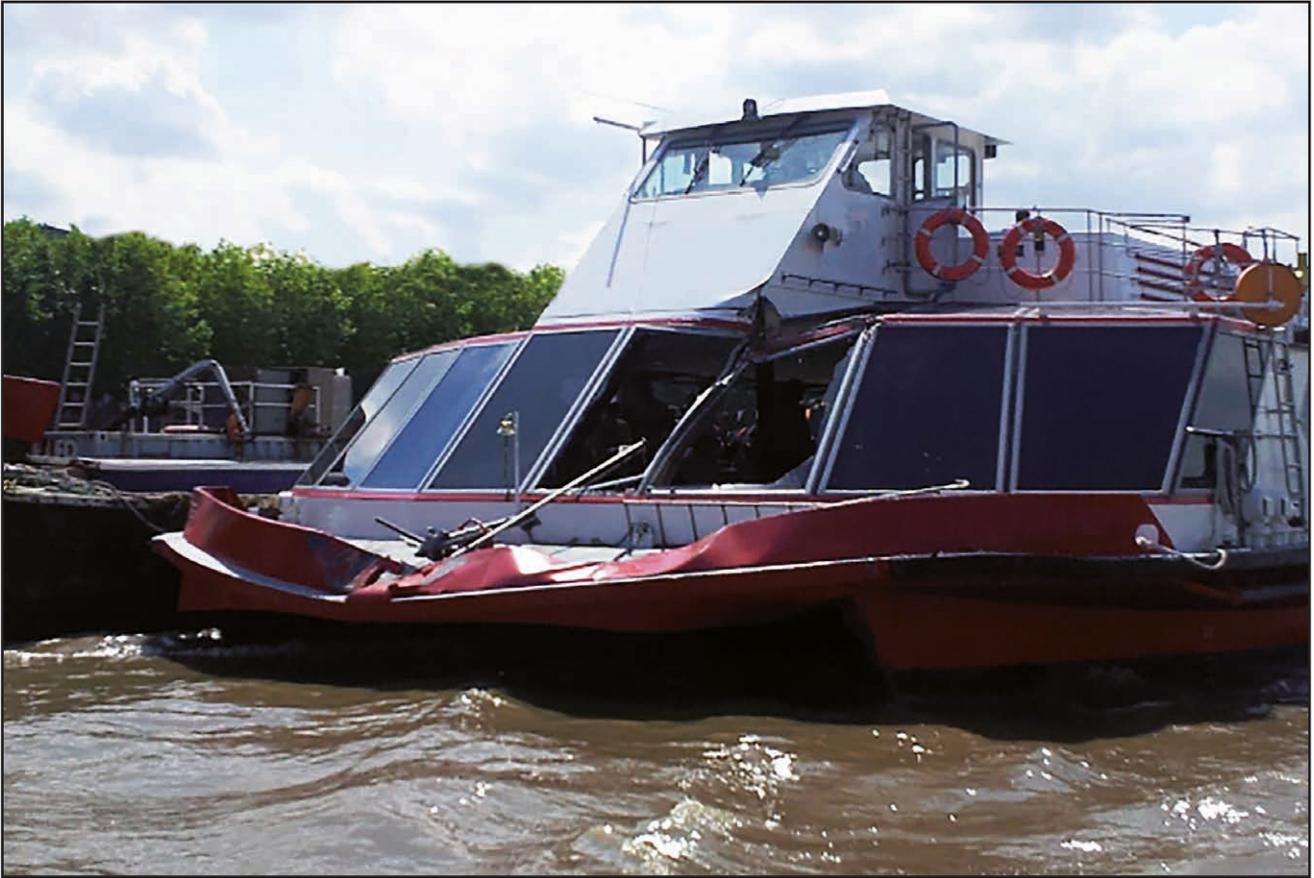
By this time, the tug's skipper had moved the tug's helm hard over to starboard, but this did not prevent the two vessels from colliding. The passenger vessel then struck one of the towed barges, which resulted in significant damage to its bow and passenger saloon (see figure). The passenger vessel was then briefly pushed astern at a speed of almost 5kts before the master regained control and secured it alongside a moored barge. Nine passengers suffered minor injuries.

The passenger vessel was fitted with a rod and gear steering system and considerable force was required to turn the wheel hard over to both port and starboard while the vessel was making way with the engines running at their normal speed. It was also difficult to keep the vessel on a straight course. In addition, the forward and elevated position of the wheelhouse meant that the mate had no visual reference, such as the bow tip, to accurately judge the rate of turn. The rate of turn was frequently assessed by looking aft and watching the movement of the stern. No rudder indicator was fitted.

1. Hydrodynamic interaction is a phenomenon routinely encountered by many vessels in different ways such as 'squat' and 'bank effect'. These effects can be allowed for during passage planning but the effects of interaction resulting from a vessel passing other vessels and objects at close range are more difficult to anticipate. Therefore, when operating in confined water in close proximity to other vessels, the possibility of a sheer should always be borne in mind. Guidance on the dangers of interaction is provided by the MCA in MGN 199(M+F).

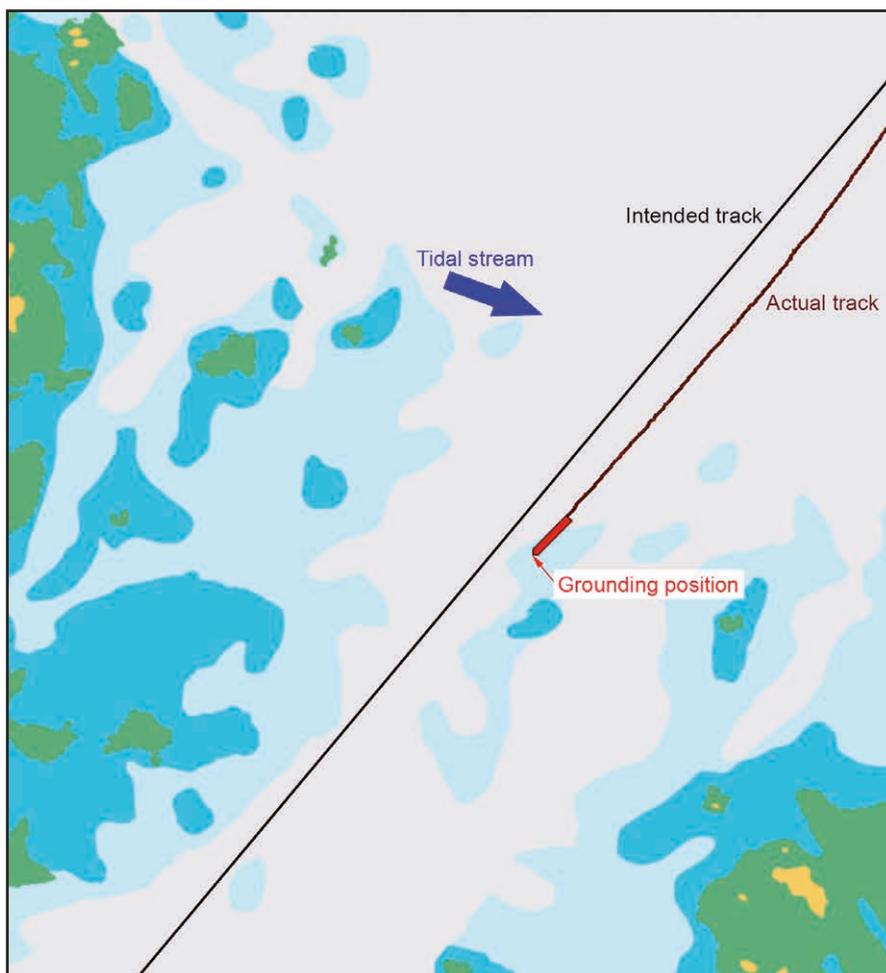
Figure 1: Chart showing the vessel's intended and actual tracks

As the ferry proceeded down the channel, the master observed visually that it was slightly to port of the intended track and made a succession of 2° heading alterations to starboard; however, these adjustments were insufficient to regain track and the ferry raked over a charted, rocky pinnacle. A heavy, shuddering vibration was felt throughout the ship as the outer hull was damaged along most

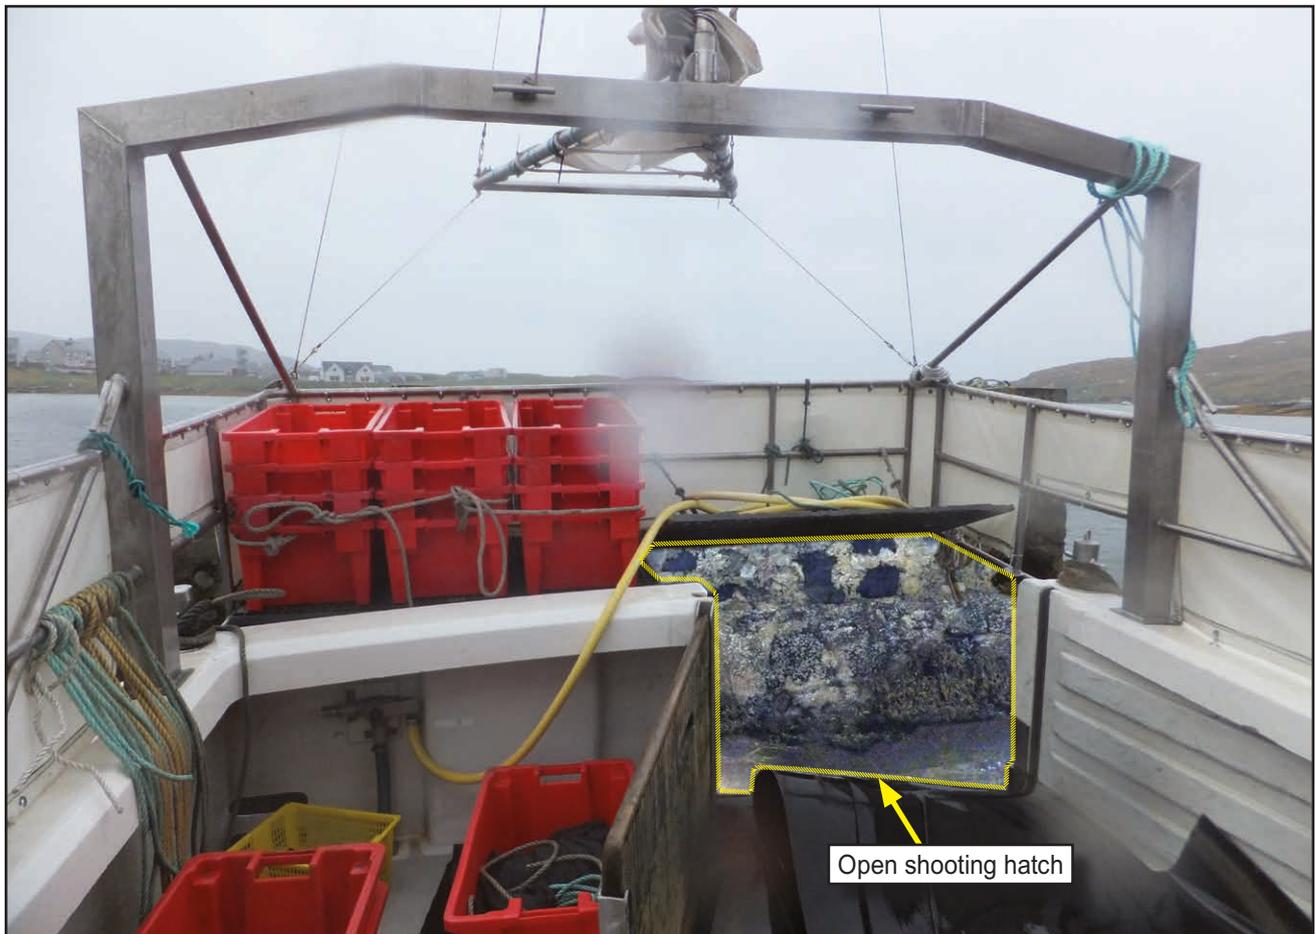
as it was dragged along the deck. On this occasion, as the crewman stepped across the moving rope to pick up the weight, his foot became caught in a bight of the backrope.

The skipper was watching his crewman and, seeing him fall to the deck he immediately put the engine to full astern. However, this was not enough to stop the crewman from being dragged overboard through the open shooting hatch (see figure) and into the sea, which was at 12°C. Being a non-swimmer the crewman struggled to stay afloat as the skipper manoeuvred the vessel to put the crewman on the starboard side. The skipper passed him a rope with a bowline loop at its end and the crewman put it around one leg. The skipper

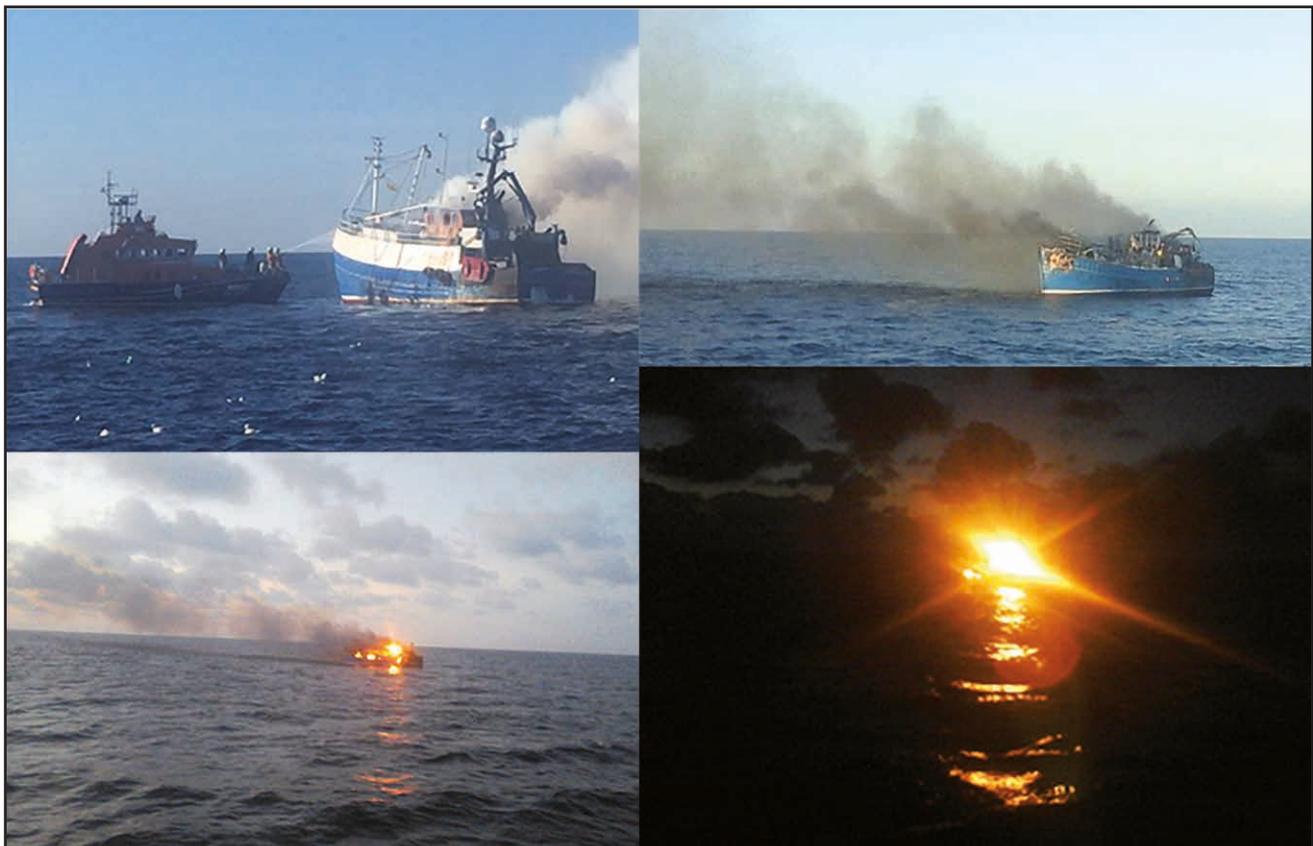
The crew were unable to collect their abandon ship lifejackets that were stowed in the burning cabin, so instead donned inflatable lifejackets that were stored in a locker on the aft deck. All five then mustered, deployed a liferaft, abandoned the vessel, and were rescued soon afterwards.

The vessel was eventually overwhelmed by the fire and foundered.

1. The fire almost certainly started in the vessel's cabin. Smoke then spread quickly, forcing the crew to evacuate the vessel rather than attempt to fight the fire. The ignition source has not been determined, but it is probable that the fire was caused by a poorly discarded cigarette that was not fully extinguished. Ensure everyone on your vessel knows where it is safe to smoke and that appropriate means are provided to enable cigarettes to be properly extinguished.

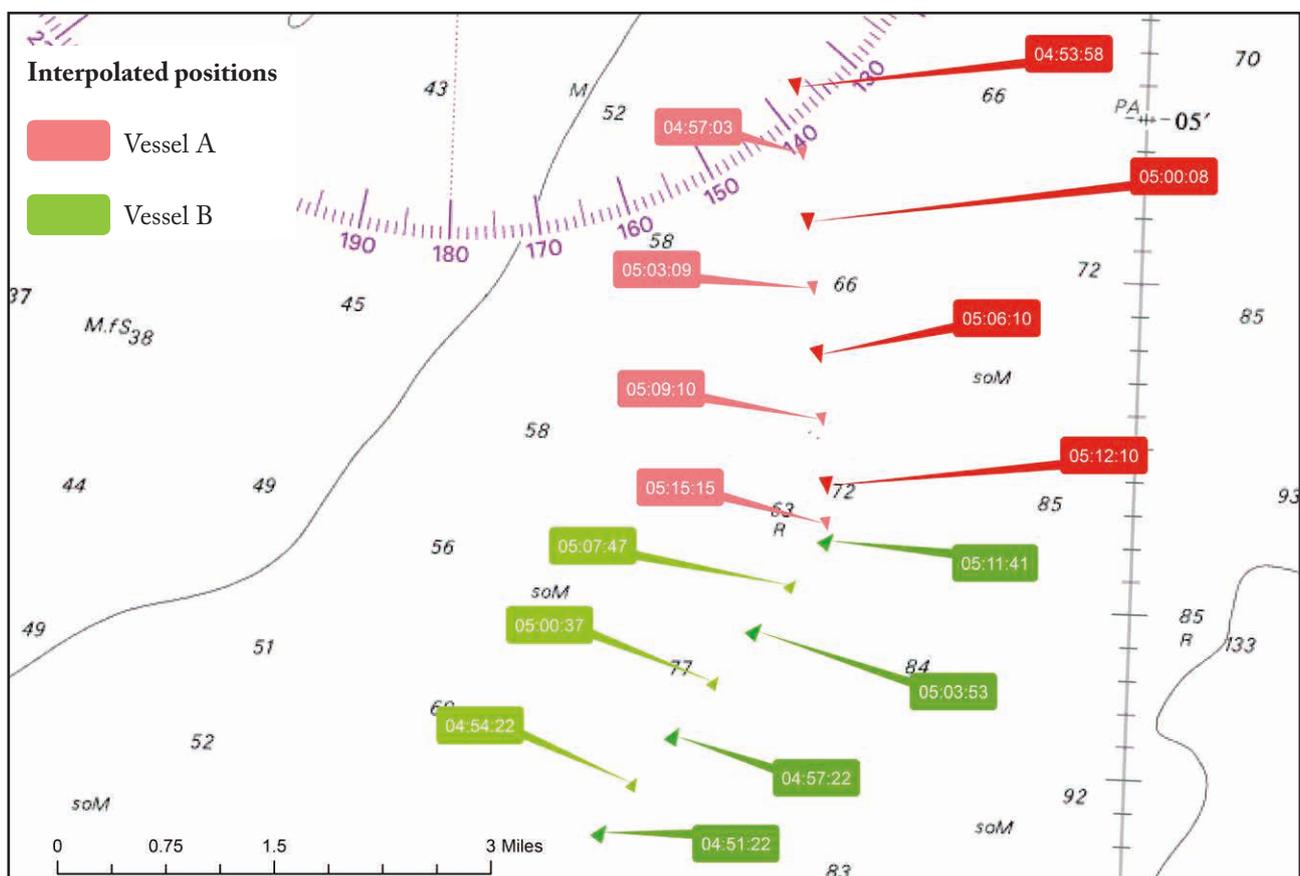
Trawler A struck Trawler B's port shoulder. Trawler A's planking split either side of the stem and water flooded into the cabin space and quickly spread to the fish hold. Trawler B suffered only minor damage. The two vessels were manoeuvred alongside each other and Trawler A's crew stepped across to Trawler B. A DSC alert was initiated and the coastguard was informed of the situation by VHF radio. Trawler A soon sank; its EPIRB and liferaft surfaced moments later.

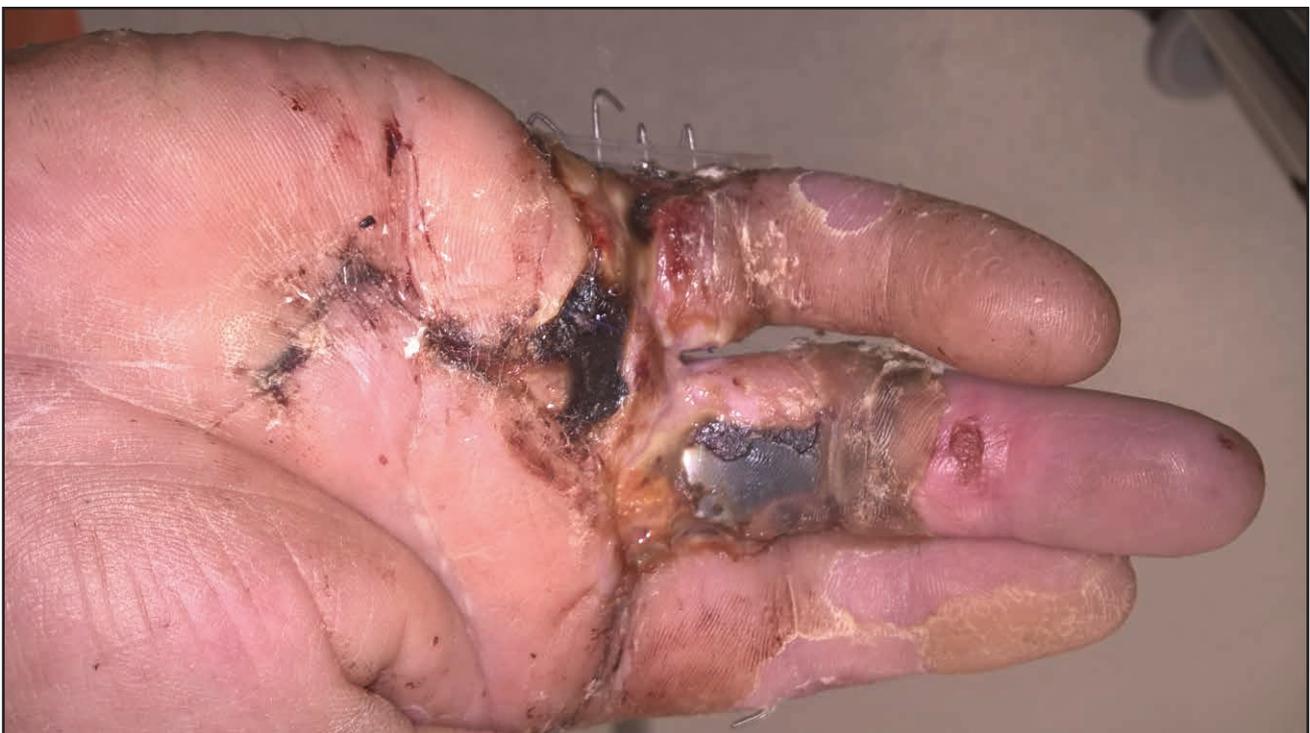
Figure 1

The crew transmitted a "Mayday" message to the coastguard, who tasked a lifeboat and rescue helicopter to attend. The skipper was airlifted from the lifeboat and flown to hospital, where it was found that his hand had suffered multiple fractures and severe loss of tissue. After lengthy surgery three of his fingers were reattached, but the skipper's recovery required numerous skin transplants over many months (Figure 1).

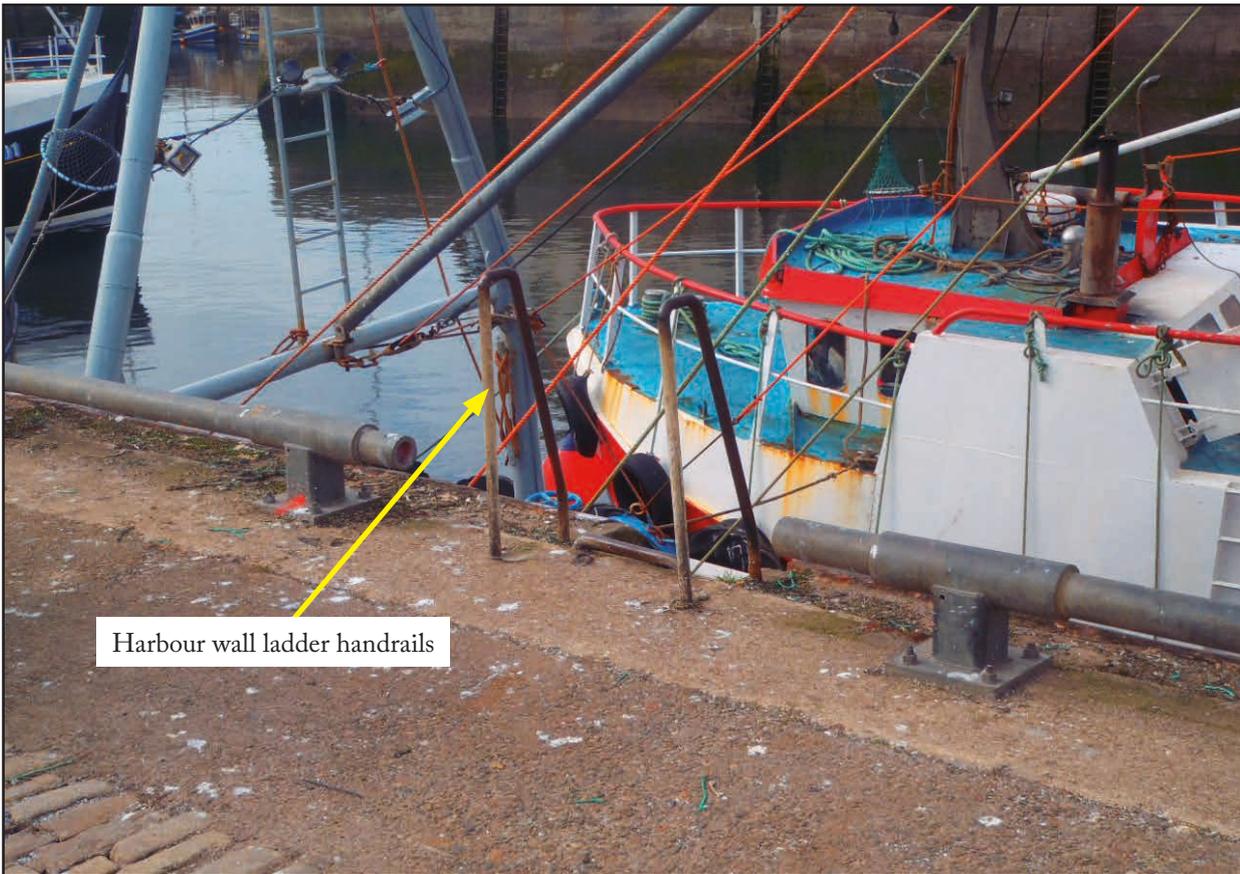
Figure 2

Later, the skipper decided to check that his crewman had got on board safely. When he arrived at the harbour wall ladder (Figure 2), the skipper saw the crewman lying unconscious on the deck of the vessel below (Figure 3), with his chips spread out around him. He called the emergency services and an ambulance soon arrived. The casualty was treated on the scene by paramedics and then taken to hospital for treatment. Despite suffering serious injuries, he eventually made a full recovery.

Harbour wall ladder handrails

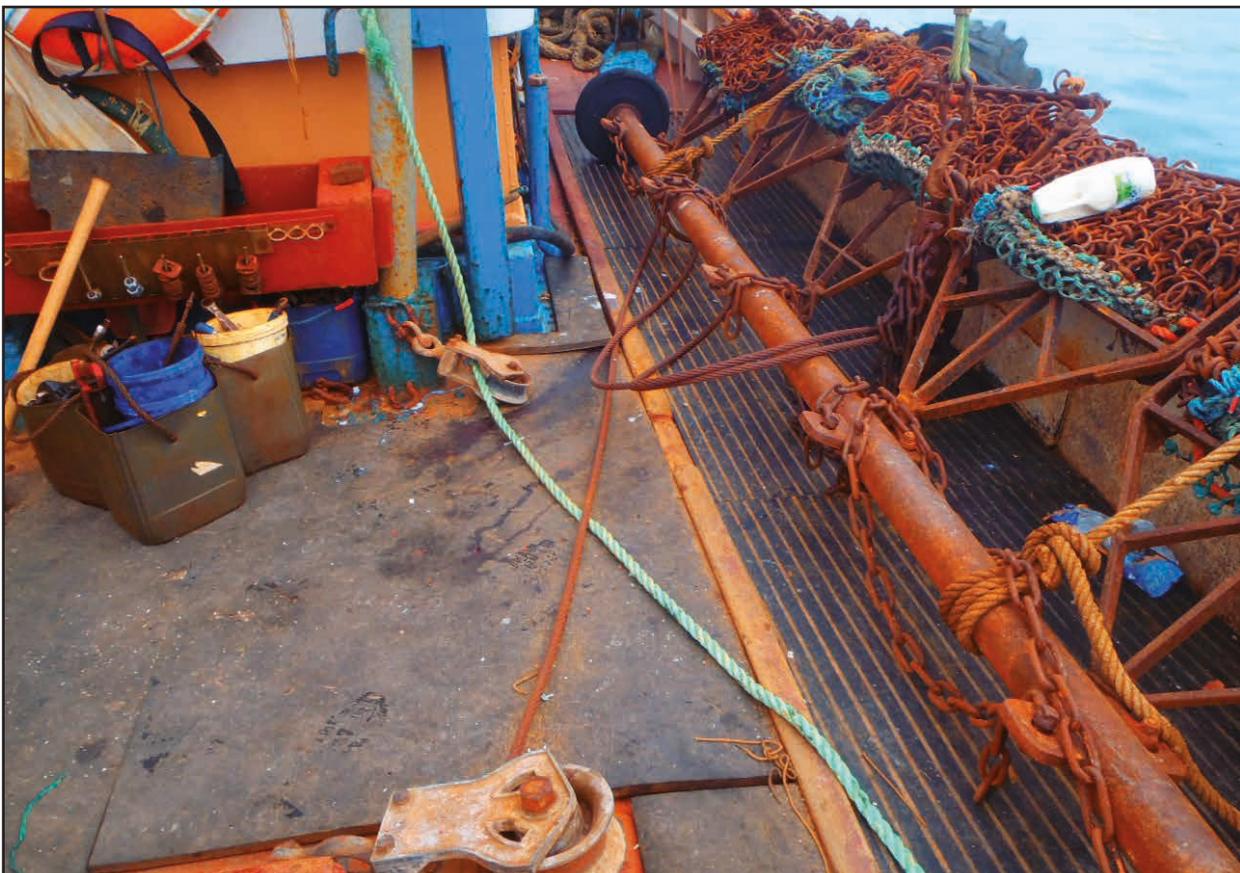
The distance from the top of the wall to the deck of the boat was about 6m.

Figure 3: Deck of fishing vessel

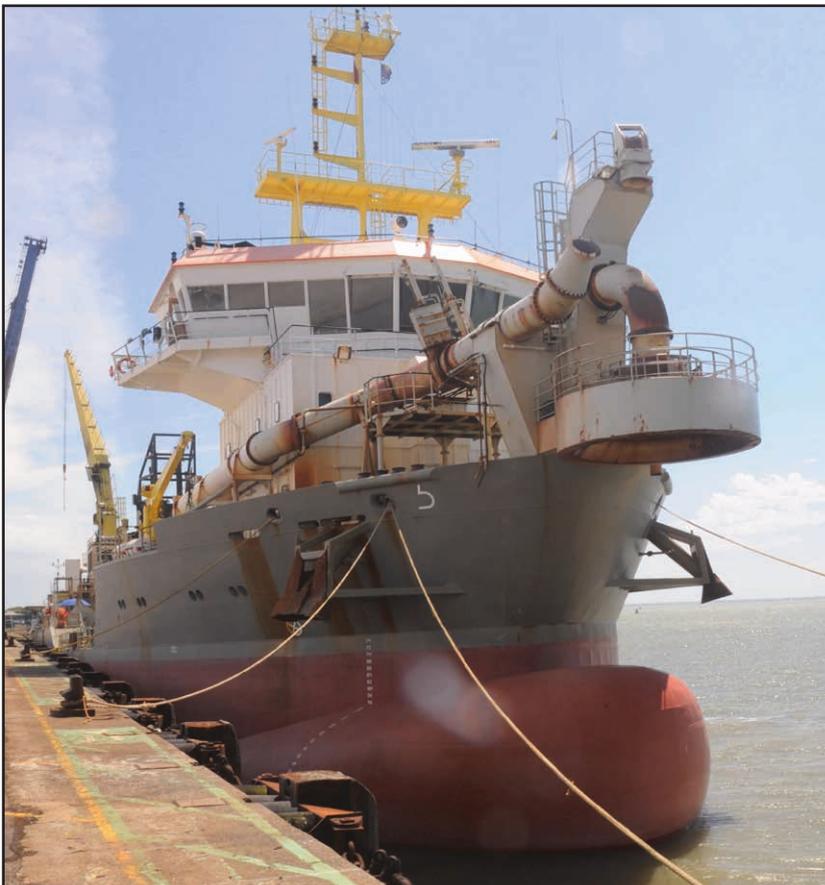
Figure 1: The dredger

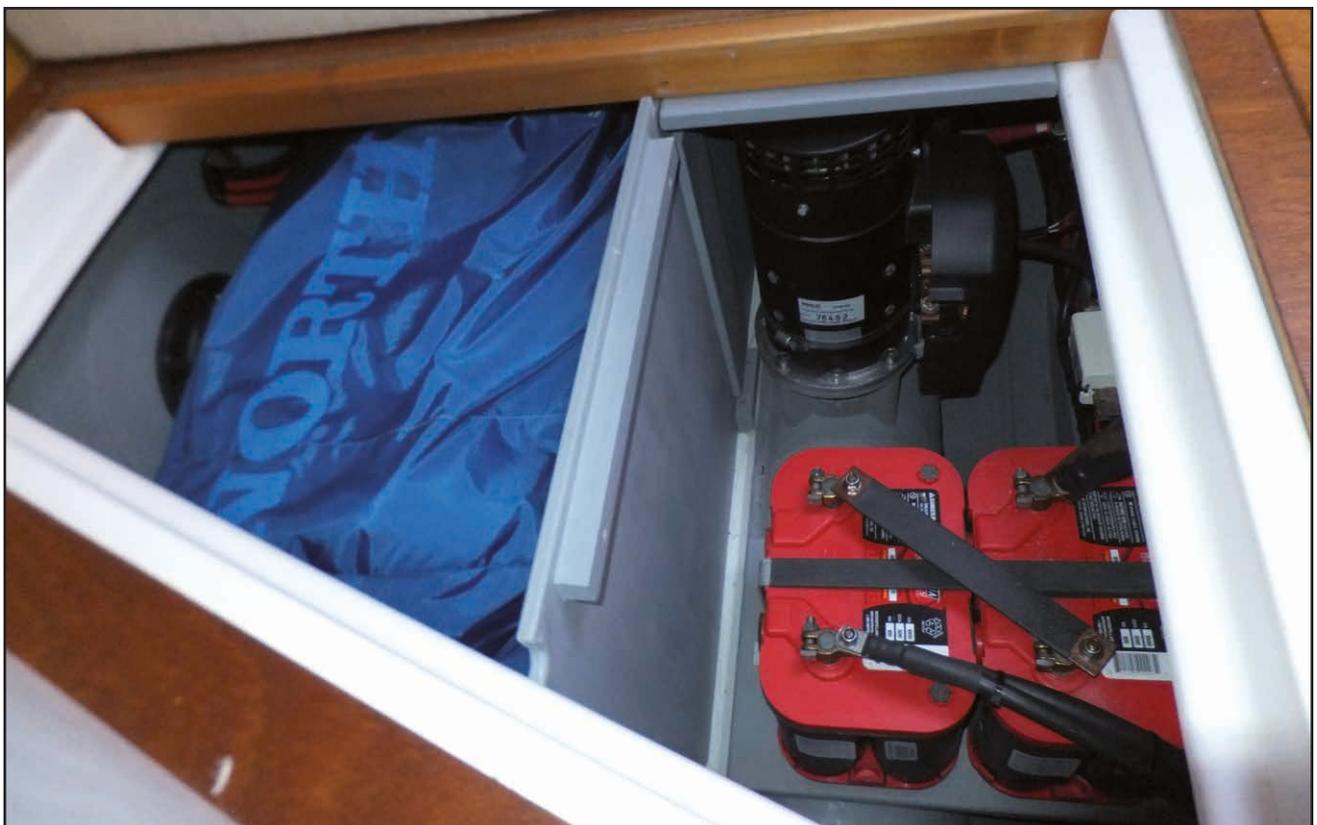
Yacht bow thrusters use powerful electric motors that may generate sparks as part of their normal operation. The full petrol can had released vapour, possibly due to a change in temperature or through having not been properly sealed, and this was ignited on the first operation of the bow thruster. Thankfully for all concerned the fuel can did not rupture in the explosion and there was no resultant fire. The yacht was transported to a boatyard for extensive repairs.

Figure 1: Typical bow thruster installation showing electric motor and dedicated batteries
