National Transportation Safety Board

Marine Accident Brief

Sinking of Towing Vessel *Spence*

Accident no.	DCA16FM011
Vessel name	<i>Spence</i>
Accident type	Sinking
Location	Caribbean Sea, about 115 nautical miles (nm) north of Cartagena, Colombia 12°17.6' N, 75°38.1' W
Date	December 14, 2015
Time	1540 eastern standard time (coordinated universal time – 5 hours)
Injuries	Non-life threatening injuries to three crewmembers
Property damage	\$1.5 million est.
Environmental damage	None
Weather	Clear skies with 12 nm of visibility, winds north-northeast at 20–25 knots, seas easterly at 6 feet, air temperature 83°F
Waterway information	The Caribbean Sea is bounded by the Greater and Lesser Antilles to the north and east, and by South and Central America to the south and west.

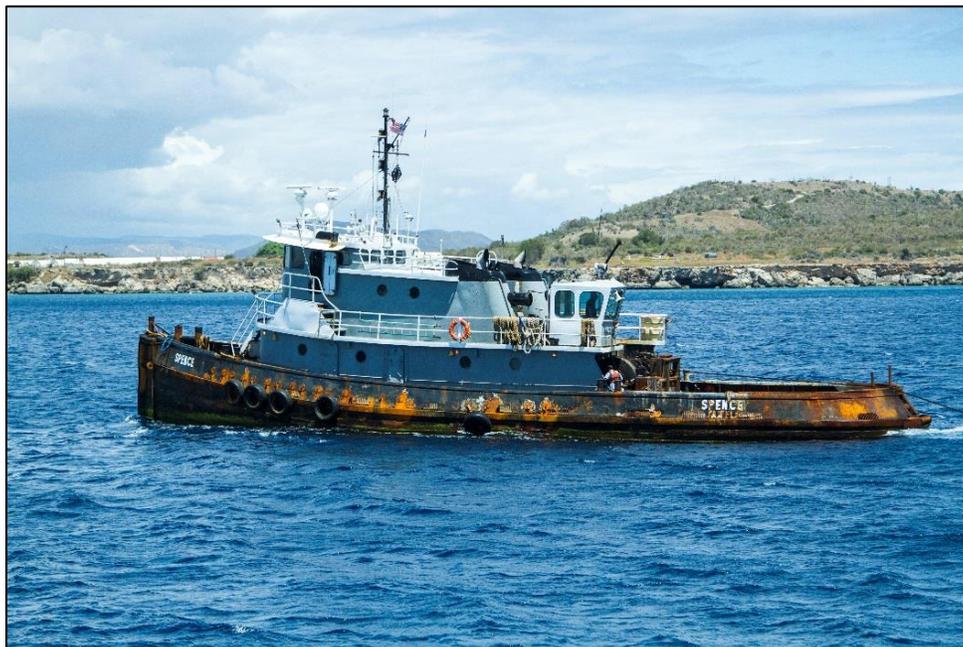
Towing vessel *Spence* under way in April 2015 prior to the accident. (Photo by Sgt. 1st Class Daryl T. Madrid, Joint Task Force Guantanamo Public Affairs)

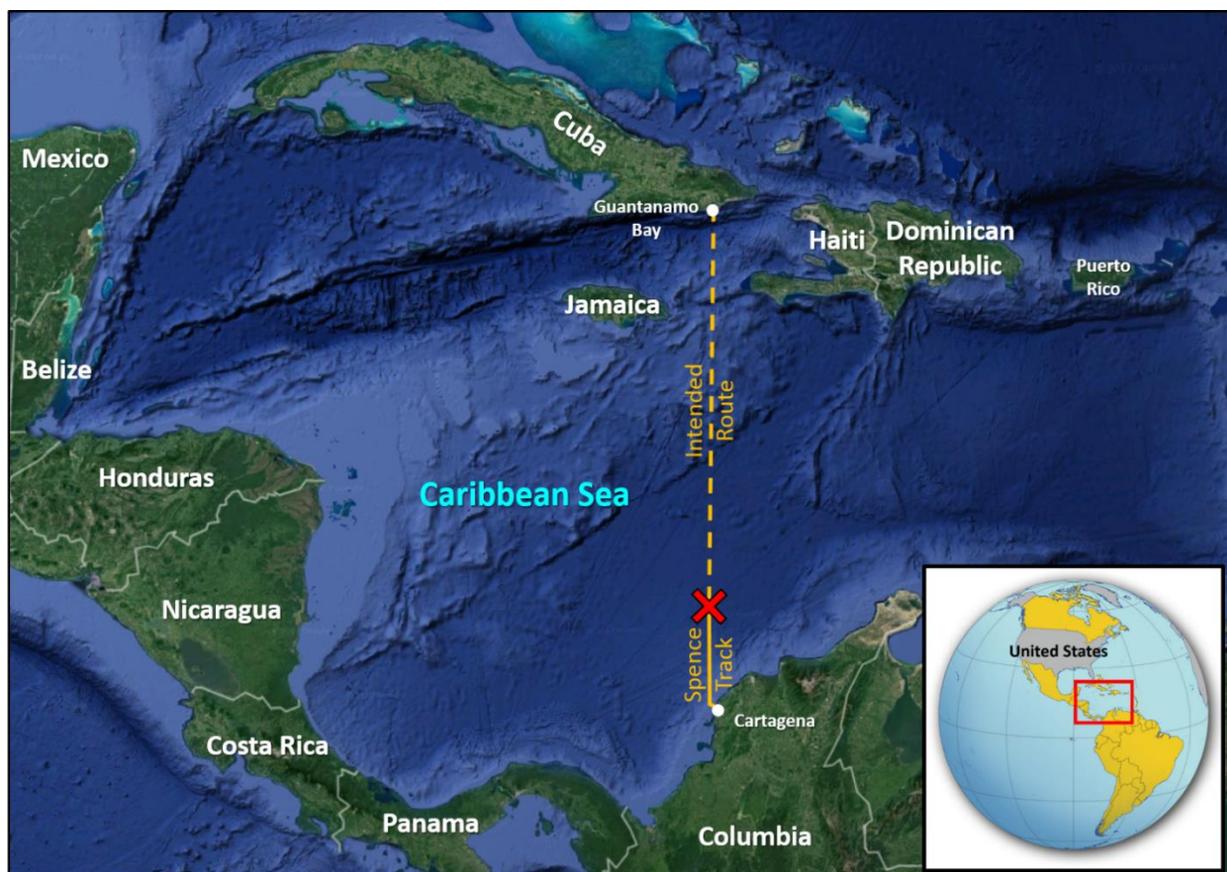
Satellite image of the Caribbean Sea overlaid with *Spence's* track and intended route. The accident location is shown with a red X. (Background by Google Maps)
