# **SAFETY DIGEST**

**Lessons from Marine  
Accident Reports  
2/2017**

**SAFETY DIGEST**  
**Lessons from Marine Accidents**  
**No 2/2017**

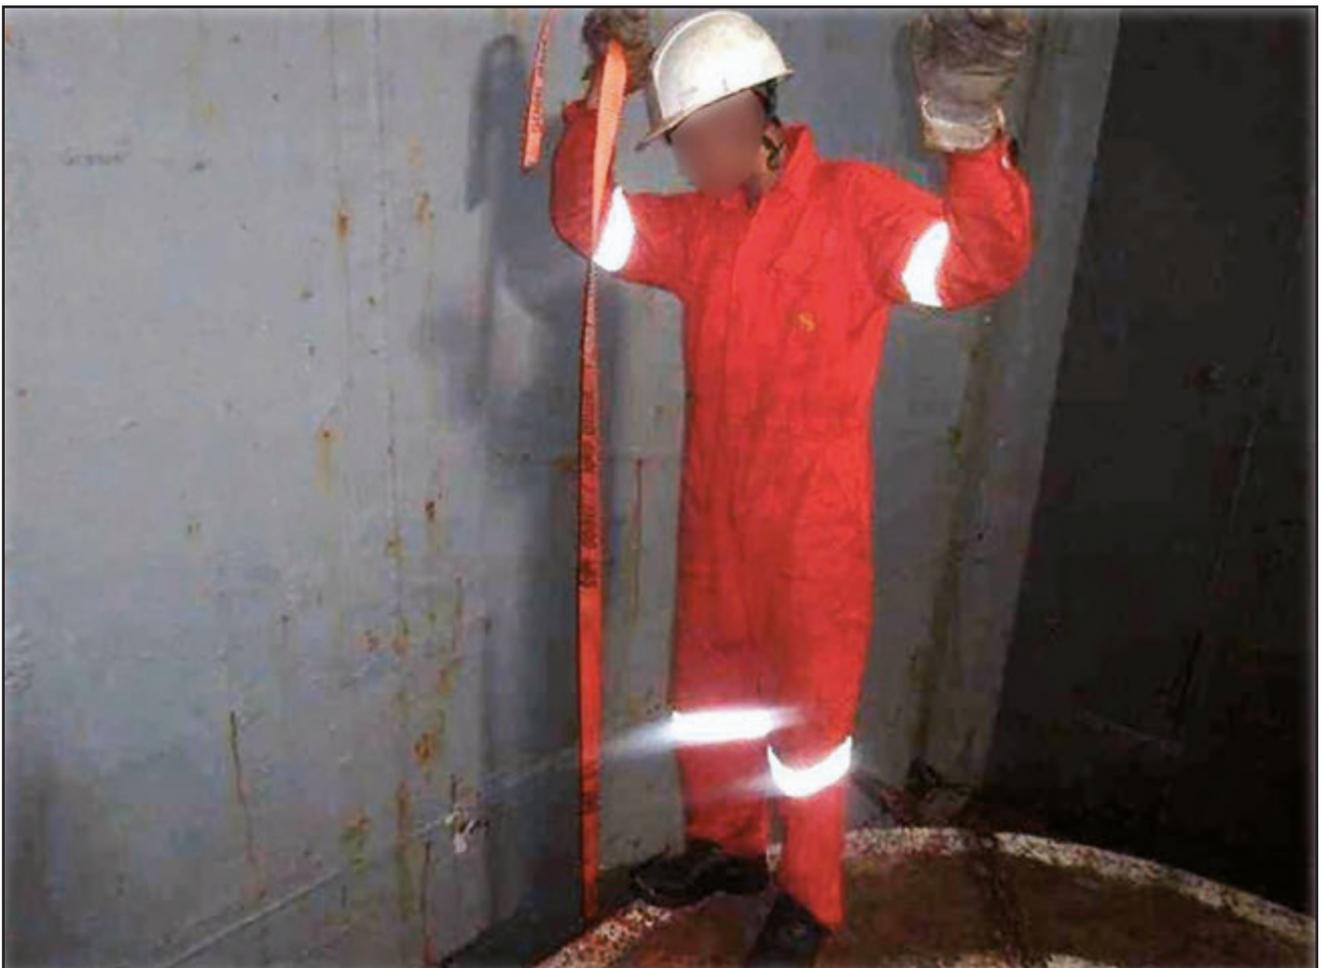
held onto one of two webbing straps that were being used to lift the unit (Figure 1). Suddenly, the unit and/or a strop shifted, causing the chief officer to lose his balance and fall through a hole in the steel unit and onto the deck (Figure 2).

Figure 1: Position of chief officer prior to fall (simulation)

1. Although hazardous, it is not unusual for crew members to stand on top of cargo during loading and discharge in order to get a job done. However, standing on the top of cargo that is being lifted is inherently unsafe and unnecessary.
2. A 'can do' attitude is invariably seen as a positive personal quality, but a 'can do safely' attitude is far better. When a problem arises while working the cargo, take time to weigh up the options and decide on the most efficient and safe course of action. The forces at play are too considerable to rush.
3. Every fall from height is potentially life-threatening. Internal injuries are always possible, no matter the distance travelled.
4. Healthcare varies considerably in different parts of the world; it might not always be up to the standard you are used to.

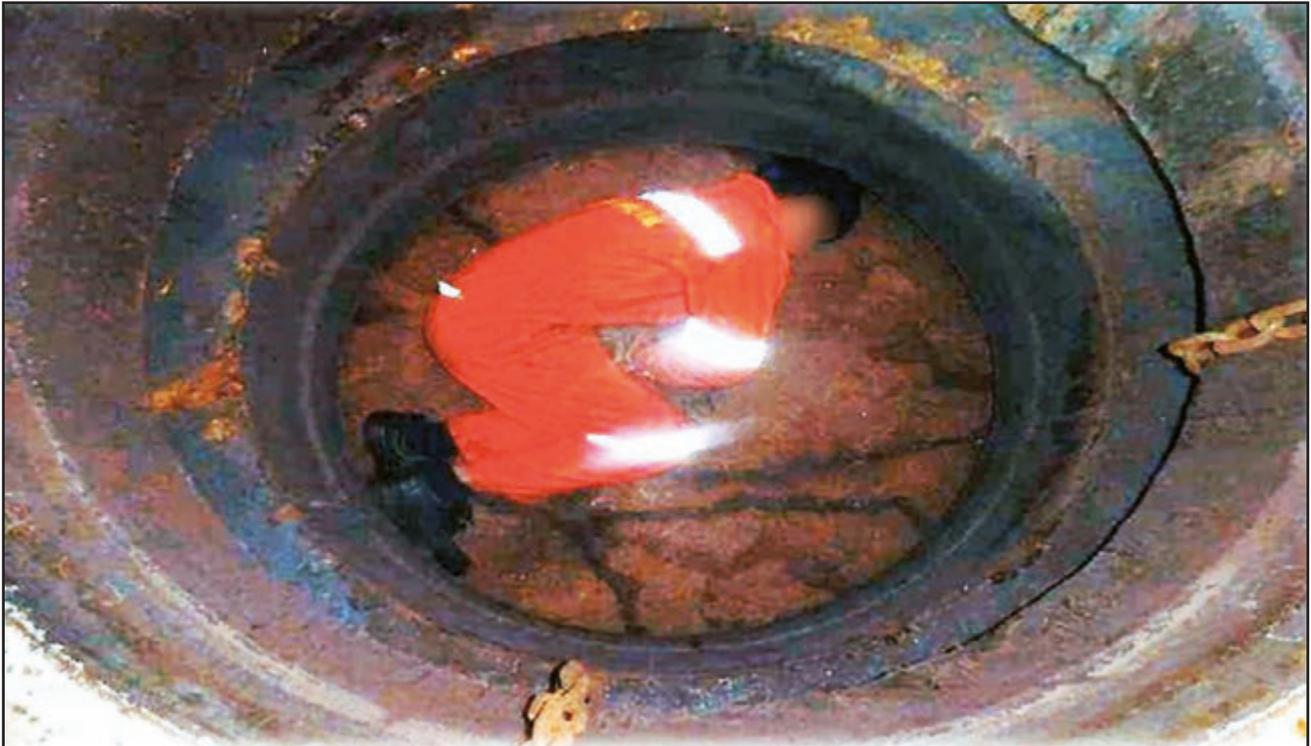
died shortly afterwards from bleeding and pneumothorax in his right chest cavity. He also suffered broken ribs and a broken humerus.

Figure 2: Position of chief officer after fall (simulation)

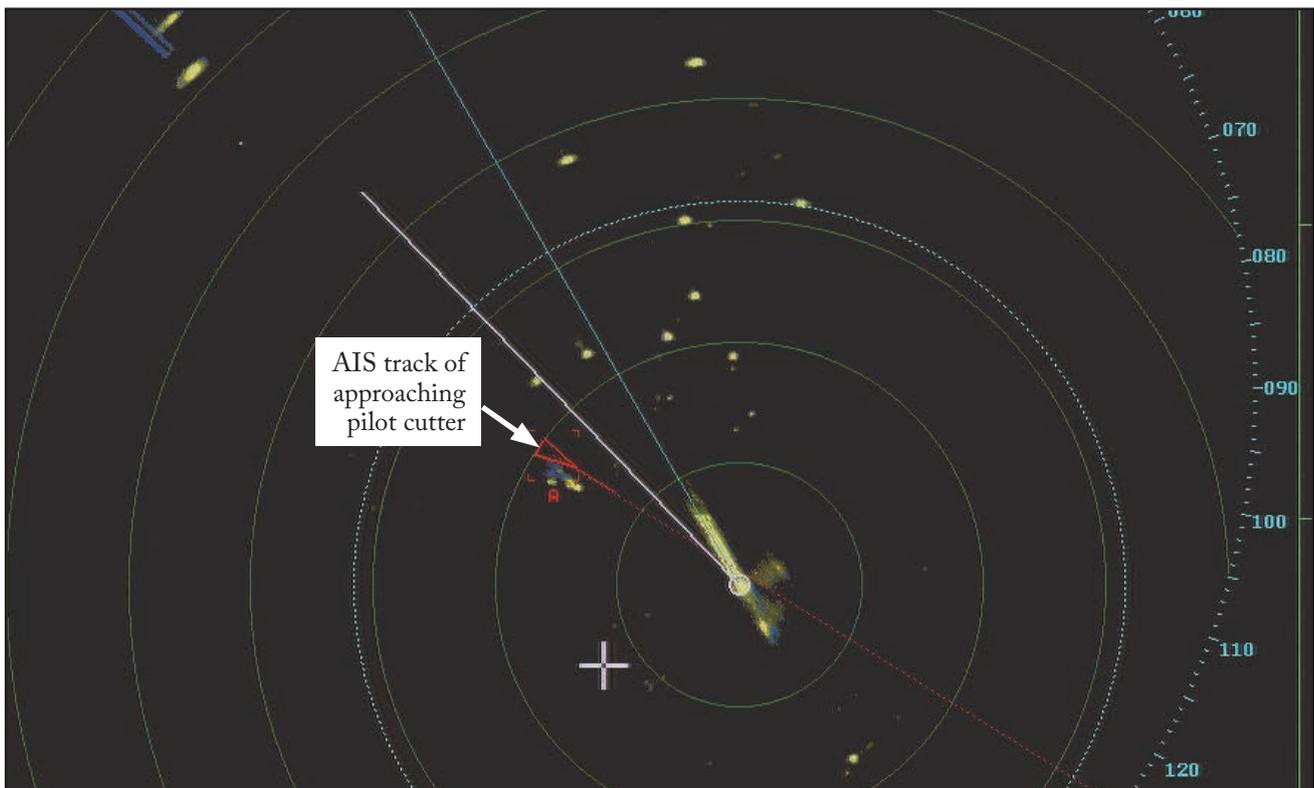
When the pilot arrived on the tanker's bridge, he realised that the fishing boat was only about 20m ahead, so he ordered full starboard rudder in an attempt to swing away from the anchored boat; however, the tanker and the fishing boat briefly came into contact. The fishing boat's anchor line broke after snagging on the tanker and the fishermen fended off by hand until the tanker had passed.

Figure: Extract of the tanker's radar picture 6 minutes prior to the collision, showing the pilot cutter approaching and the fishing vessels ahead

3. Sound signals should be used when the actions of another vessel are uncertain. It was good, daylight conditions and neither vessel thought to use sound signals to warn the other.

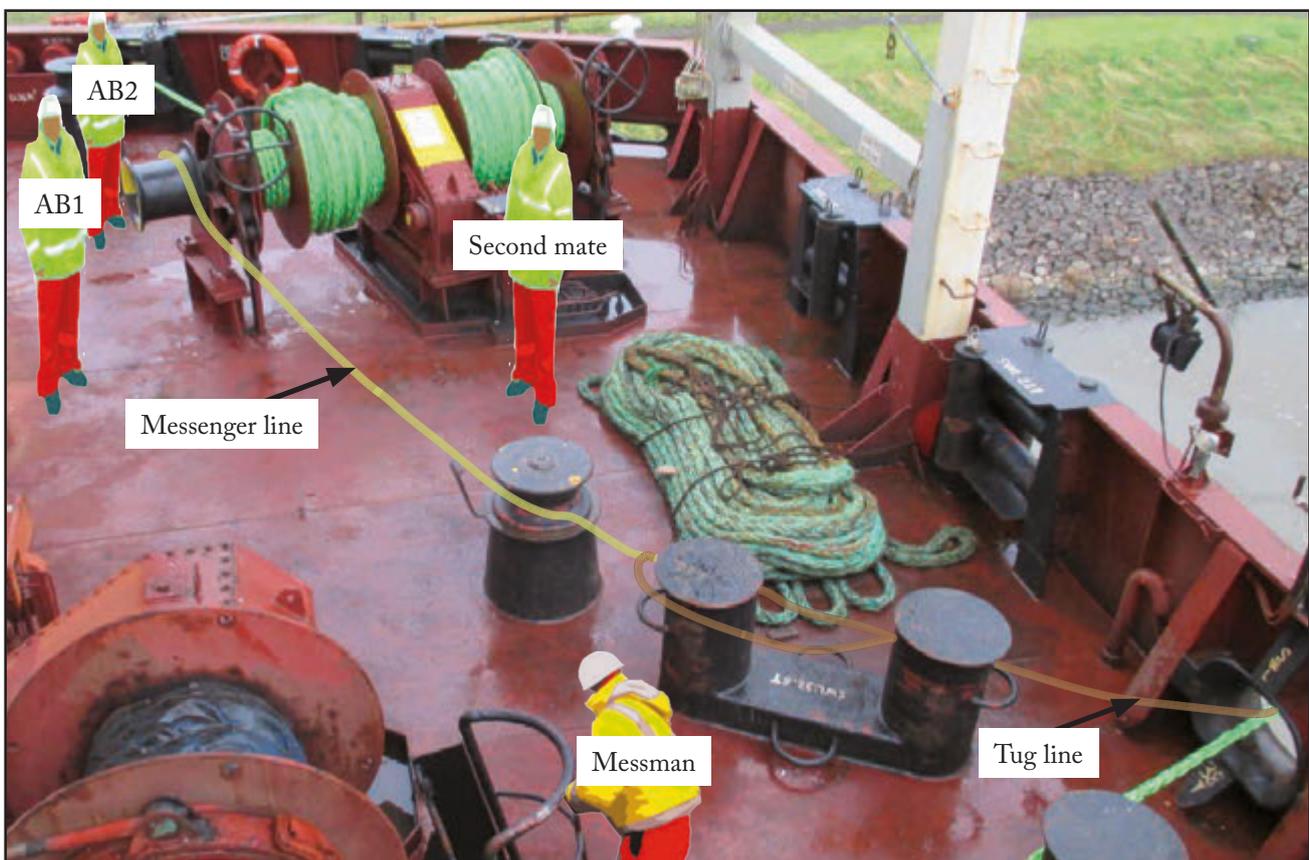
Figure: Locations of the aft mooring team

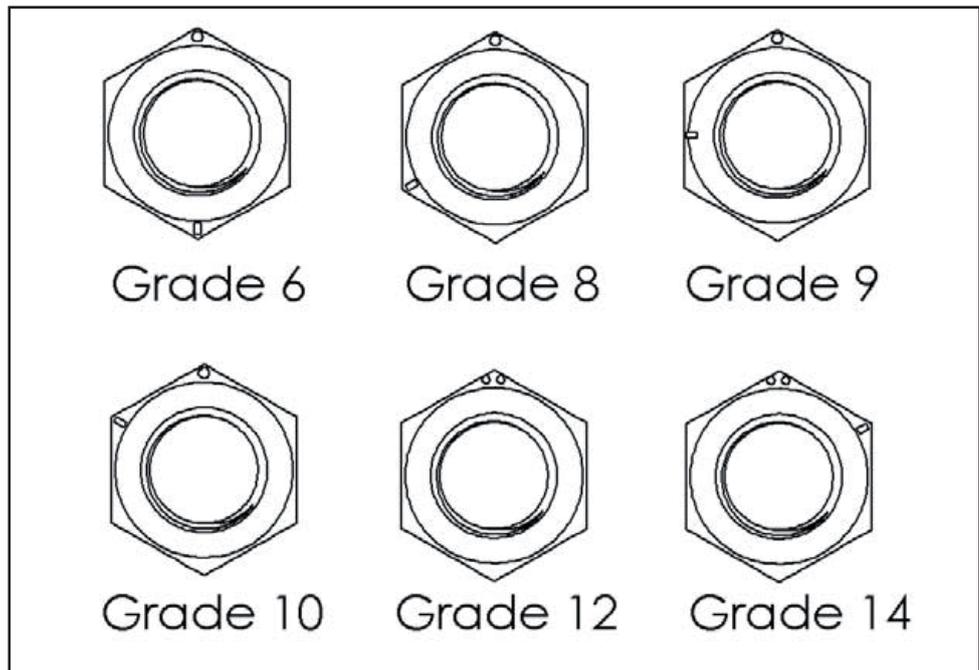
Figure 6: Clock face marking on nuts

3. To be fully effective, testing procedures and visual inspections during thorough examinations must be followed to the letter. Short-cuts and work arounds can easily lead to deficiencies not

being identified, and the absence of installation guidance makes it impossible to tell whether a crane has been fitted in accordance with the manufacturer's design intent.

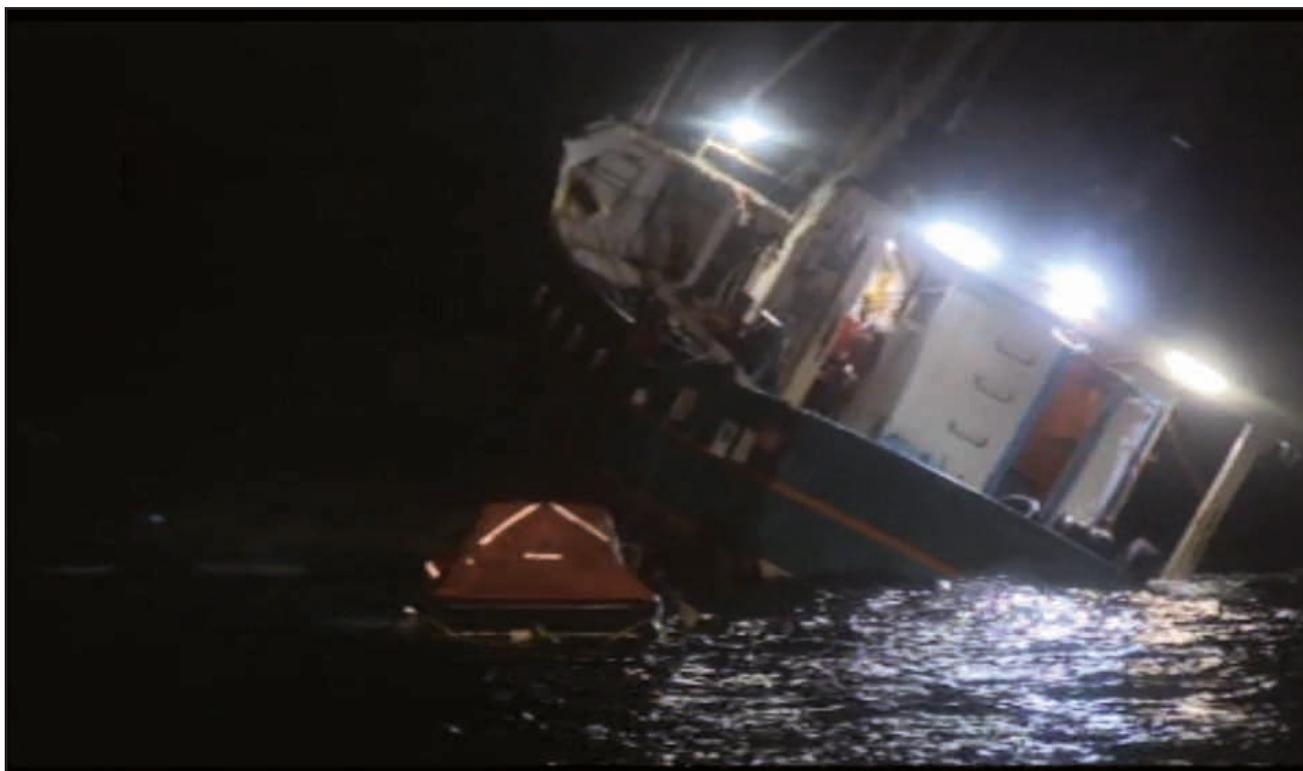
of hours later, the scalloper was to the starboard of the route on the plotter. As the vessel approached the entrance to the sound at 9 knots, it suddenly veered off course and grounded on a small island. Although the scalloper did not appear to be taking water, the tide was falling and it soon took on a starboard list. Attempts to refloat it were unsuccessful, so with the list worsening the crew abandoned into a liferaft (Figure 1). They were soon picked up by a lifeboat.

Figure 1: Crew abandoning vessel into a liferaft

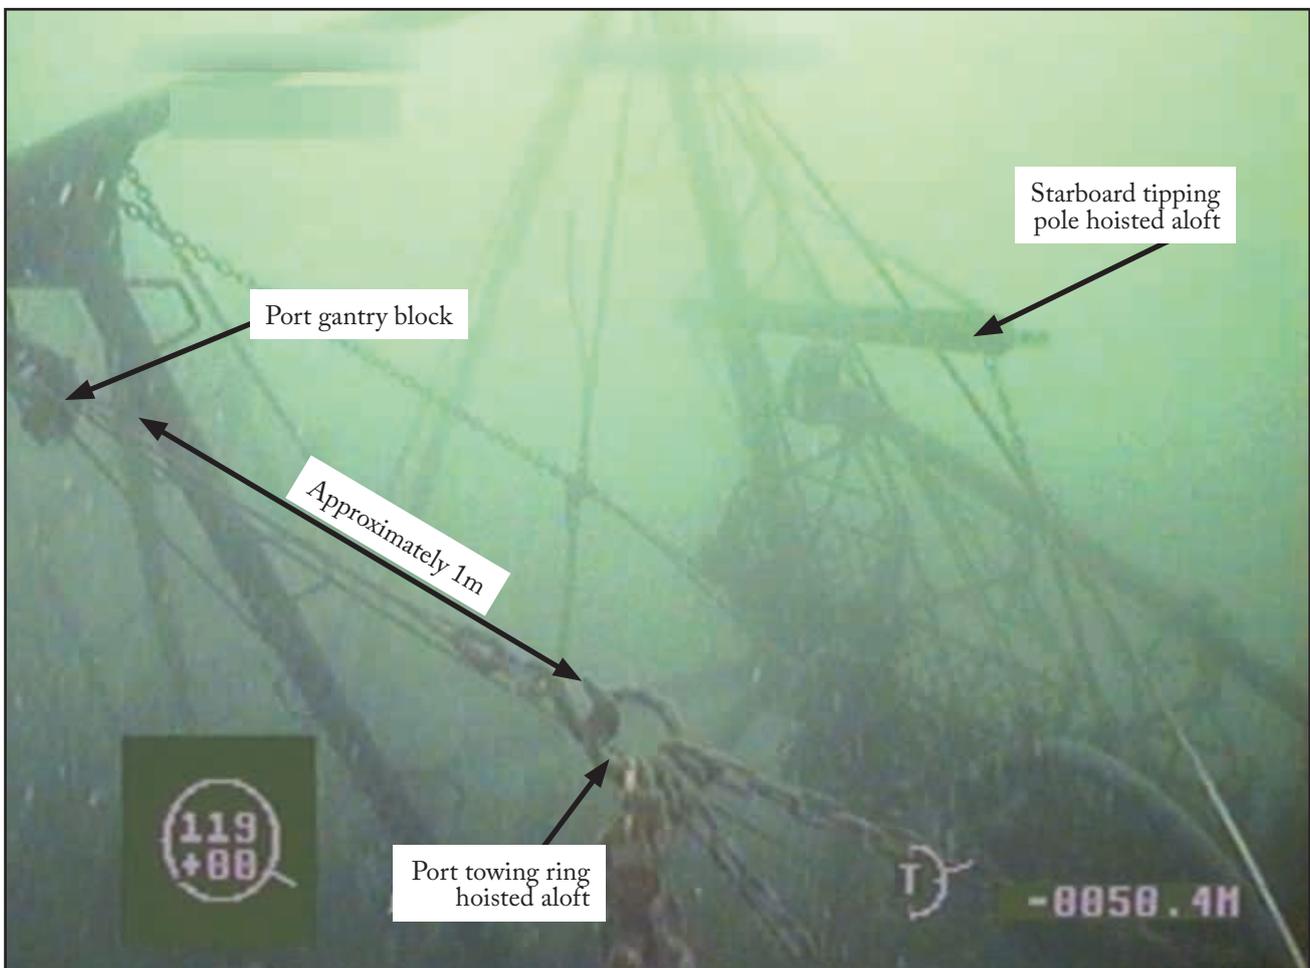
From the evidence gained from underwater surveys (Figure 1) along with the vessel's salvage (Figure 2) and subsequent stability assessment, it was apparent that it had capsized quickly while the two crew were in the process of emptying the starboard scallop dredges with the port dredges suspended from a gantry block. The scallop dredger's poor initial stability had been worsened by a low fuel level, the suspension of weights from a high point, storing catch on deck and uneven loading initiated by the earlier winch failure.

Figure 1: Underwater image of port and starboard scallop gear

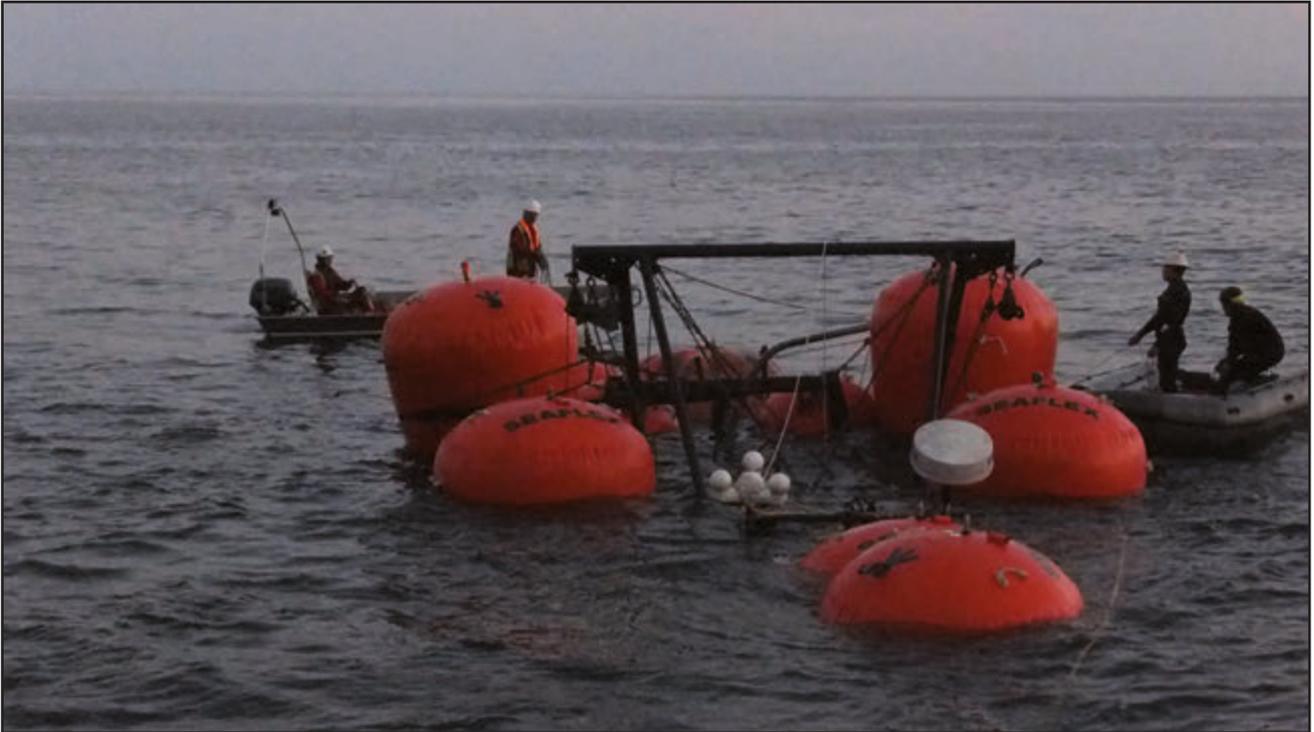
The vessel had been built as a stern trawler but had been modified for scallop dredging. A high gantry had been fitted to lift the scallop dredges, but no calculations had been required or carried out to assess the use of the gantry on the vessel's stability.

Figure 2: The vessel's salvage

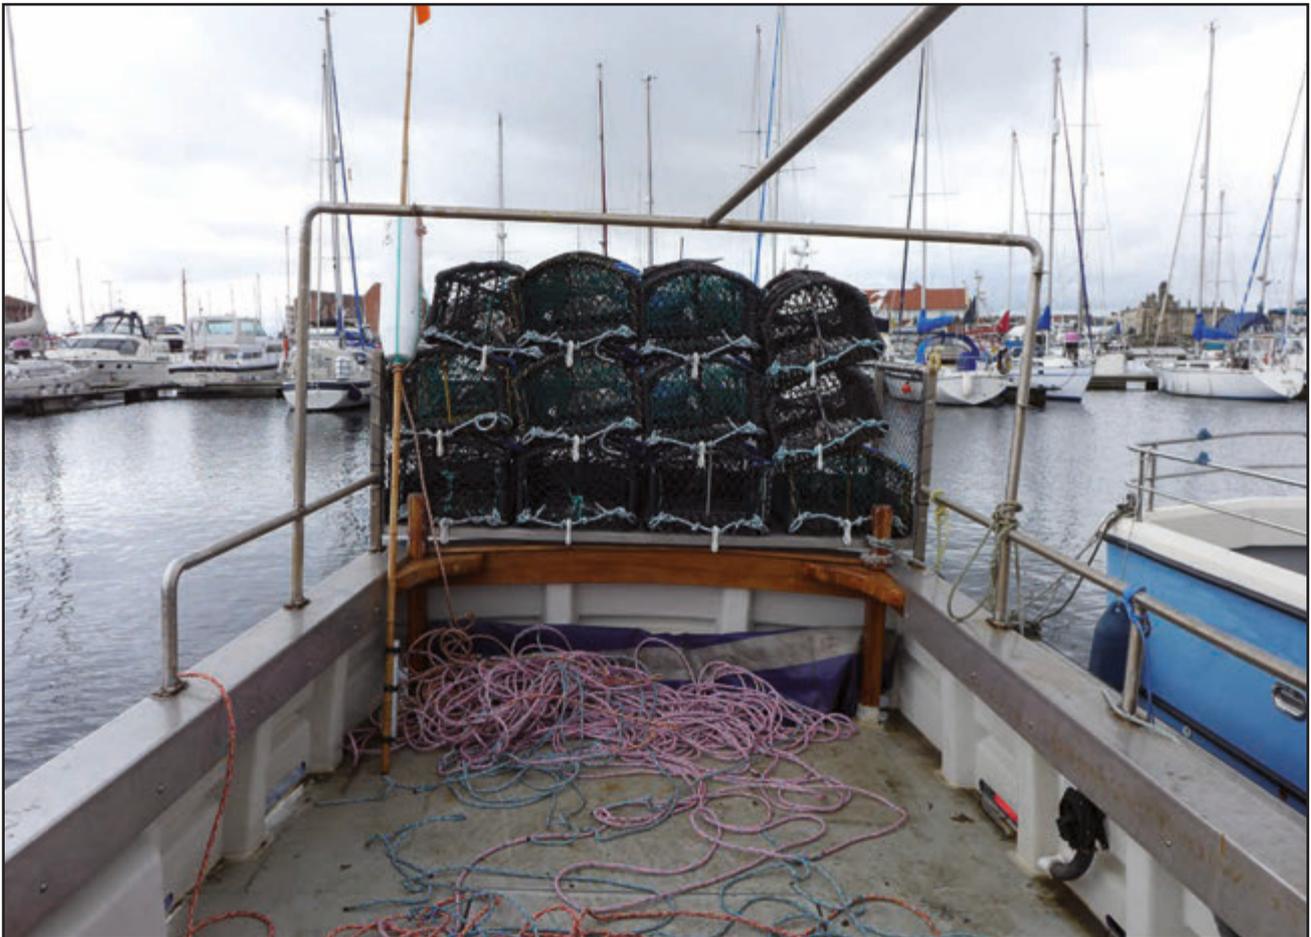
an attempt to free the crewman. However, this was unsuccessful and the crewman was dragged back under water by the weight of the pots still in the sea.

Figure 1: Reconstruction of the deck at the time of the accident showing the hazard associated with loose ropes

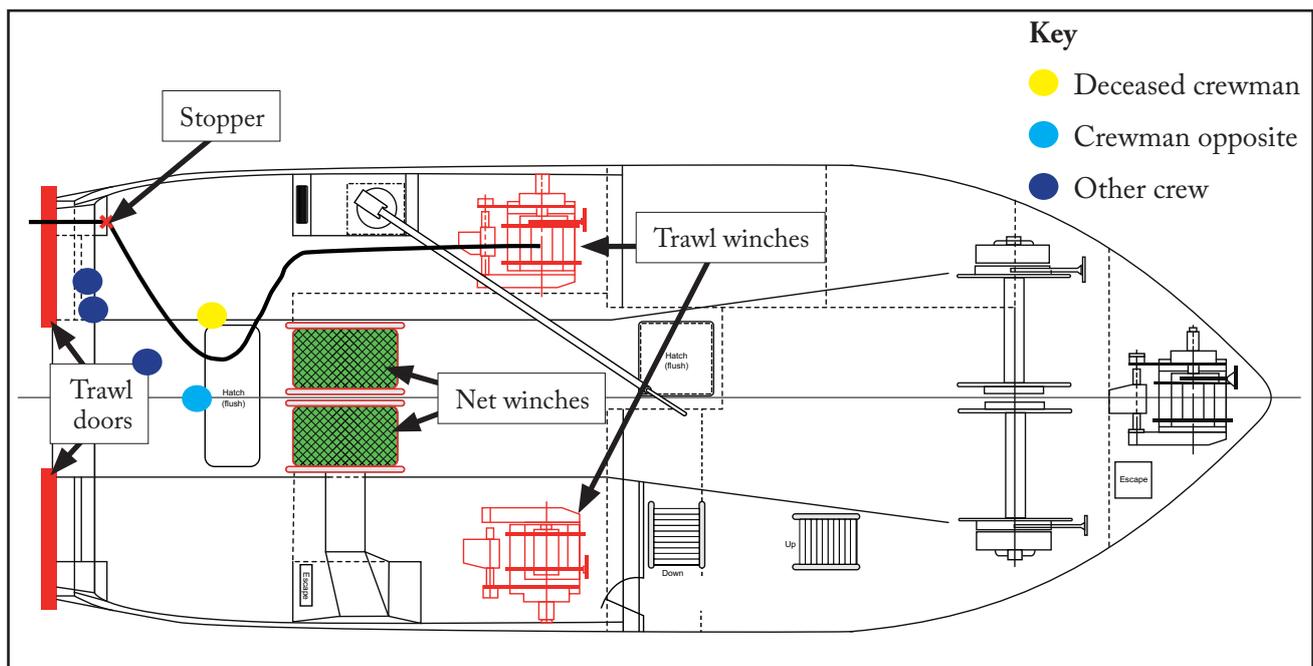
Moments later, the rope stopper failed and the trawl warp snapped tight. The warp struck the crew member across his chest and violently hurled him backwards over the side of the boat and into the sea. Although probably injured by the force of the impact, the crewman was alive and treading water astern of the vessel.

Figure 1: Positions of the deck crew when the stopper failed

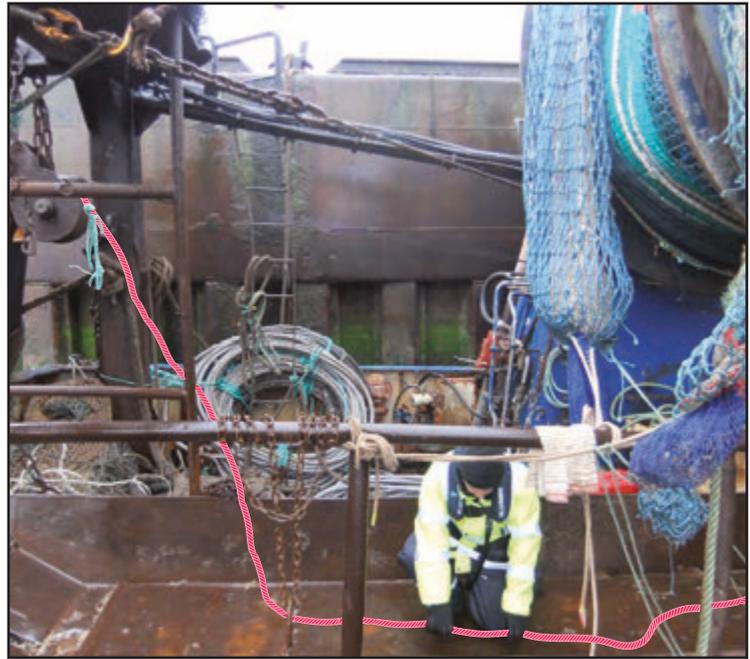
To mark the warps, the crew intended to open up the warp's steel wire strands with a marlin spike and insert short strips of synthetic fibre rope yarns. To give themselves enough room to work, one crew member kneeled inside the bight of the slackened warp while another kneeled opposite him and held the warp down (Figure 2).

Figure 2: Reconstruction of marking the warp

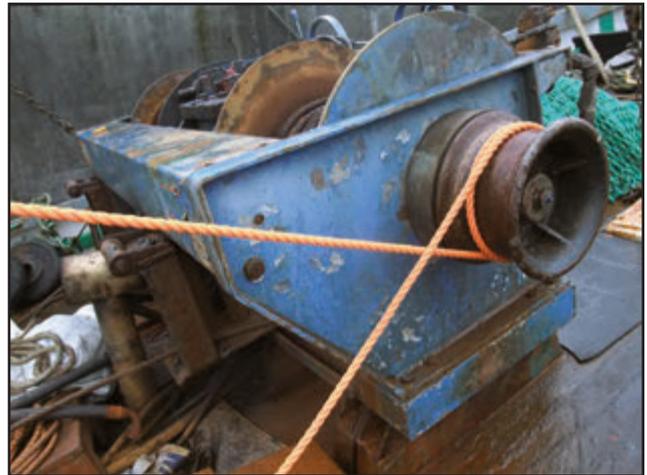
the young deckhand placed his gloved hand against the rope on the drum, pushing against the direction of rotation. His glove and hand became trapped between the rope and the drum, causing them to be drawn in and around the drum.

Starboard whipping drum with 1.5 turns of rope

1. Following the accident, the whipping drums on this boat were modified to be used as captive drums, removing the dangers associated with whipping drums. Have you considered safer options on your boat?
2. This boat was not required to be fitted with emergency stops for its winches. Why wait until you are required to fit stops? Be proactive and fit them now, before you or one of your crew loses a hand.
3. The skipper was new to the boat and did not know the limitations in the young deckhand's knowledge. Know the capabilities of your crew and, if in doubt, ask!

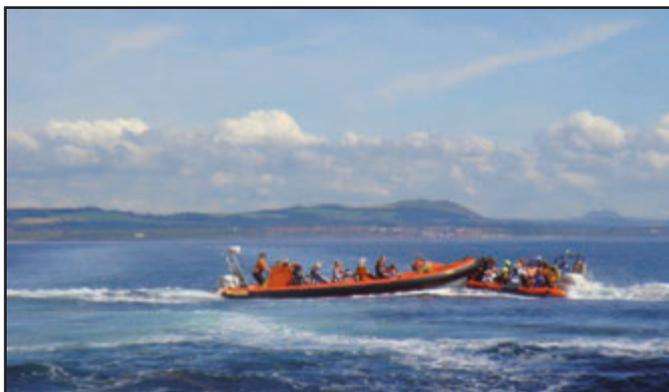
Figure 1: Power turn manoeuvre and collision

A passenger who was sitting on an inflatable tube of one of the RIBs was crushed between the helm console of the RIB she was sitting on and the bow of the colliding RIB. She sustained serious resulting injuries.

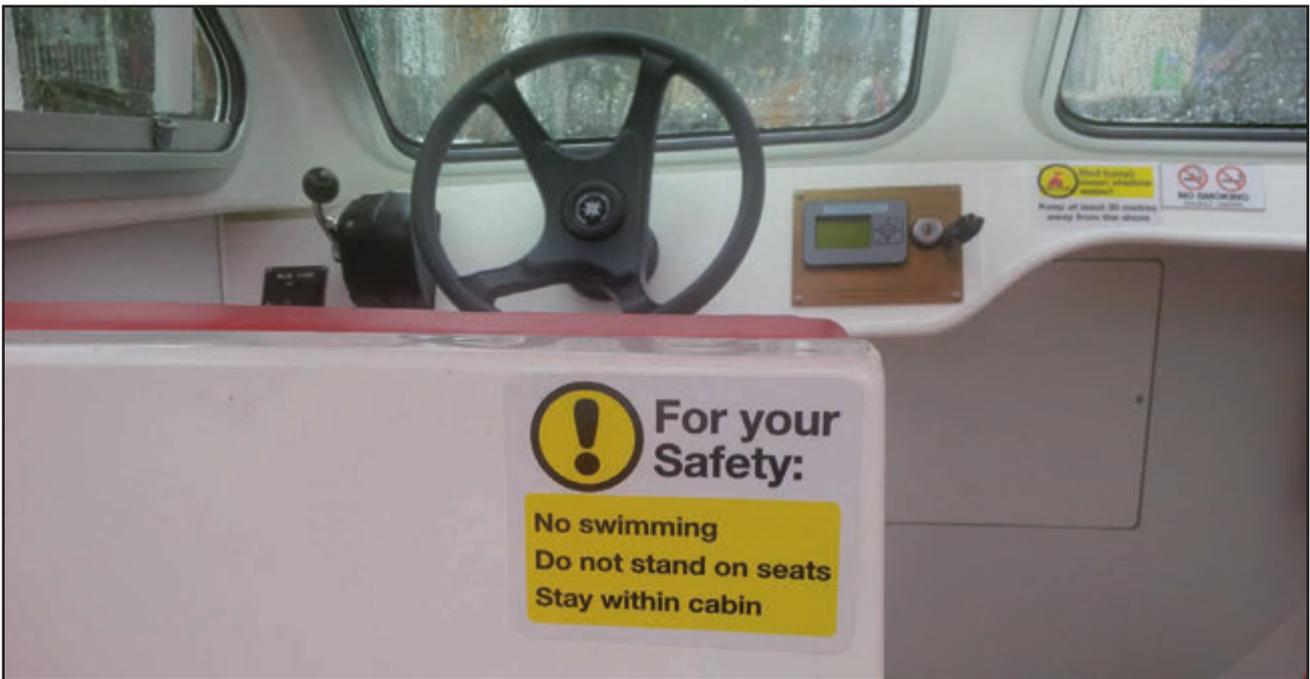
Figure 2: Safety placard

1. In this case, the safety instructions were clear but were ignored. Safety instructions and safety equipment are provided for good reason and are based on the hazards associated with an activity. Follow the rules and you should enjoy a safe and rewarding experience on the water; ignore them and you will expose yourself and others to dangers that you might not fully appreciate.

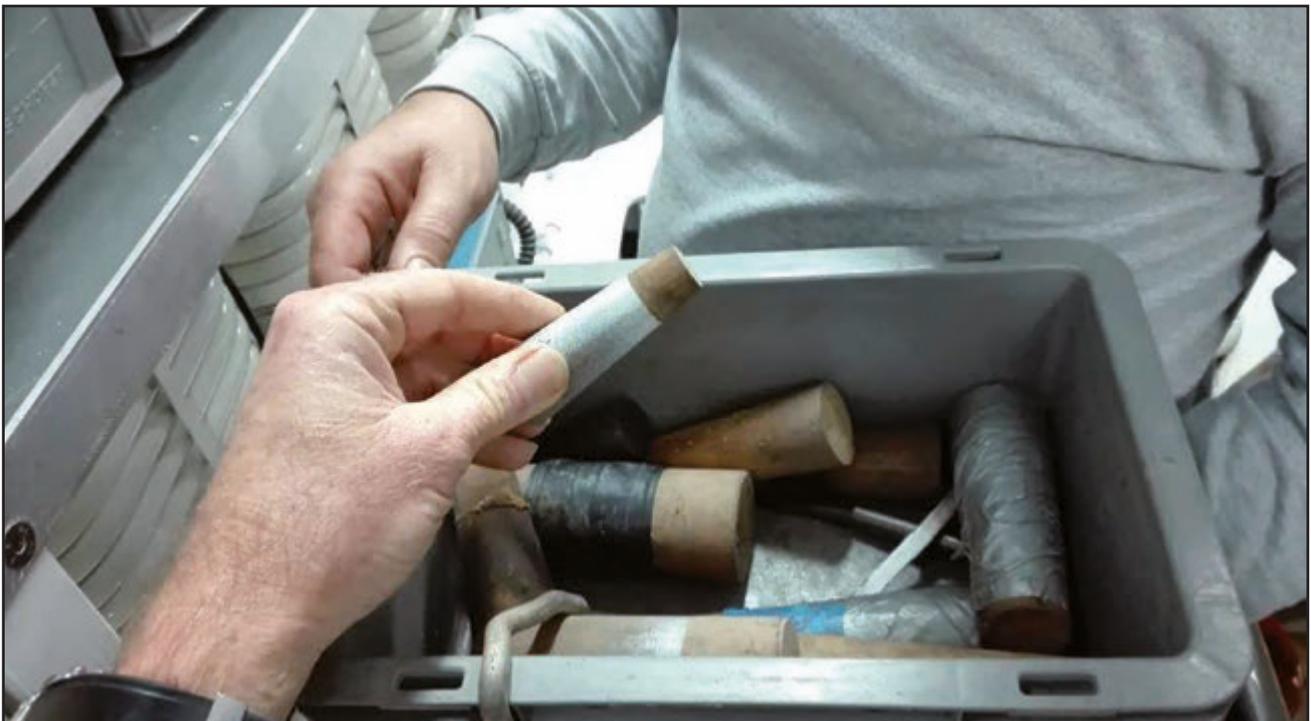
Figure 1: Damage control equipment

The crew of a large luxury yacht were completing maintenance of the hull following a 20-year special survey in preparation for the forthcoming season. The work involved cleaning and de-scaling the engine room bilges before applying anti-corrosion treatment. As the work was being conducted below the yacht's waterline, the master had instructed the crew to have damage control equipment (Figure 1) ready in case the worst should happen.

1. The master's risk assessment of the task had identified the potential for flooding and he had mitigated this through the readying of damage control equipment. Without this preparation, the crew would not have been able to take such effective prompt action and the yacht might have been lost. Careful planning clearly brings its rewards.

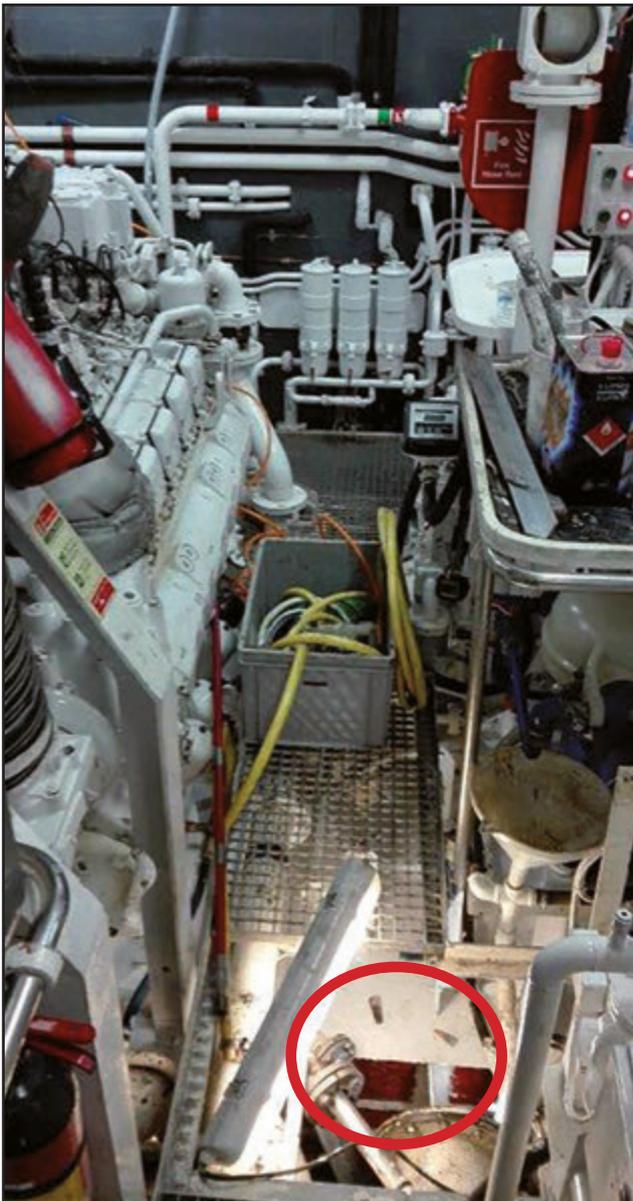
Figure 2: Location of works

The last area of the hull that required maintenance was an area of the hull plating between the main engines (Figure 2). This part of the hull was not accessible when the yacht was operational and was prone to corrosion as

The descaling was going well until the needle gun suddenly punched straight through the hull plating. As the hole was below the waterline, water started flooding quickly into the engine room bilge. The crew immediately used a bung from the damage control equipment to plug the hole, and secured it in place with resin (Figure 3). This initial fix was later replaced by a tapered bung applied by a diver from outside the hole. The tapered plug was secured in place by resin on both sides of the hull plating.

2. The hull of any vessel may be a point of failure if not adequately maintained. Difficult to reach locations are sometimes neglected due to their inaccessibility and are prone to corrosion if not properly maintained. Don't rely solely on surveys to tell you about the condition of your hull; you will know best where the likely weak points are.

The motor yacht was later lifted out of the water for permanent repair.

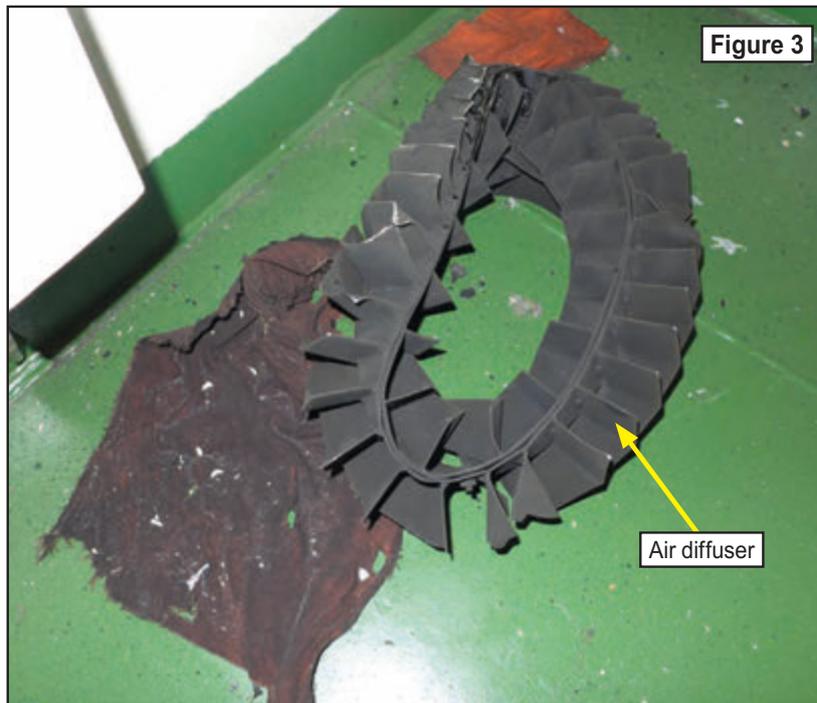
**Figure 3**

The boiler explosion occurred while the second engineer and the oiler were trying to restart the boiler burner unit following a flame failure cut-out. The force of the explosion blew open the boiler burner unit door (**Figure 2**) and propelled the burner's air diffuser into the engine room (**Figure 3**). The oiler was standing directly in front of the burner unit and the second engineer was close by.

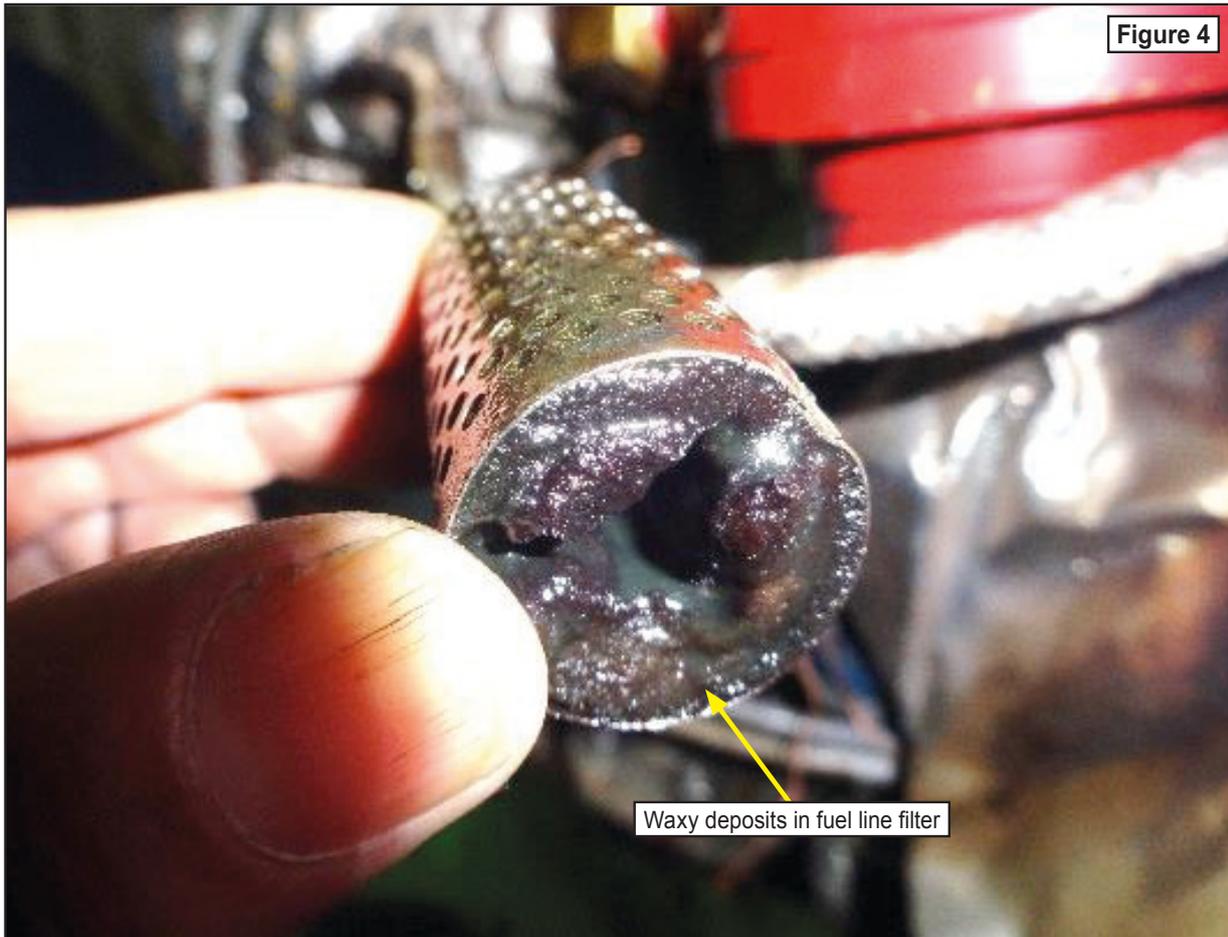
**Air diffuser**

Industry reports indicate an increased incidence of boiler and marine diesel engine performance problems in colder waters following the implementation of the more stringent sulphur emissions limit. This has been attributed to the increased paraffin content found in some low sulphur distillate fuels (MGOs) and the subsequent formation of waxy deposits or crystals as the fuel temperature falls. Restricted fuel flow due to wax deposits in filters and pipework can cause intermittent and incomplete combustion to the point of flame failure.
