Final report MO-2016-201: Restricted-limits passenger vessel the *PeeJay V*,
Fire and sinking , 18 January 2016

Marine inquiry MO-2016-201

Restricted-limits passenger vessel the *PeeJay V*
Fire and sinking

18 January 2016

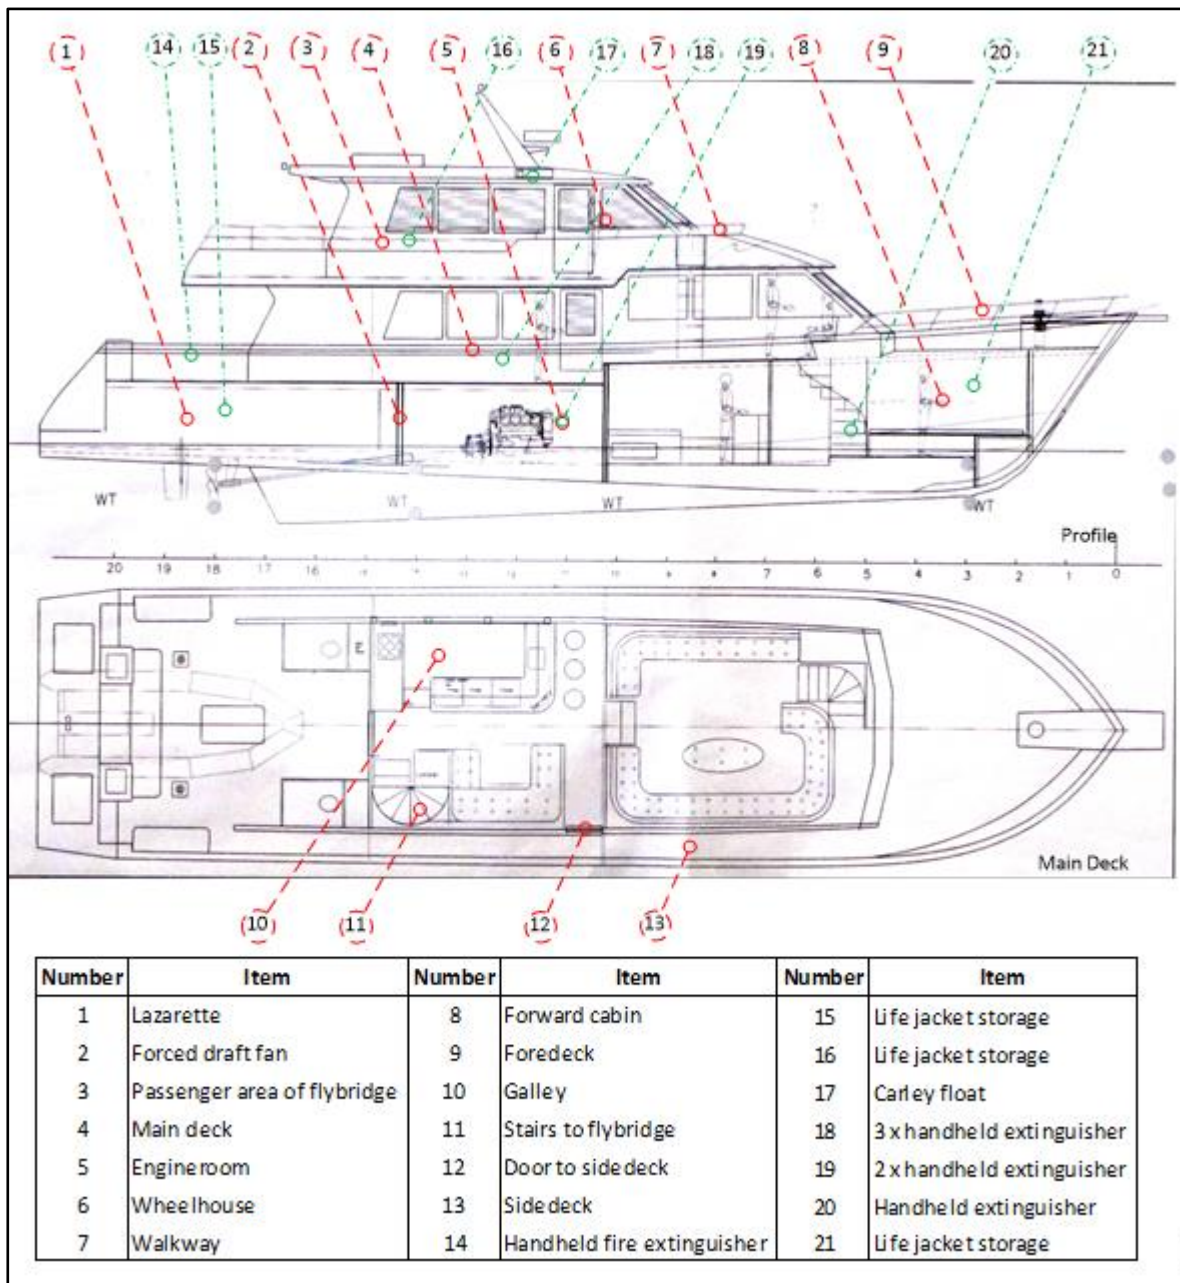
Figure 1
General arrangement of the *PeeJay V*

- 3.1.3. As part of the pre-sailing preparations he reviewed the recent entries that had been made in the maintenance logbook, opened the engine room hatch and visually inspected the bilge and bilge pump, fuel level, the batteries, steering system, generator and the inverter. He started the engines and checked systems before shutting them down again. During his pre-sailing checks the skipper did not notice anything irregular. He returned to the bridge (shown in Figure 1) and continued preparations for sailing.

- 3.1.9. At about 1530 the *PeeJay V* was about half a nautical mile away from crossing the Whakatāne bar when the tour manager and a deckhand standing near the galley (shown in Figure 1) smelt fumes. The deckhand immediately went up the stairs to the flybridge from where he could alert the skipper in the wheelhouse. The skipper checked the wheelhouse dashboard gauges and control panels but did not see or hear anything irregular.

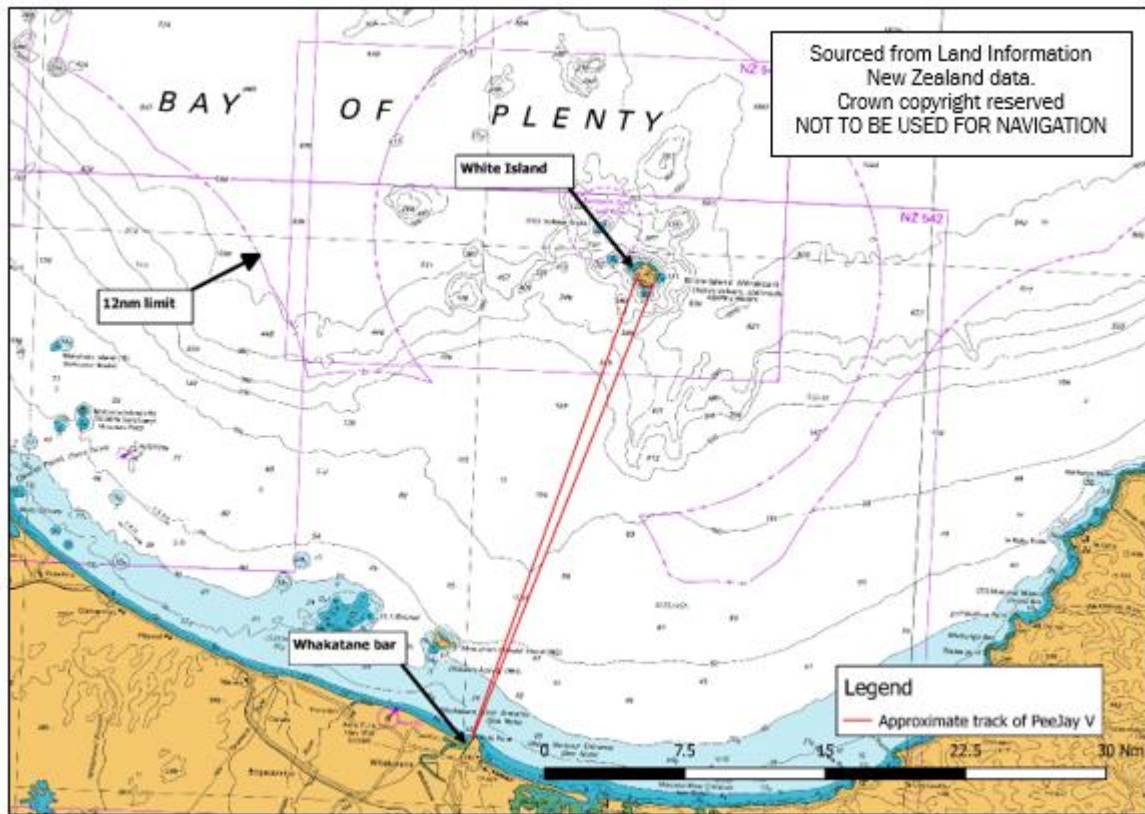
Figure 2
Chart showing approximate track of the *PeeJay V* on its passage to and from White Island²

3.1.6. At about 1000 the passengers started boarding. When all 53 passengers were aboard the crew delivered the introductory briefing. The briefing included an overview of the day's itinerary, the location of life-jackets and other information pertinent to the safety and enjoyment of the passengers. At about 1010 the skipper started the engines and the *PeeJay V* departed Whakatāne. The *PeeJay V* crossed the Whakatāne River bar at about 1015 and began the 26 nautical mile (nm) passage to White Island (shown in Figure 2).
