# National Transportation Safety Board

## Marine Accident Brief

### Fire aboard Sailing Vessel *Best Revenge 5*

| <b>Accident no.</b> | DCA17FM021 |

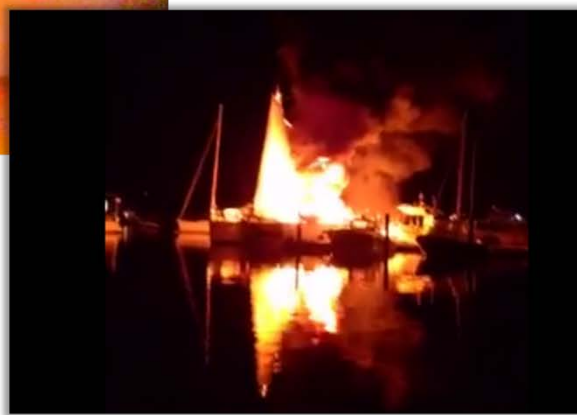
*Best Revenge 5* on fire at the dock. (Photo courtesy of Satellite News Service; screen shot from video courtesy of Gayle Kiley via Cape Cod Times)
