Isle of Man Ship Registry

Casualty Investigation Report No. CA 128

M/V Cheshire

Ammonium nitrate fertiliser cargo decomposition

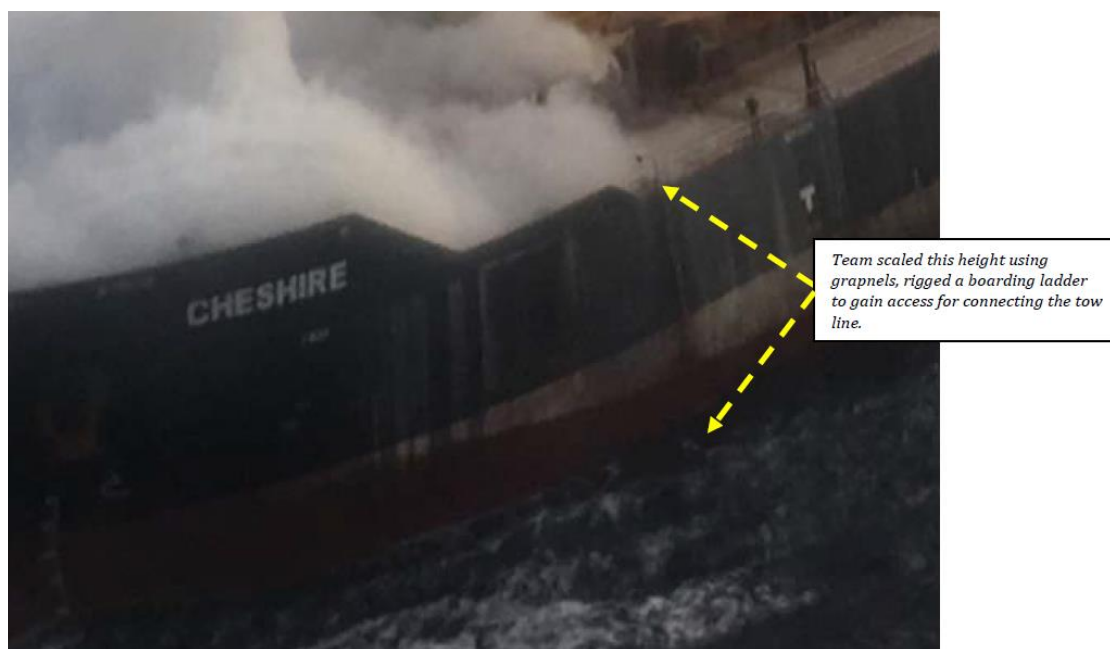
Initial salvage access to vessel, by gas colour CH#2 is seen to be at a more advanced stage of decomposition than CH#1^[1]

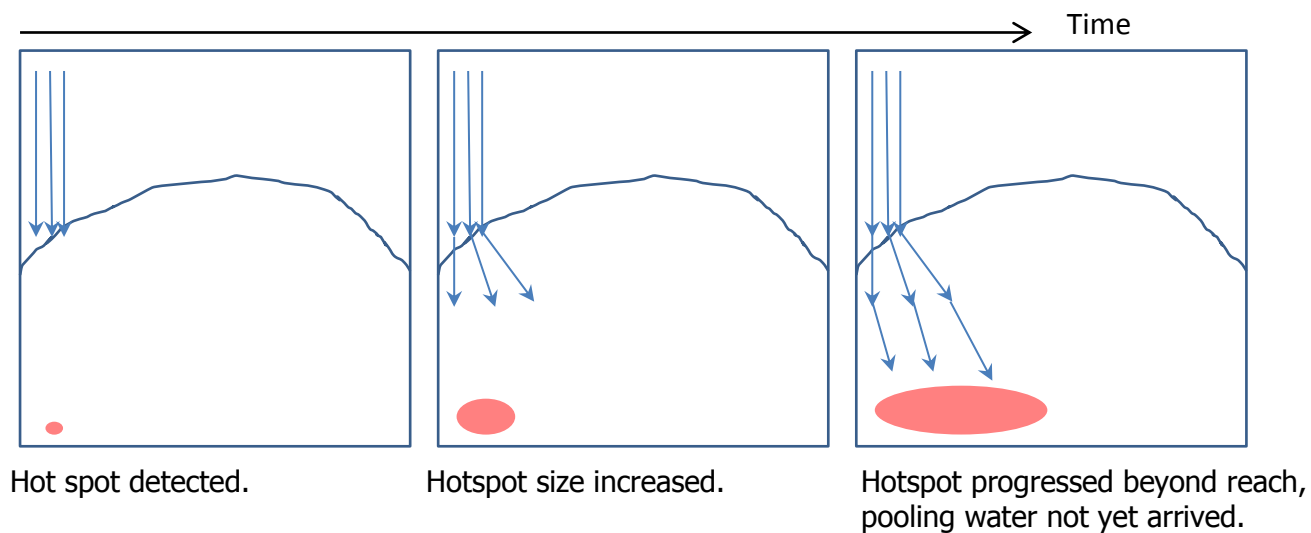
Figure one - Hose cooling from the cargo surface, time is taken for the water to fall through the bulk pile - large quantities of water are required for cooling effect to be observed (can cause stability issues for the vessel and significant cargo water damage!)

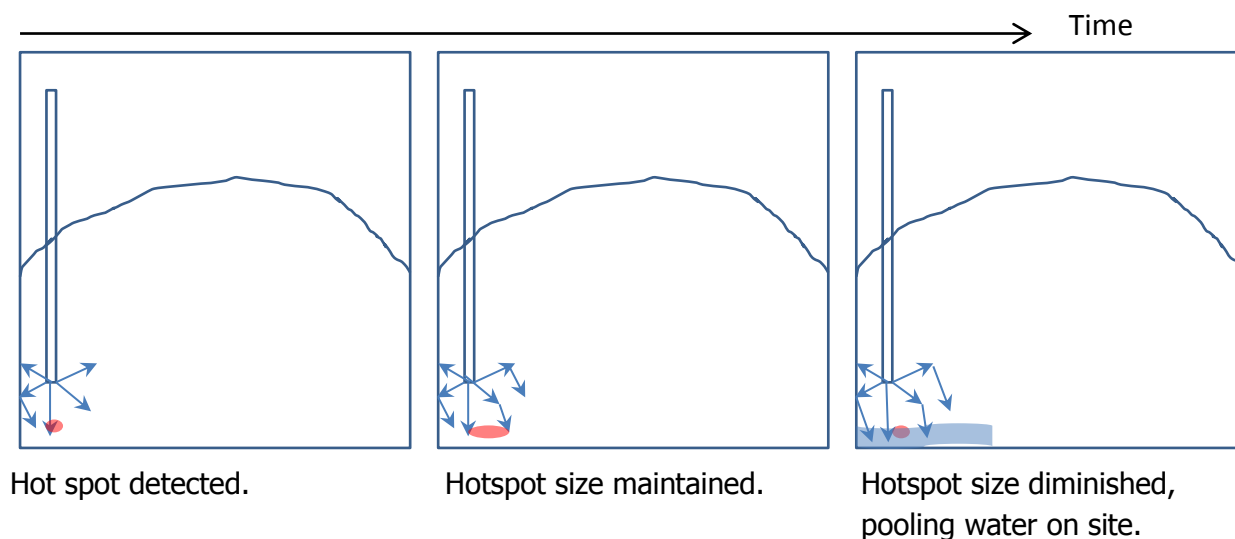
Figure two - Victor Lance application of water directly at the source of the decomposition – much smaller quantities of water are required (very effective use of it, minimal stability impact and less cargo water damage)
