NTSB | National
Transportation
Safety Board

SAFER SEAS DIGEST

Lessons Learned from Marine Accident Investigations | **2017**

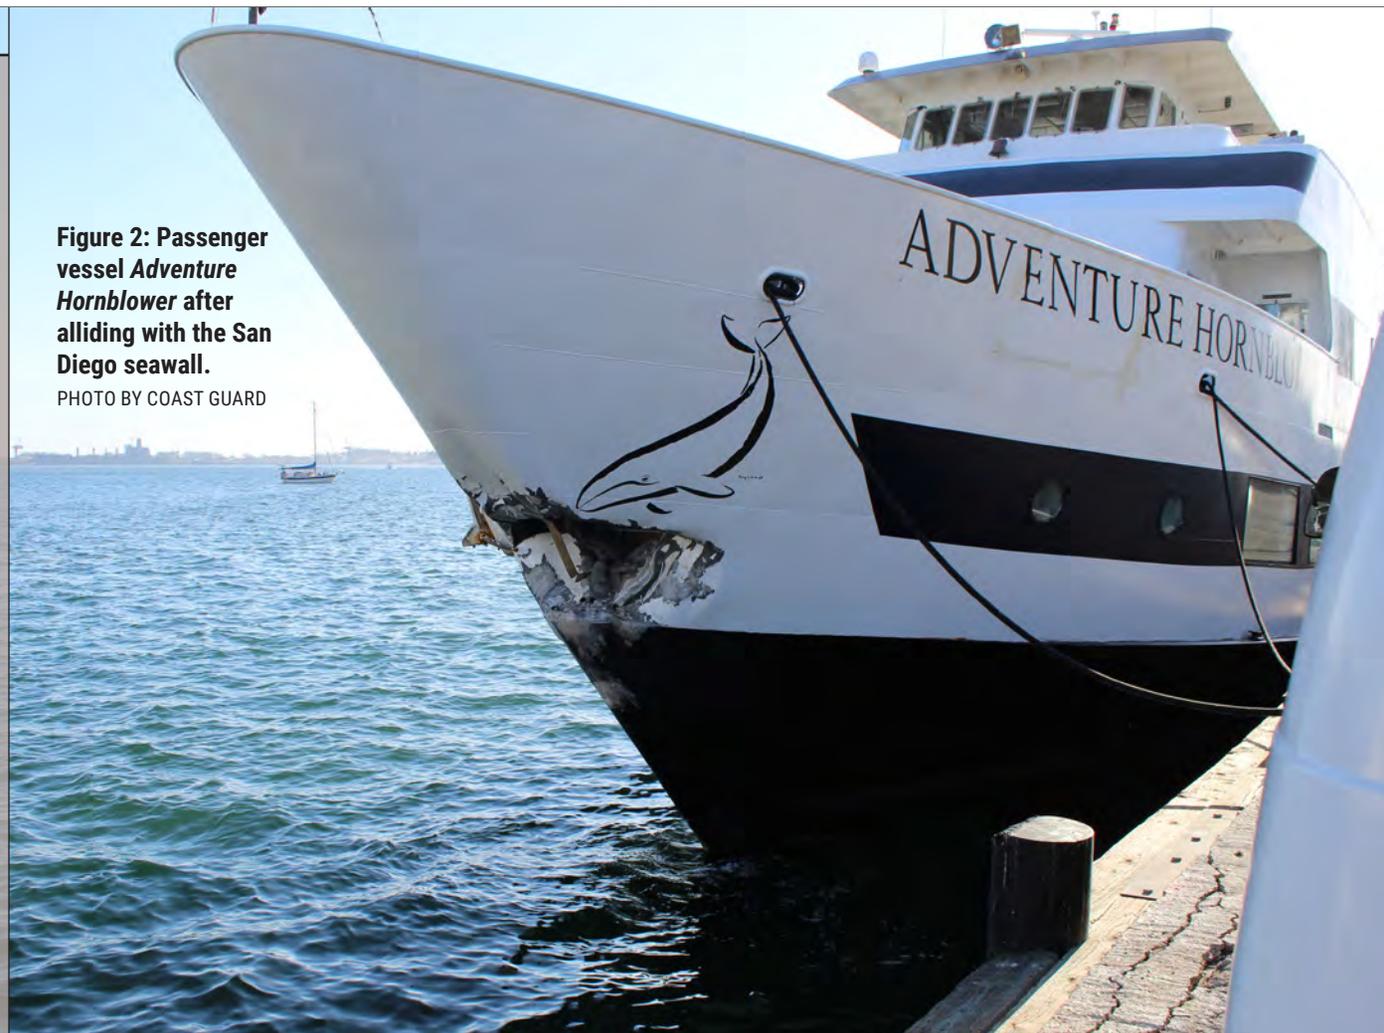
Figure 2: Passenger vessel *Adventure Hornblower* after alliding with the San Diego seawall.

On the afternoon of March 31, 2016, the passenger vessel *Adventure Hornblower* was attempting to dock at the Navy Pier in downtown San Diego, California, following a whale-watching excursion. As the vessel made its approach to the pier, its bow unexpectedly swung to starboard and allided with the pier's passenger embarkation dock. The *Adventure Hornblower* then accelerated forward until it struck the seawall at the foot of the pier. Eight passengers sustained minor injuries in the accident. The allision caused nearly \$1.06 million in damage to the vessel, pier, and seawall.

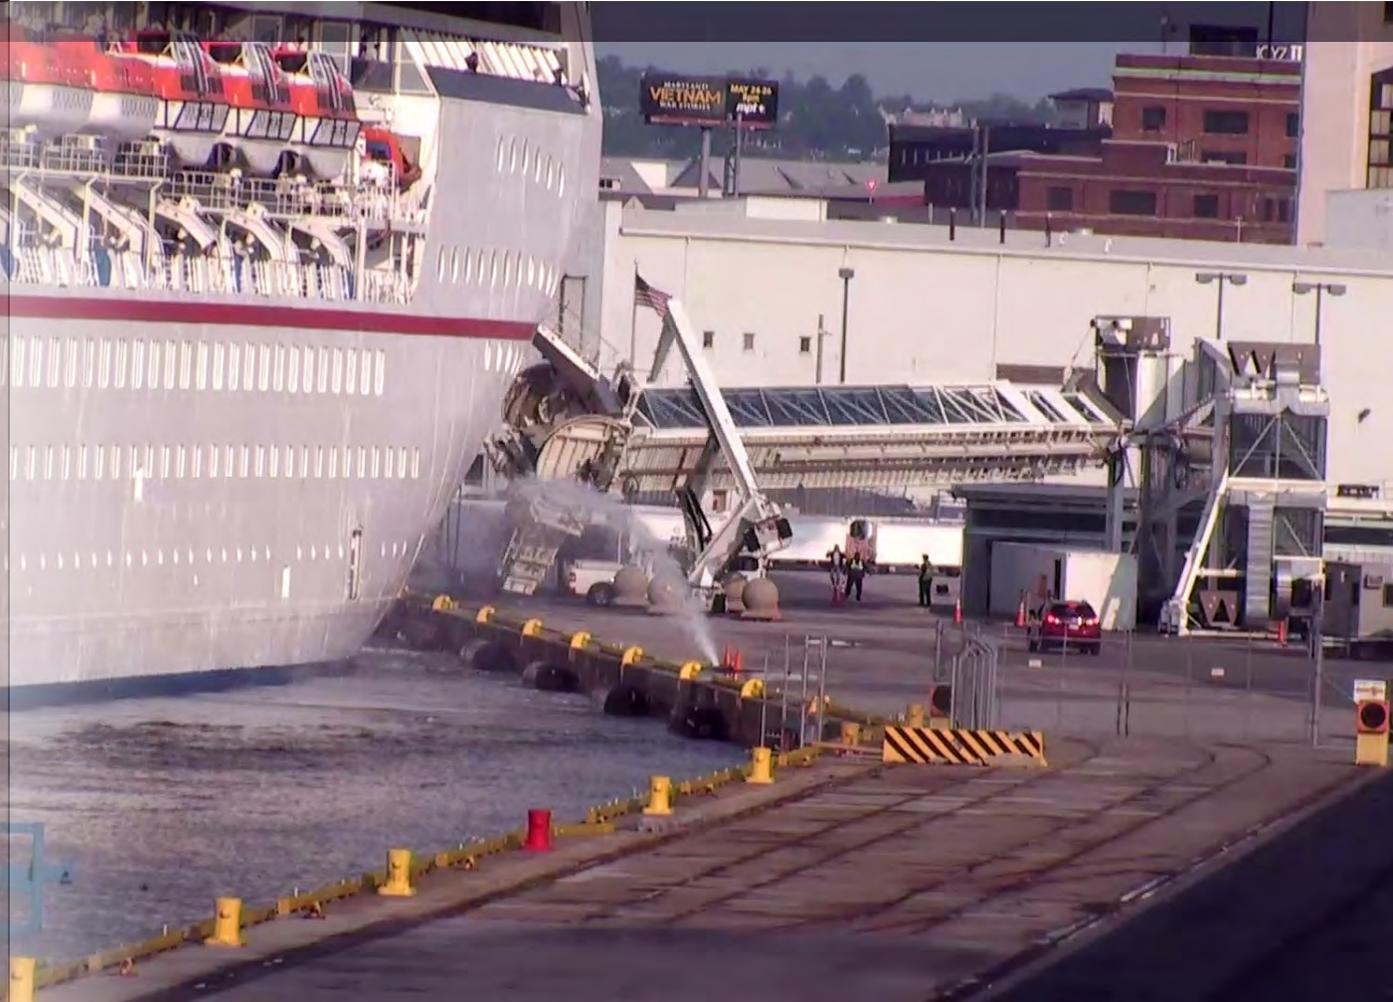
Figure 7: The elevated passenger embarkation walkway, in the midst of falling to the ground and crushing three vehicles, after it was impacted by *Carnival Pride's* observation and mooring platform.

On the morning of May 8, 2016, at 0800 local time, the cruise ship *Carnival Pride* was attempting to dock in Baltimore, Maryland, when its bow struck the pier, fendering, and an elevated passenger embarkation walkway on shore. The allision caused nearly \$2.1 million in damage. The walkway was destroyed, three vehicles that were under it during the collapse were damaged, and the vessel sustained minor damage. No one was injured and no pollution was reported.

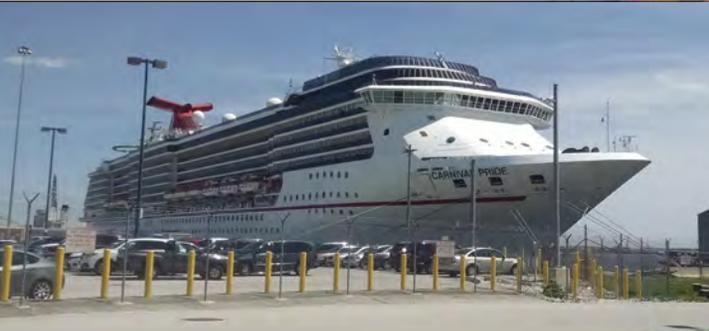
Figure 8: *Carnival Pride* at the Cruise Maryland Terminal berth following the accident. PHOTO BY COAST GUARD

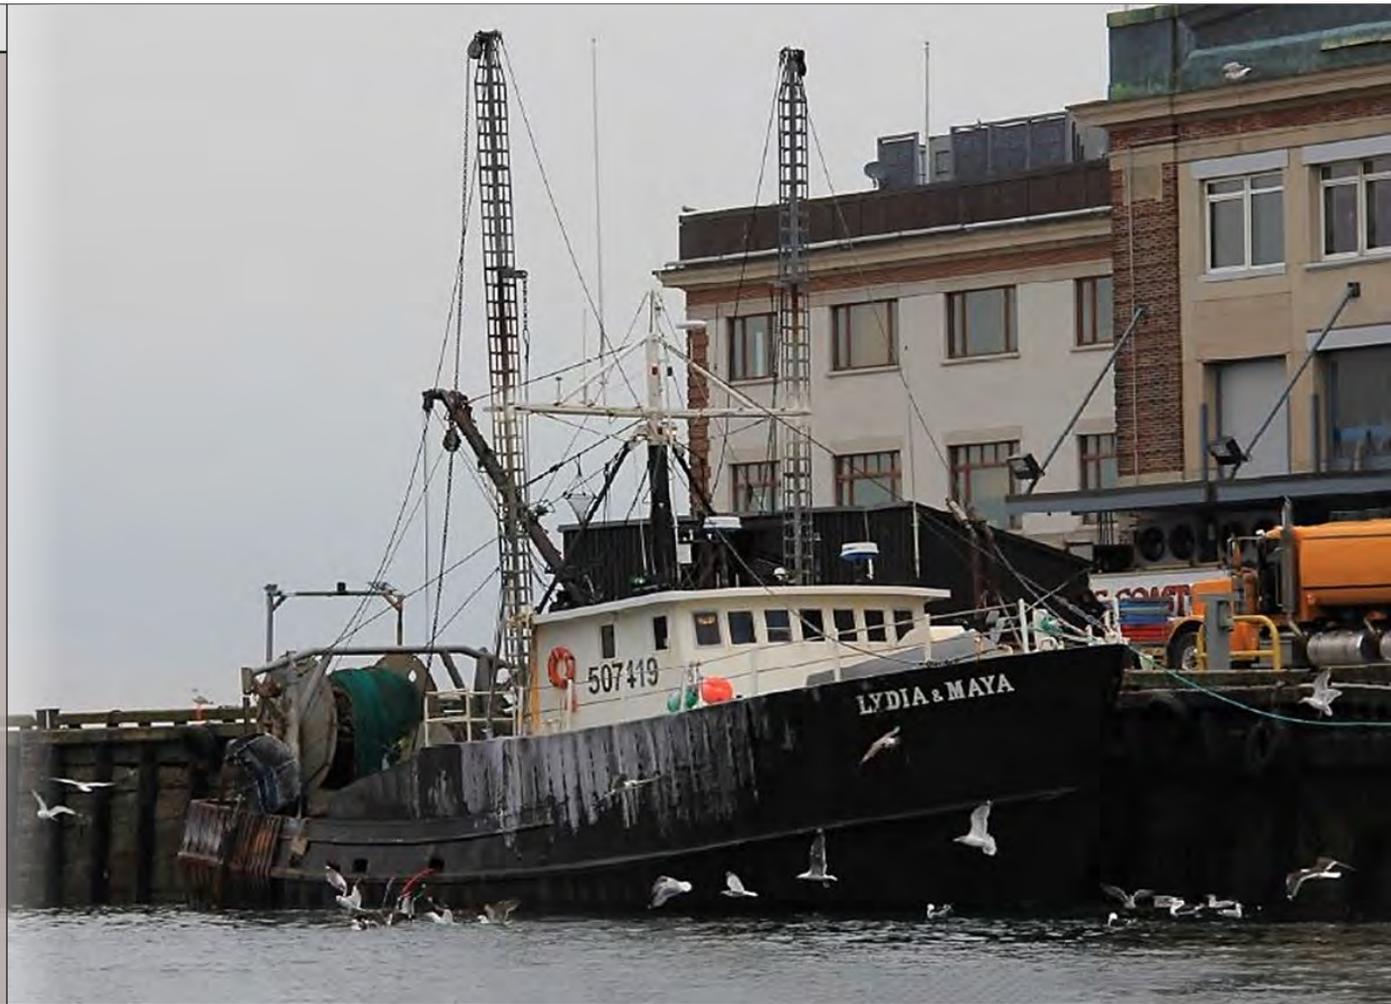
Figure 23: *Lydia & Maya* before the sinking.

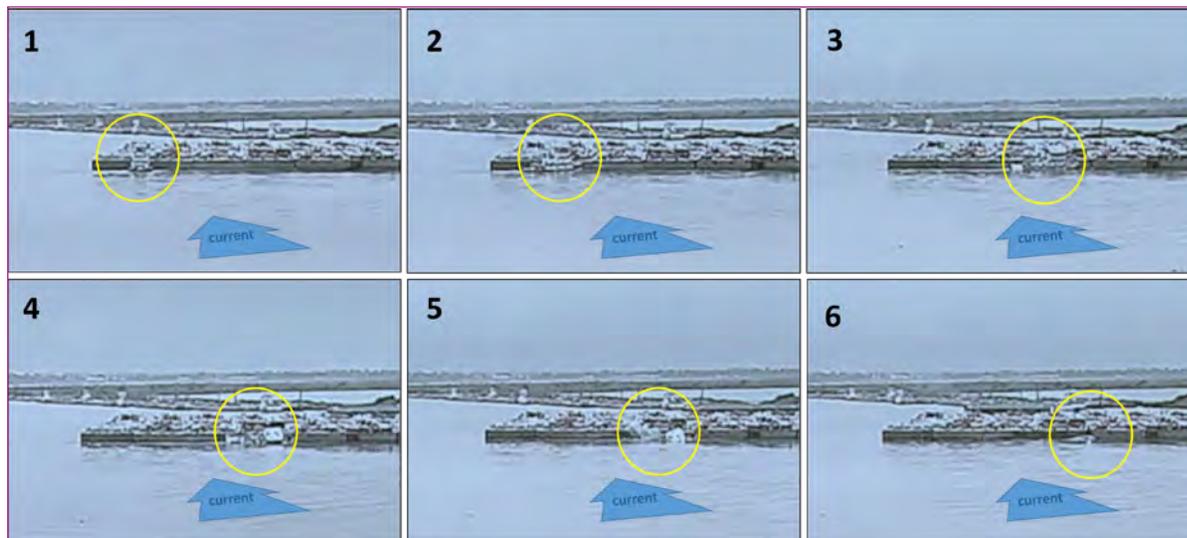
■ The NTSB determined that the probable cause of the capsizing and sinking of the towing vessel *Ricky J Leboeuf* was the relief captain's ill-advised decision to perform a downstreaming maneuver in high-water conditions without implementing the operating company's risk mitigation strategies or other safeguards.

Figure 26: Still-images from video of the capsizing and sinking. IMAGES BY HARRIS COUNTY SHERIFF DEPT.

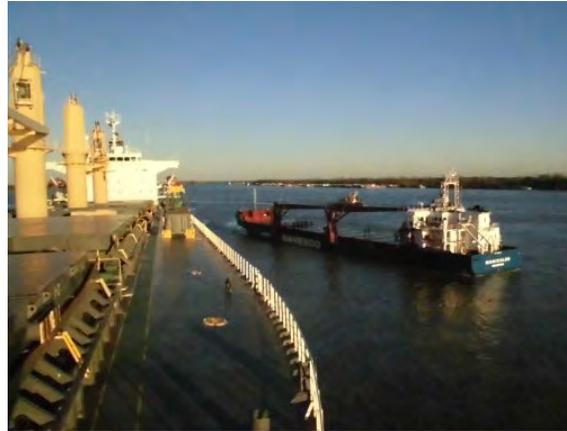
About 17 minutes after anchoring the *Manizales*, the pilot noted that the anchor chains had become taut. At this time, the stern of the *Manizales* was about 500 feet from the bow of the *Zen-Noh Grain Pegasus*. Just as the pilot was about to disembark the *Manizales*, at 1628, the *Manizales's* bow swung into the river. By the time the pilot returned to the bridge, the ship was almost perpendicular to the river. At 1629, the pilot ordered the rudder to starboard and the engine to half-ahead speed. However, the pilot told investigators that the engine was not in standby and therefore not available for several minutes to provide the ordered propulsion power. Conversely, the vessel's chief officer stated that the engine was operating and that he saw propeller wash before the collision. Investigators could not conclusively

Figure 31: *Manizales* drifting down the port side of the anchored *Zen-Noh Grain Pegasus*.

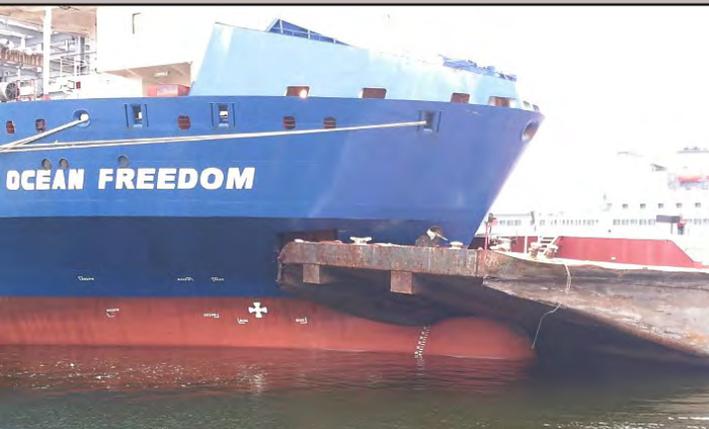
■ The NTSB determined that the probable cause of the collision of the *Ocean Freedom* with the moored tank barges was the pilot's rudder order in a direction opposite of which he intended. Contributing to the accident was the failure of the bridge team to identify the risk of collision and take appropriate action.

Figure 34: Impaled by the bow of the *Ocean Freedom*, the starboard bow of the *Kirby 28044* is lodged just above the vessel's bulbous bow.

On the night of October 29, 2015, at 2226 local time, the cargo vessel *Ocean Freedom* collided with a fleet of moored empty tank barges while entering the Port of Corpus Christi, Texas. One crewmember, who was working on one of the barges, suffered non-life-threatening injuries. Although no environmental damage was reported, the *Ocean Freedom* and the three tank barges sustained structural damage estimated at \$750,000.

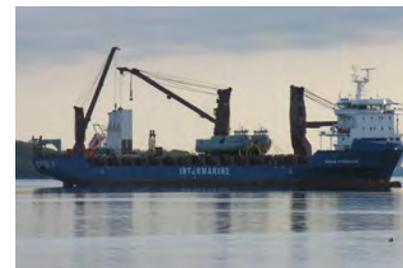
Figure 35: Cargo vessel *Ocean Freedom*. PHOTO BY RICK COMEAU

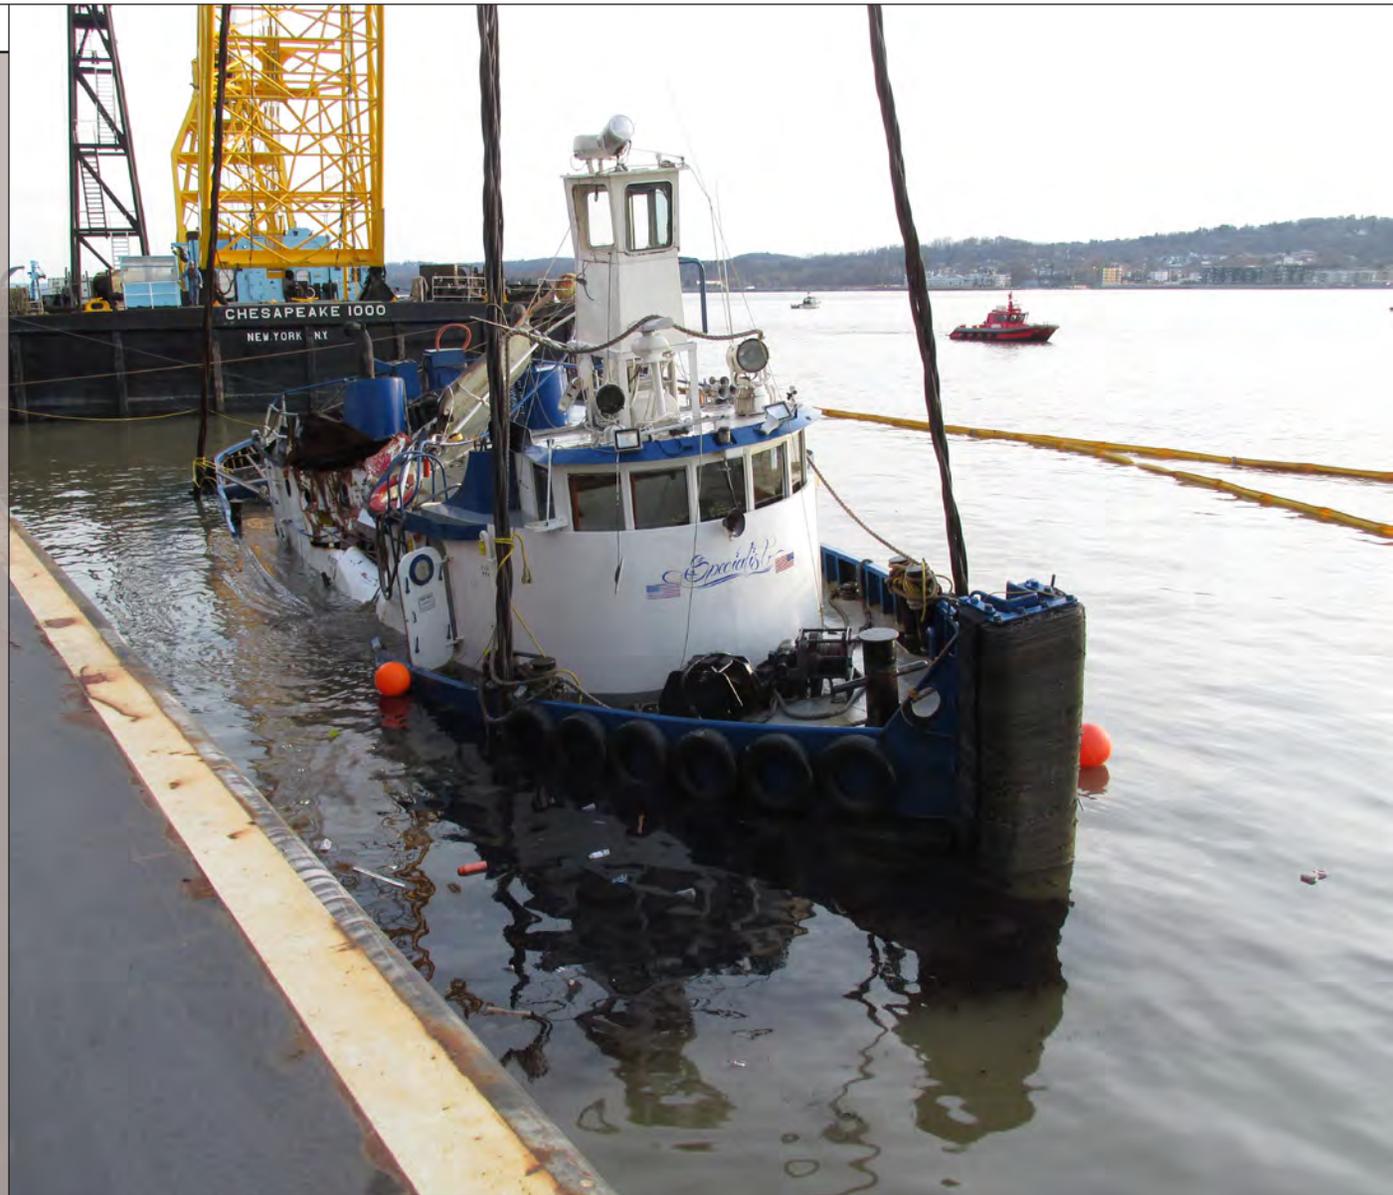
Figure 36: Towing vessel *Specialist* after being raised from the river bottom.

■ The NTSB determined that the probable cause of the collision and sinking of the *Specialist* was inadequate manning, resulting in fatigued crewmembers navigating three tugboats with obstructed visibility due to the size of the crane on the barge they were towing and the location of the tugboats alongside the barge.

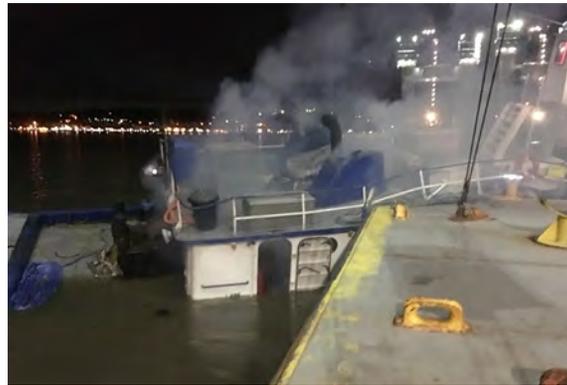
Figure 37: The *Specialist* (left), moments after colliding with a work barge at the Tappan Zee Bridge.

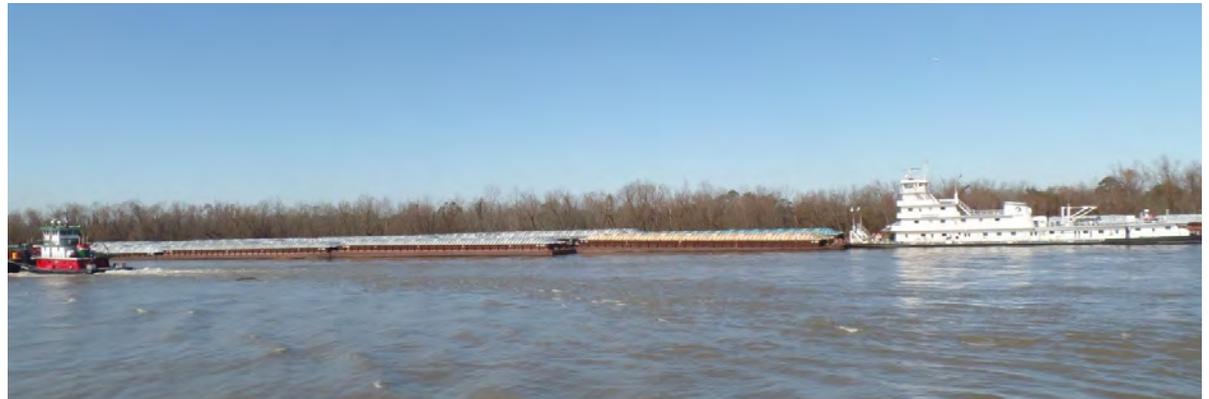
Figure 40: Towing vessel *Crimson Gem* with the remaining barges following the collision. PHOTO BY COAST GUARD

■ The NTSB determined that the probable cause of the collision of the *Crimson Gem* tow with the moored bulk carrier *Yangtze Ambition* was the *Crimson Gem* pilot's ineffective maneuvering for the prevailing current in a river bend.

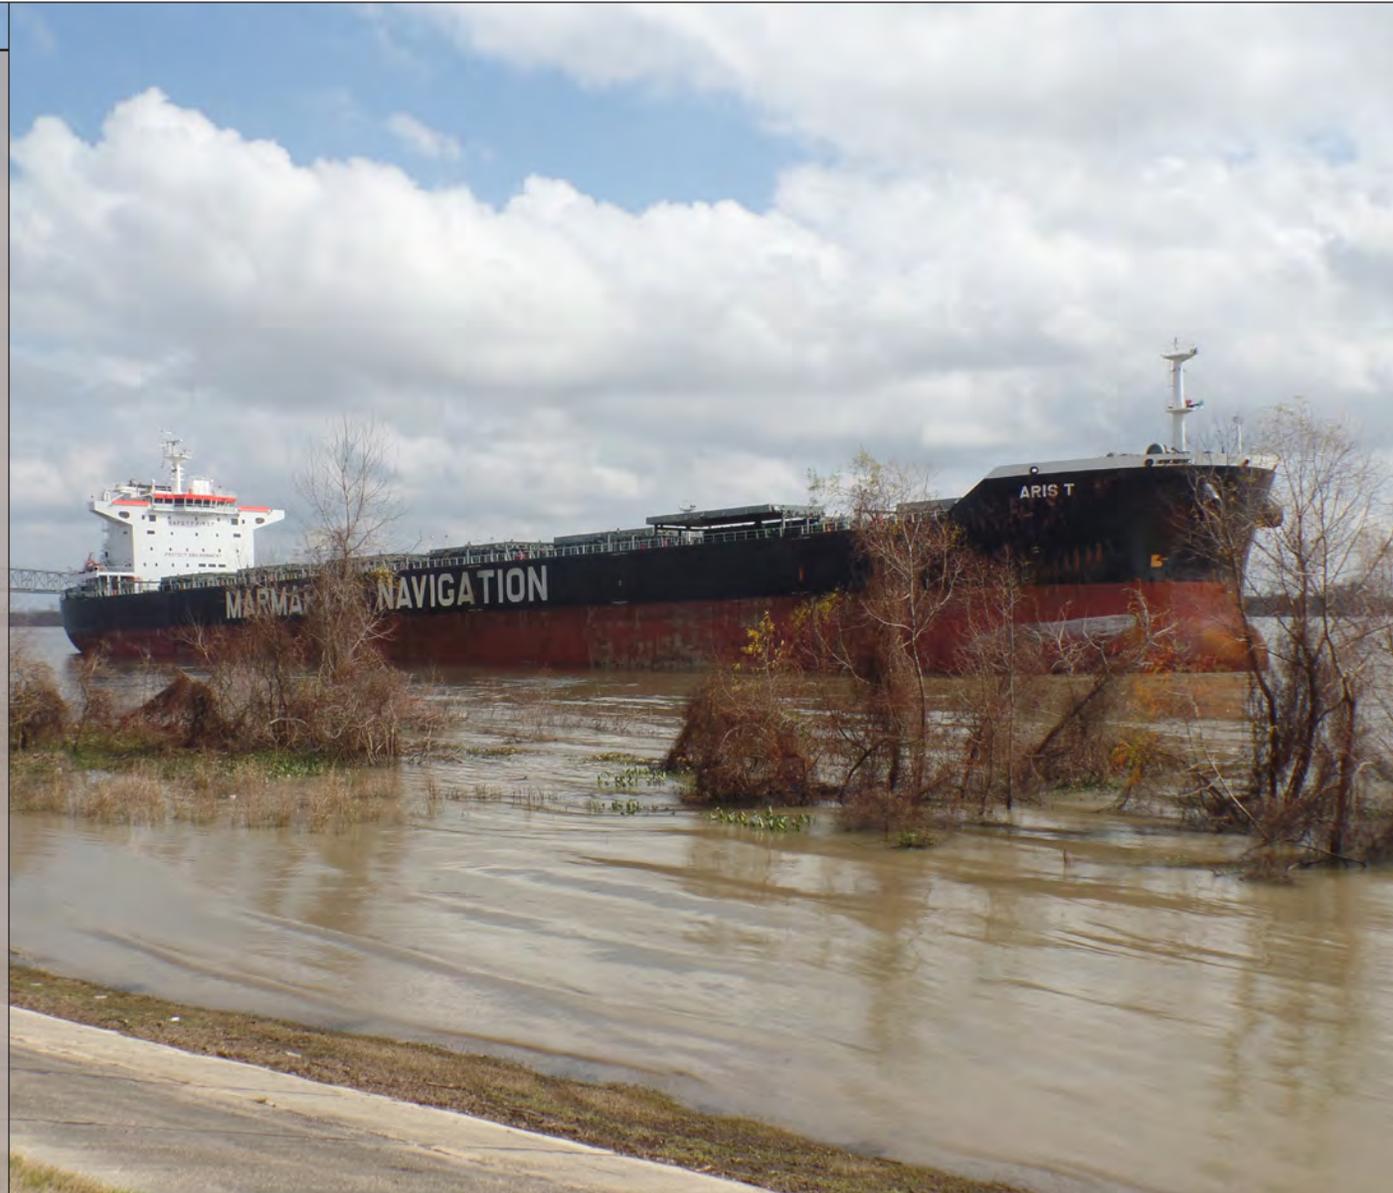
Figure 41: Postaccident image of the *Aris T* anchored on the Mississippi River at Grand View Reach Anchorage, mm 147.0, near Gramercy, Louisiana. PHOTO BY COAST GUARD

■ The NTSB determined that the probable cause of the collision of bulk carrier *Aris T* with tank barge *WTC 3019*, towing vessel *Pedernales*, and shoreside structures was the failure of the pilot on the *Aris T* to take early and effective action to mitigate the risk presented by the developing upriver traffic situation, and the distraction of the captain on the *Loretta G. Cenac* from safety-critical navigational functions as a result of his cell phone use.

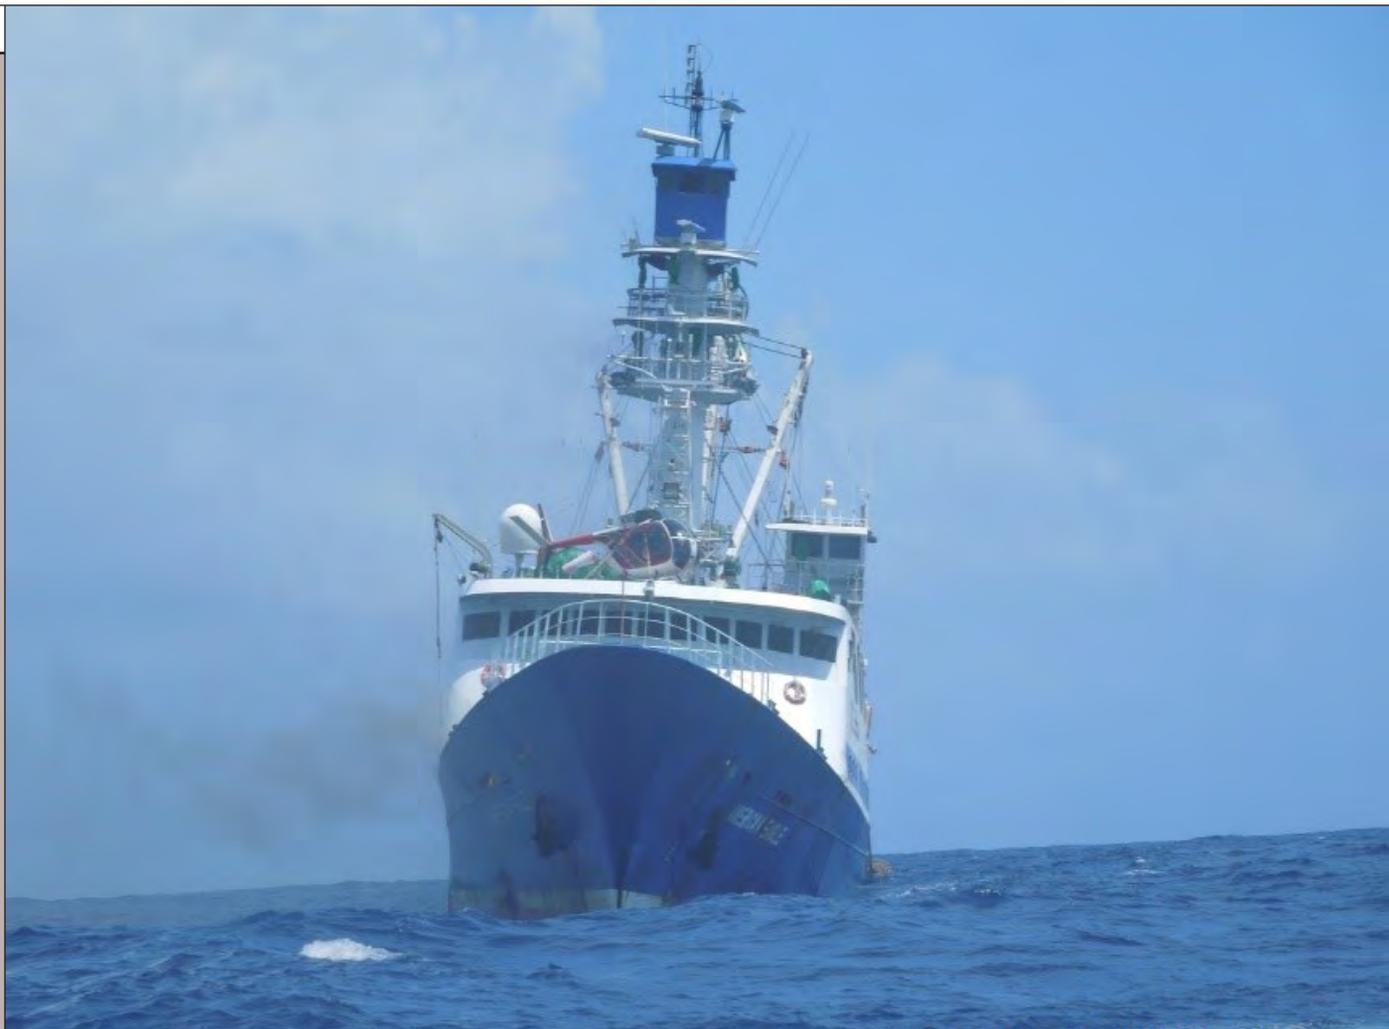
Figure 42: *American Eagle* abandoned and listing to port. PHOTO BY AMERICAN EAGLE CREW

At some point during the emergency, the *American Eagle* suddenly listed to port as water was likely accumulating from firefighting efforts and was not being pumped overboard. About the same time, smoke from the fire increased significantly. At 1010, the captain ordered abandon ship. The crew launched and boarded four lifeboats and two inflatable liferafts, and they activated the EPIRB.

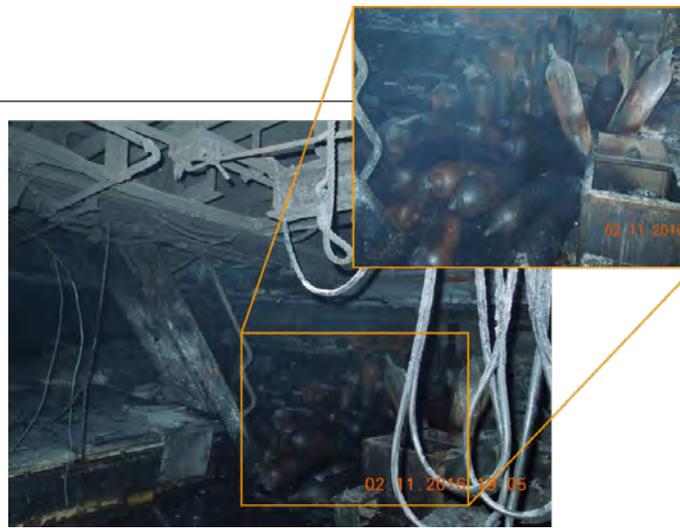
Figure 43: Oxygen and acetylene bottles post-fire on the starboard side of the wet deck aft of the ladder, with close-up of bottles without safety caps. Bottles were displaced from their storage location forward of the ladder. PHOTO BY AMERICAN EAGLE CREW

The fuel source for the fire was determined to be acetylene gas. The hose that connected the cylinders to the torch was in poor condition (cracking, bending wear, several holes, and a 6-inch electrical tape repair at a hose separation). Investigators learned that the area where the cylinders were stowed was a regular smoking stop for the crew; a waste bucket for discarded cigarette butts was located adjacent to the cylinders. Cinders from the waste bucket were a potential ignition source, but the ignition source could not be definitively determined. Investigators discovered that over 25 oxygen and acetylene cylinders were stored together, they were not secured in a suitable rack and that none of the cylinders had safety caps to protect the valves atop from damage.

■ The NTSB determined that the probable cause of the fire on board fishing vessel *American Eagle* was the ignition from an undetermined source of acetylene gas mixed with oxygen, most likely leaking from a degraded hose connected to cylinders stored in a working space below decks. Contributing to the severity of the fire were the numerous acetylene and oxygen cylinders improperly stowed near the fire, which provided additional fuel and oxygen to the fire. Contributing to the extent of the damage on board the vessel was the lack of a common language between all crewmembers, which hampered firefighting efforts.

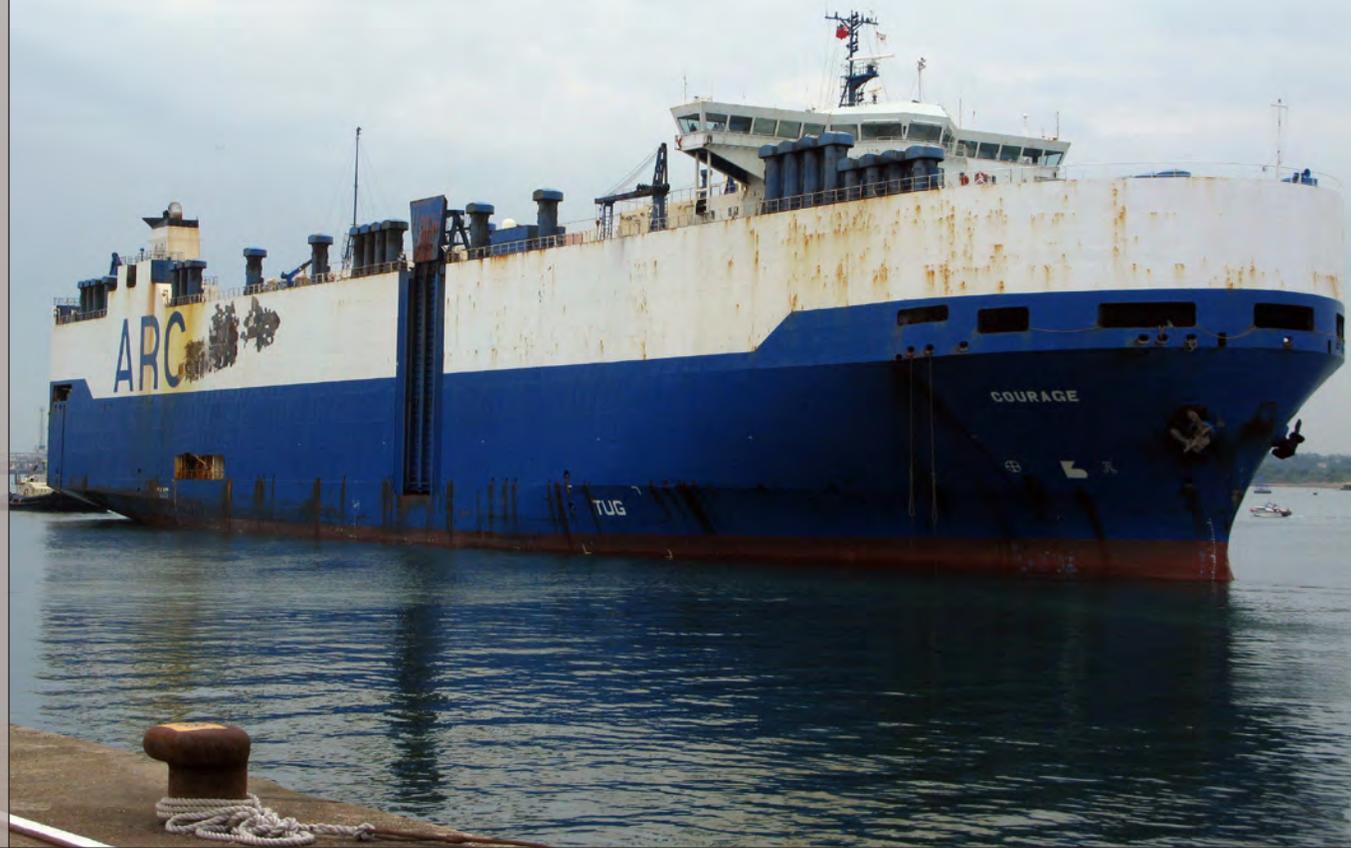
Figure 47: *Courage* just after the accident, with scorch marks on the starboard aft side as a result of the fire.

■ The NTSB determined that the probable cause of the fire on the vehicle carrier *Courage* was electrical arcing in the ABS module of a vehicle carried on board.

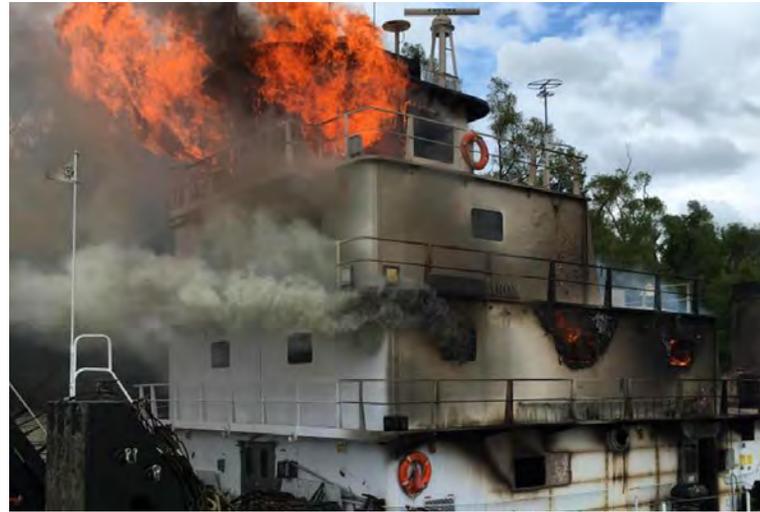
Figure 51: *Jaxon Aaron* on the river bank during the firefighting effort.

The cause of the fire was determined to be a catastrophic failure of components of the no. 15 power assembly or “power pack” on the 16-cylinder EMD 16-645-E7 port main diesel engine. The engine was designed to allow replacement of the cylinder head assembly, cylinder liner, piston, piston rings, and piston rod without removing the entire engine. These parts were pre-assembled into a power pack unit, which then could be removed or installed during a maintenance period. The engine had approximately 9,100 hours of service since the last replacement.

■ The NTSB determined that the probable cause of the fire aboard the towing vessel *Jaxon Aaron* was the failure of the power assembly components on the port main diesel engine’s no. 15 cylinder. Contributing to the extent of the fire damage was the substantial use of combustible materials in the interior spaces and the chief engineer’s unfamiliarity with the firefighting equipment.

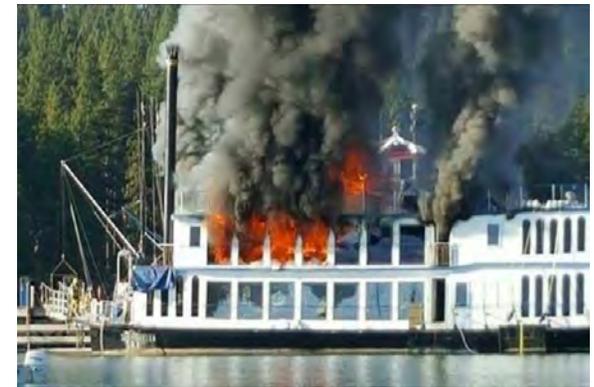
The *Tahoe Queen* was undergoing maintenance (such as welding and painting) by contractors on the day of the fire. The fire began while welding (hotwork) was being conducted on a deck plate seam of an exposed weather deck. The owner of the contracting company told investigators that a fire watch was typically stationed near the hotwork area with a fire extinguisher or hose, but on the day of the accident, no fire watch was posted. Combustible material—such as lifejackets, painting supplies, and storage containers for flammable liquids—were kept in an accommodation space directly below the deck where seam was being welded. Sparks and hot slag from the welding ignited either the combustible material, a flammable vapor layer, or both. The fire was then fueled by the combustible materials in the space and aboard the vessel.

Figure 55: Fire aboard *Tahoe Queen*. PHOTO BY WITNESS

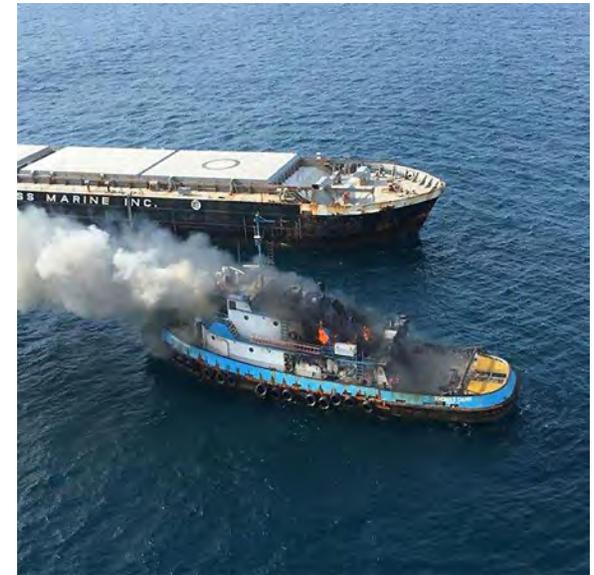
The greatest fire damage was to the central portion of the upper engine room. A drum of waste oil and extra hoses for the fire pump had been stored there, providing combustible material to fuel the fire. An electrical fuse box located in the central portion of the upper engine room bore evidence of electrical arcing at its aft side. There was also evidence of electrical arcing to wiring in this area. As a result of the heat damage, the source of those wires could not be traced. Arc mapping of all electrical wiring, which is a systematic evaluation of fire-damaged electrical circuits, further indicated that the electrical fuse box was the general area of origin.

■ The NTSB determined that the probable cause of the fire aboard towing vessel *Thomas Dann* was an ignition originating near an electrical fuse box in the upper engine room. Contributing to the intensity of the fire was the presence of combustible materials in the upper engine room.

Figure 57: *Thomas Dann* ablaze and abandoned near the barge it was transporting. PHOTO BY DAYTONA FIRE DEPARTMENT

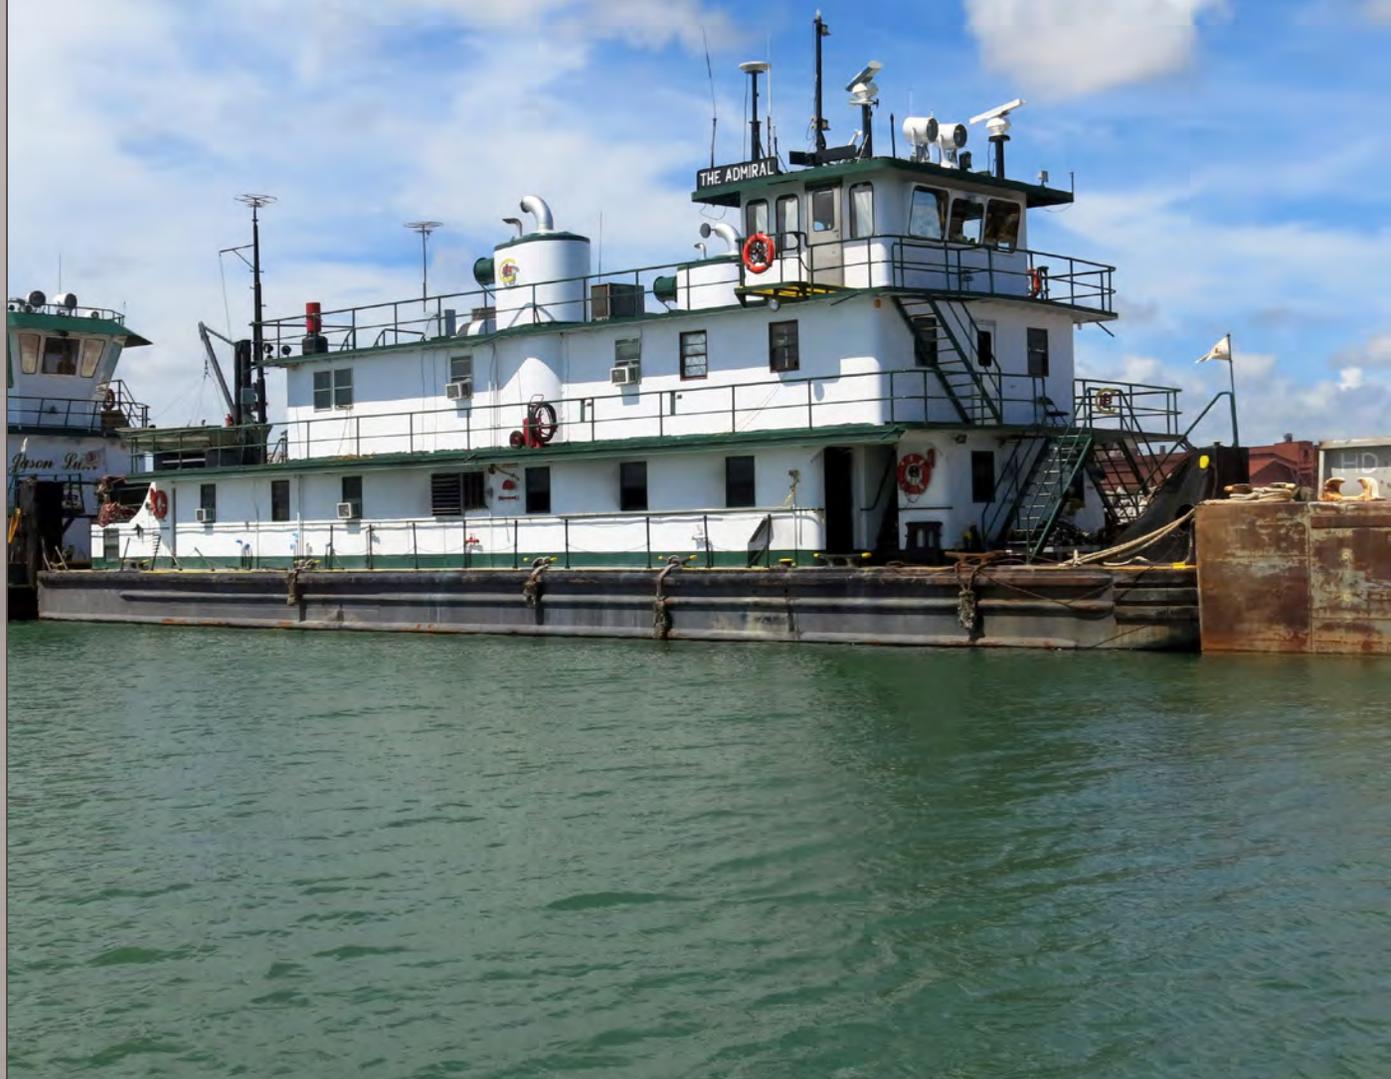
**Figure 58: *The Admiral*
at the accident site
after the fire.**

On July 14, 2016, the towing vessel *The Admiral* was moored alongside barges in the La Quinta Channel, Gulf Intracoastal Waterway, near Ingleside, Texas. About 1635, the vessel's starboard main engine oversped and then exploded, causing a fire in the engine room. Two crewmembers who were in the engine room at the time of the explosion were severely burned; one subsequently died. Damage to the vessel was estimated at \$300,000. No pollution was reported.

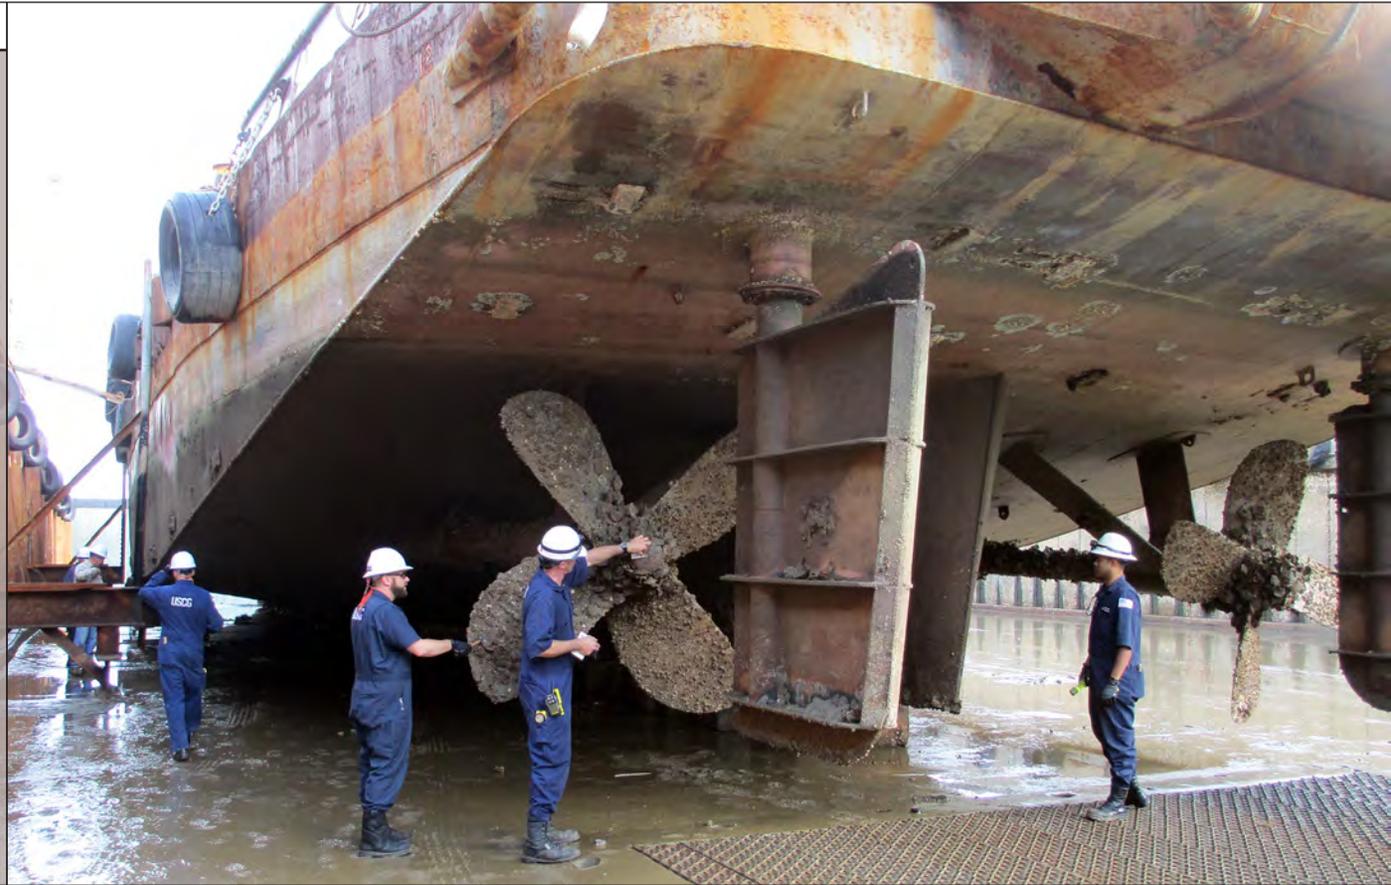
**Figure 61: Coast Guard investigators examining the
Hammerhead after the accident.**

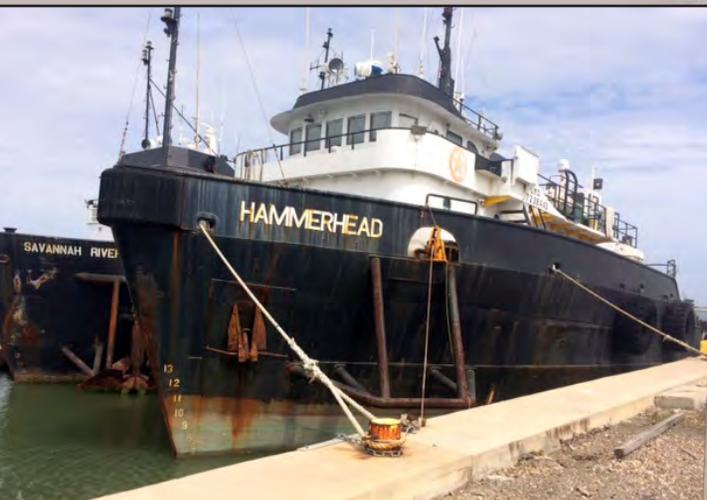
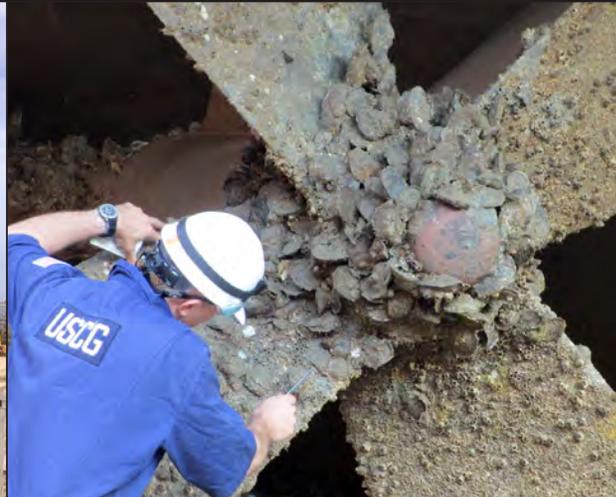
chlorite prevention, or a shaft earthing system. Marine growth had flourished on the idle vessel, blocking and narrowing cooling water intake piping. Clusters of barnacles, mollusks, algae, and sea hair were found on and around the tail shafts, propellers, and rudders. The operating company did not have written procedures for periodic inspections or continuous monitoring of the vessel during layup; therefore, no preservative measures, log reports, or checklists were completed during that time. The vessel was also not equipped with a bilge alarm system that could be monitored from ashore.

Figure 62: At left, the hole found near frame 31 of the bottom plating. At right, the screwdriver placed in the hole as a temporary repair. PHOTO BY COAST GUARD

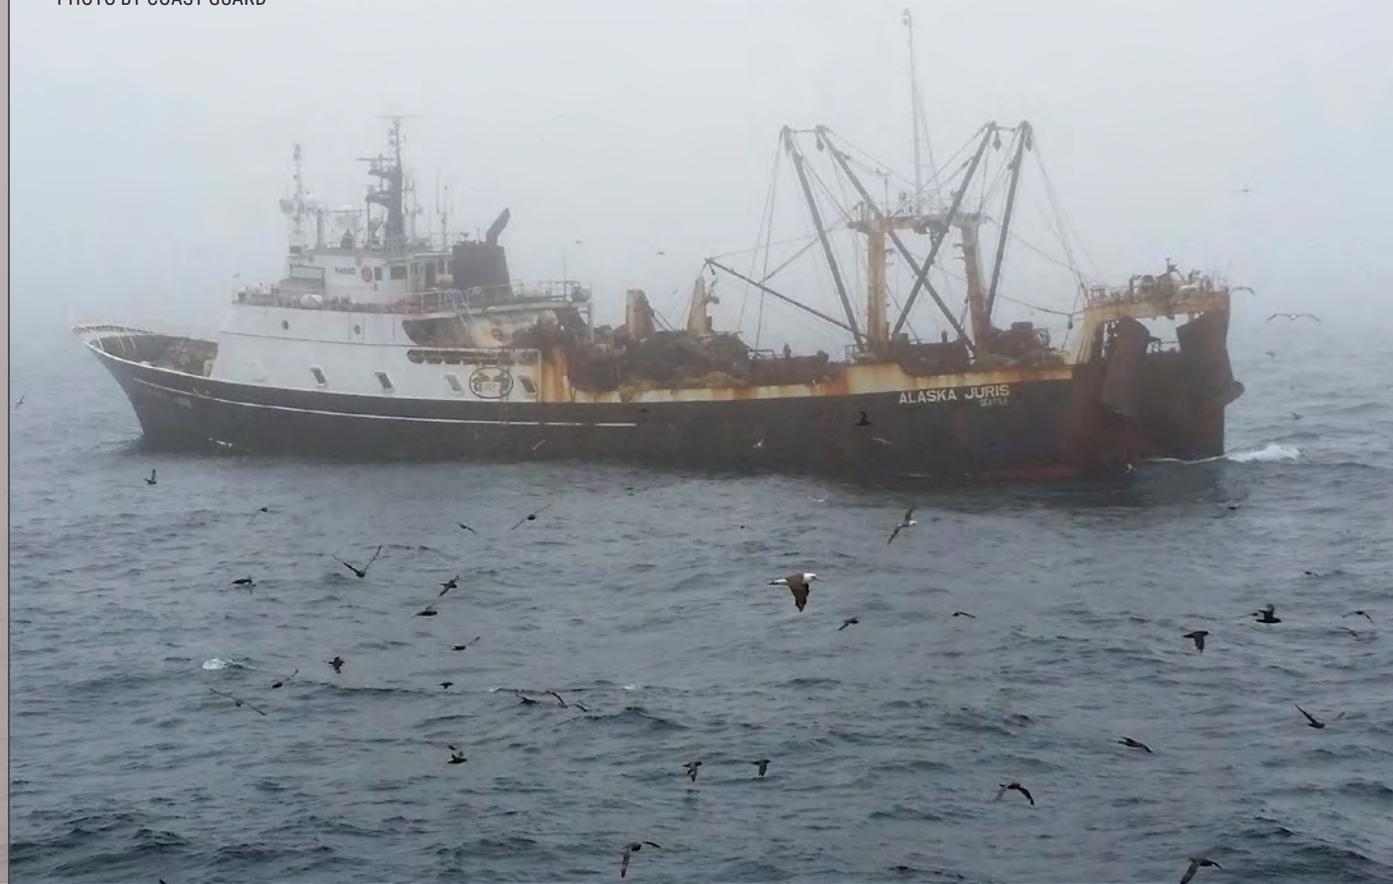
Figure 63: Alaska Juris, abandoned on the day of the sinking.

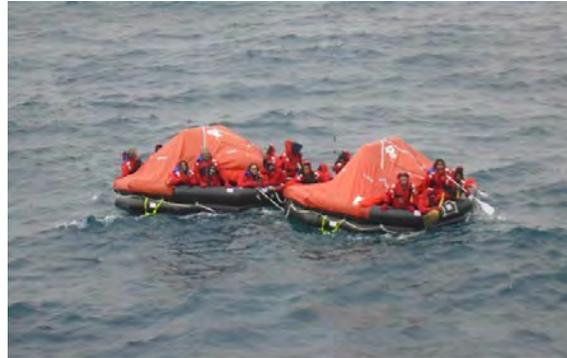
Figure 64: Two of *Alaska Juris*'s liferafts with a total of 28 crewmembers aboard. A third liferaft with the other 18 crewmembers had drifted away after being deployed from the starboard side of the vessel.
