NTSB | National
Transportation
Safety Board

SAFER SEAS DIGEST

Lessons Learned from Marine Accident Investigations | **2017**

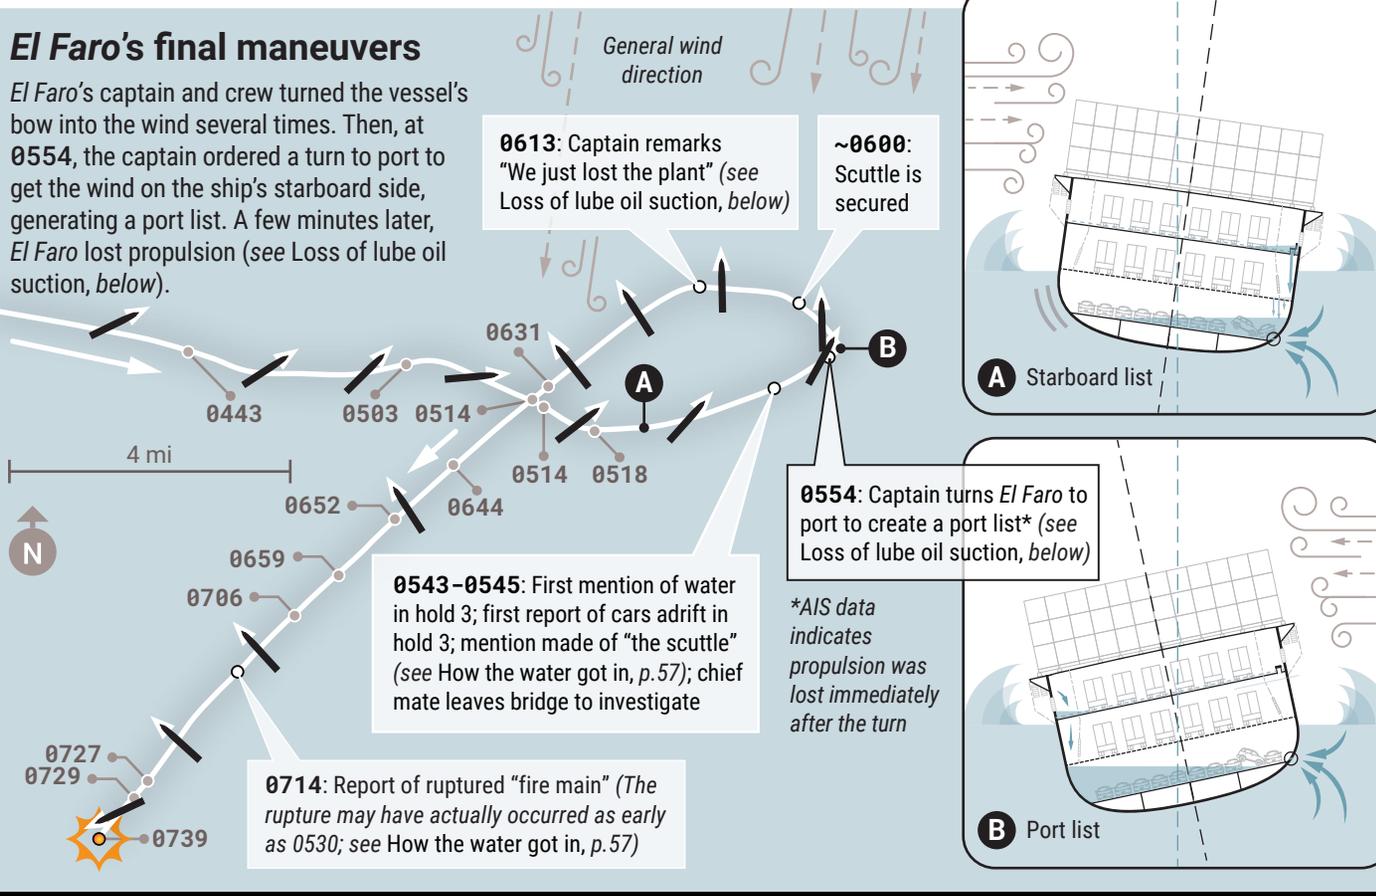
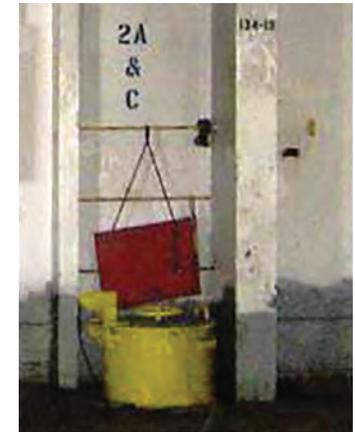
El Faro’s partially enclosed second deck had a number of scuttles that had to be closed and fastened (“dogged”). Flooding began through an open scuttle.

The crew found that a scuttle (small watertight hatch) on the second deck, starboard side, was open and seawater on deck was flowing over it and down into cargo hold 3. The ship's list to starboard was causing seawater to pool near the scuttle located on the starboard side. The captain told an engineer to begin transferring

Figure 66: Second deck scuttle to hold 2A, similar to hold 3 scuttle

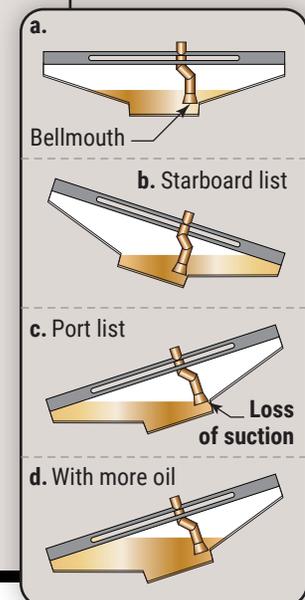
Detail of oil sump and bellmouth

Because the bellmouth (intake) for the main propulsion engine lube oil pump was located toward the starboard side, it mattered whether the ship was listing to port or starboard. (The trim of the ship also affected the oil suction; forward trim was worse). It also mattered how much lube oil was in the sump (see Detail of oil sump and bellmouth, at right).

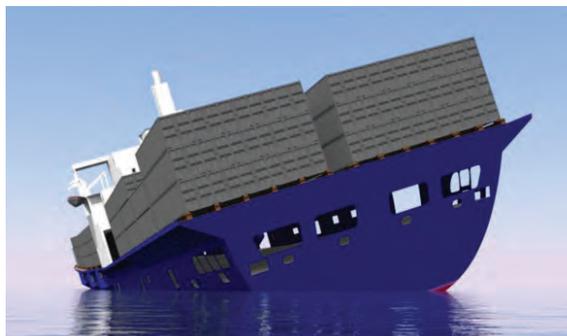
Figure 67: *El Faro* computer rendering in static surface water showing list to port of 18° with departure trim 5.8 feet by the stern due to flooding of hold 3, estimated at 20% and windheel.

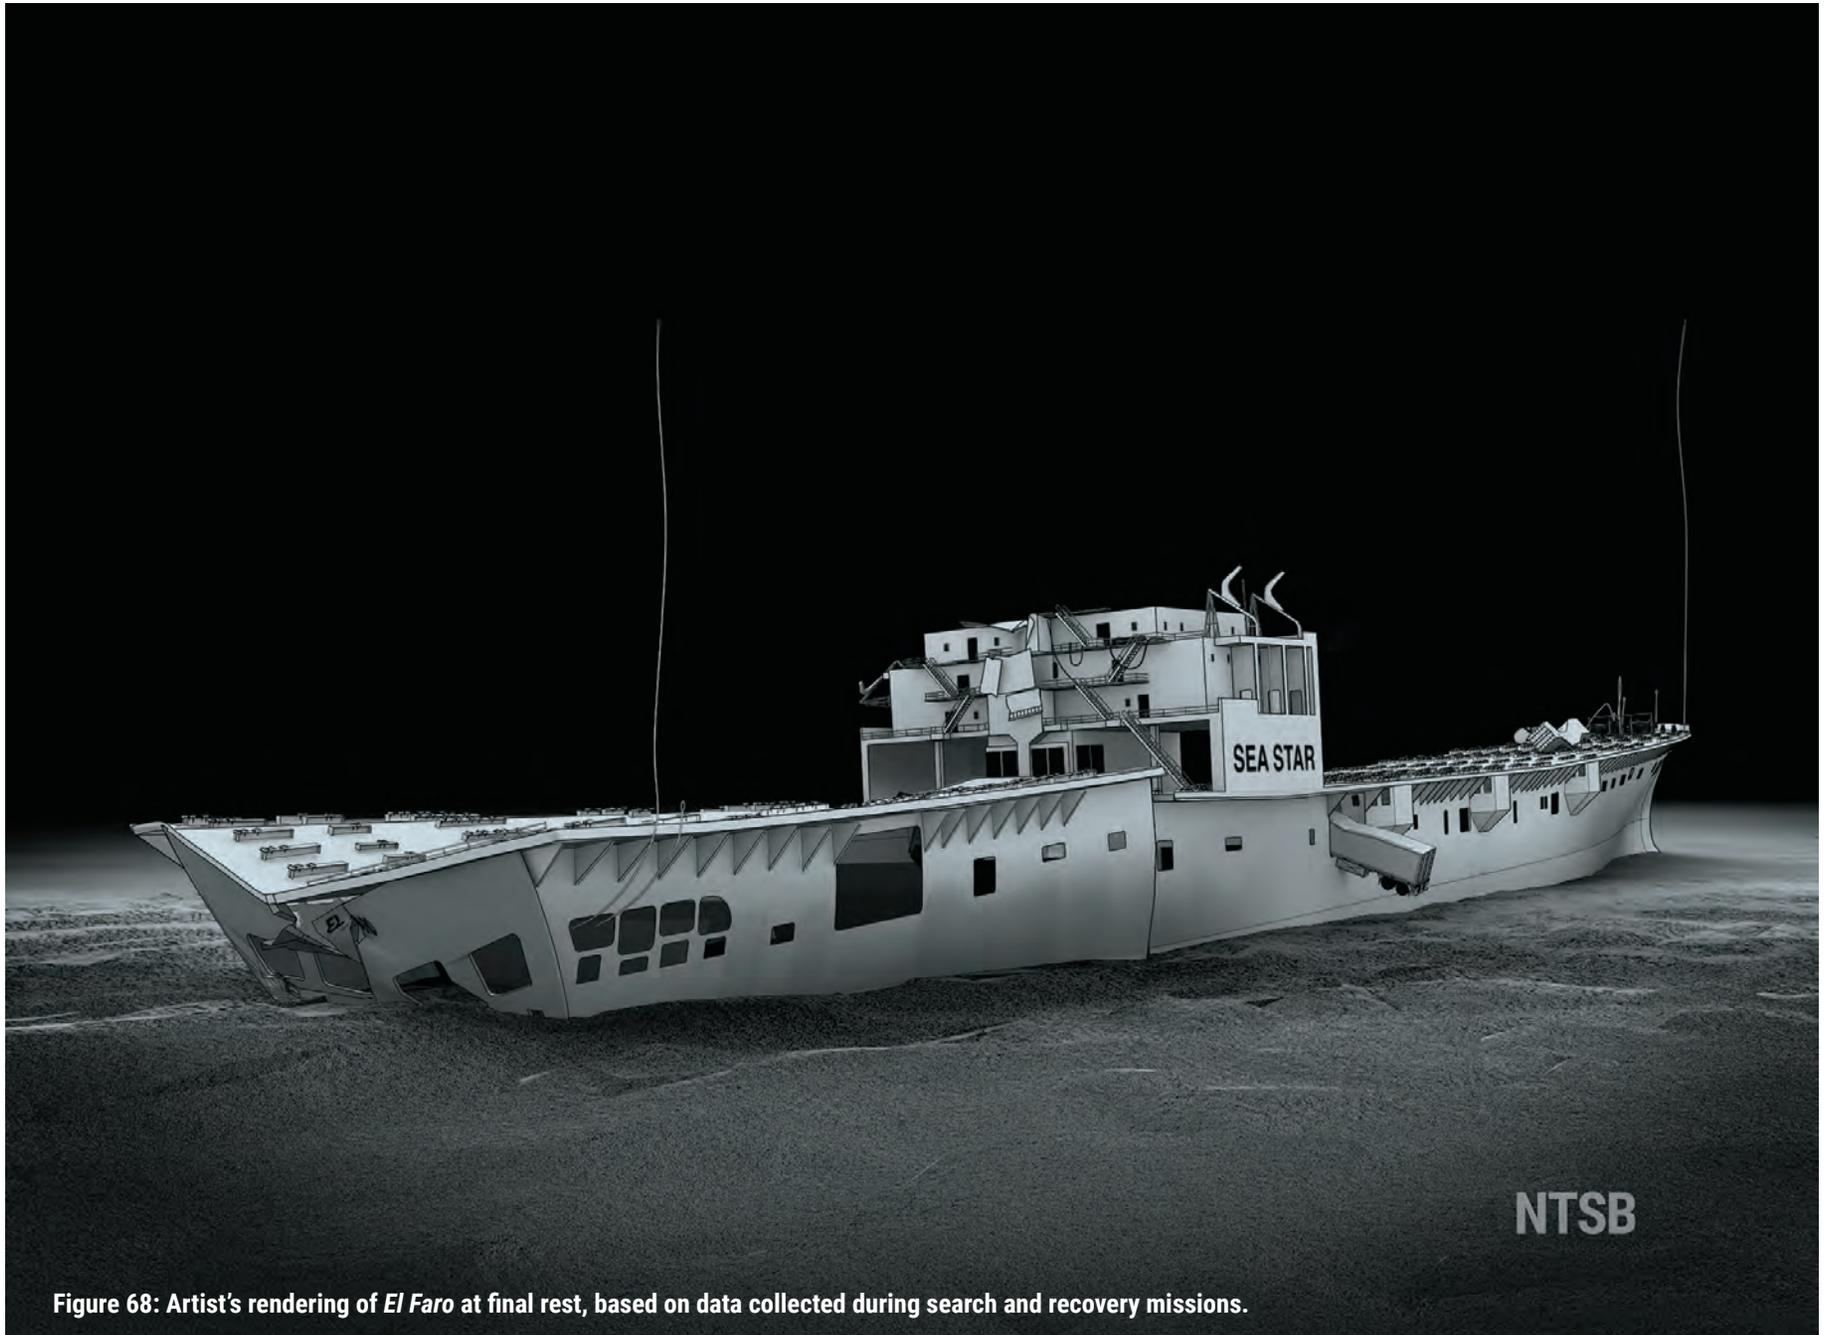
Figure 68: Artist's rendering of *El Faro* at final rest, based on data collected during search and recovery missions.

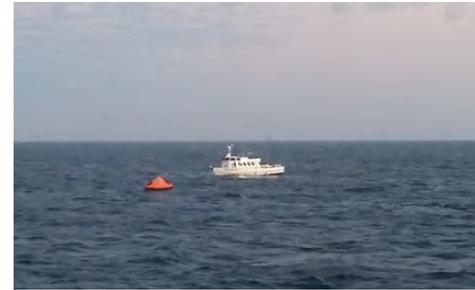
Figure 79: *Maximus* and its liferaft.

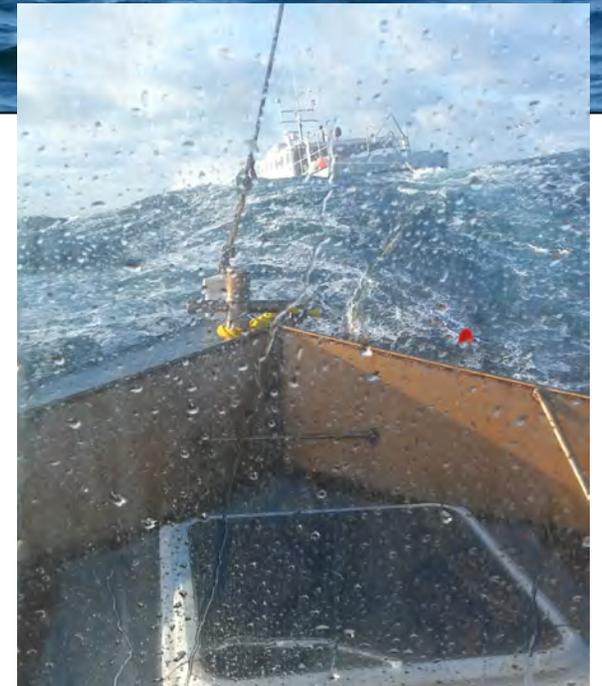
Figure 81: Photo taken from the *Orin C*, while being towed by the *Foxy Lady*, moments before the *Orin C* was hit by the wave that caused damage.

The *Foxy Lady* made up a tow line of about 200 feet to the *Orin C*, and commenced towing at about 4 to 4.5 knots. Weather conditions continued to worsen, with winds increasing to 25–30 knots and wave heights to 8–10 feet. At 1447, the *Orin C* was hit by a large wave that parted the tow line, damaged the overhead and visor of the wheelhouse, and broke out two forward windows. A crewmember, who estimated the wave to be about 15 feet high, also recalled hearing a “loud snap” and “creak” that sounded like the wood hull of the boat “coming unglued.” Crewmembers later concluded that the vessel must have “blown a plank” when impacted by the 15-foot wave.

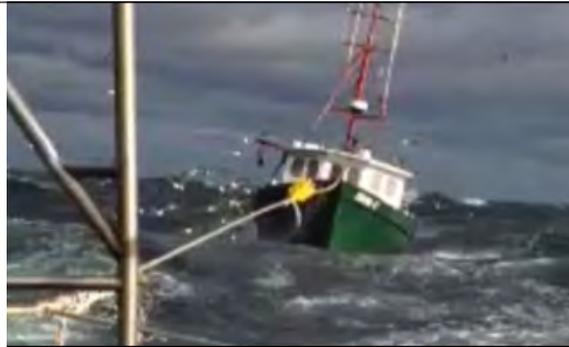
The 4-inch nylon towline used, although suitable for towing, was not an ideal length—too short—for the sea conditions and the vessel being towed. The *Foxy Lady* captain commented that the wooden-hulled *Orin C* was heavier than his fiberglass boat and the type of line was all they had for the tow. The line parted several times

Figure 81: Photo of the *Orin C* taken at 1324 from the aft deck of the *Foxy Lady*. PHOTO BY *FOXY LADY* CAPTAIN

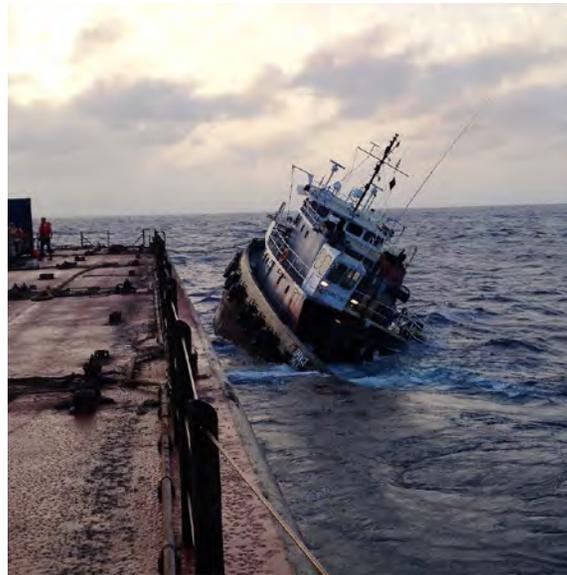
Figure 84: *Spence* shortly before sinking, after crewmembers had abandoned ship.

■ The NTSB determined that the probable cause of the sinking of the towing vessel *Spence* was gradual flooding from an unknown point of ingress into the aft void space followed by downflooding to the engine room.

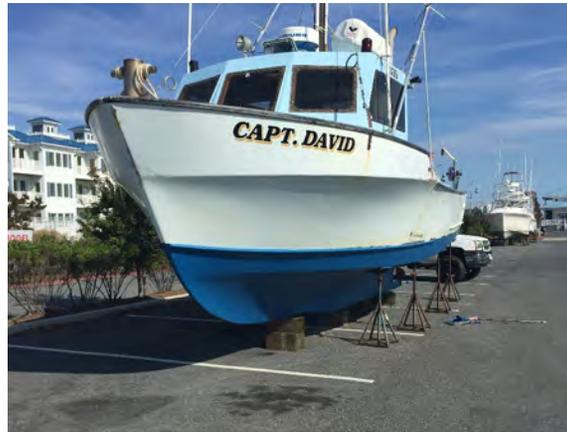
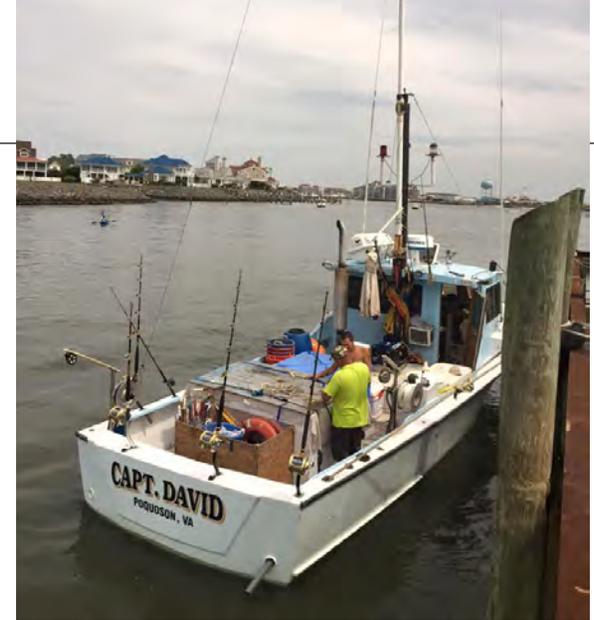
Figure 85: Bow and stern views of the *Capt. David* prior to the accident

■ The NTSB determined that the probable cause of the flooding and sinking of fishing vessel *Capt. David* was an engine cooling water leak that disabled the vessel during a forecasted small craft advisory and developing gale conditions.

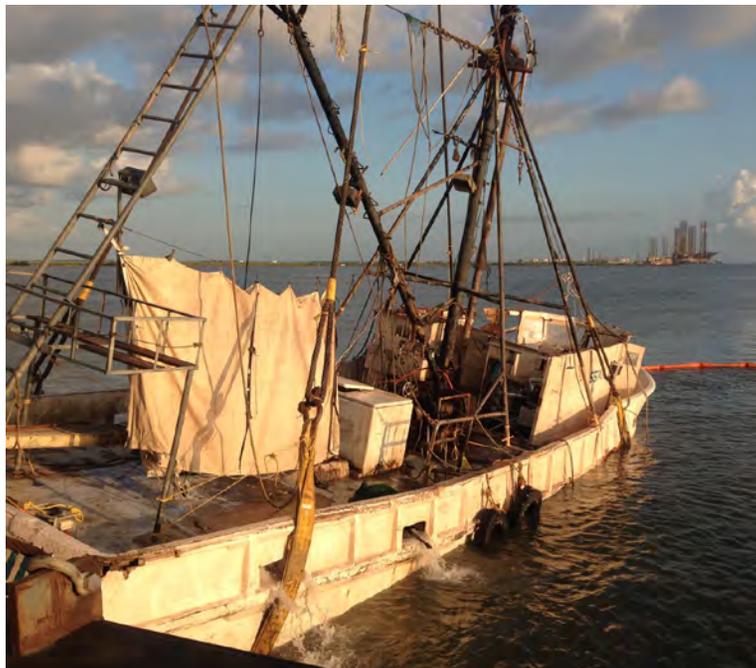
■ The NTSB determined that the probable cause of the sinking of the *Capt. Kevin* was (1) an inadequate and temporary hull repair that failed, allowing flooding of the vessel's interior spaces, and (2) the crew not securing the watertight hatch to the forepeak that would have contained the flooding to the forepeak tank.

Figure 88: The recovery of *Capt. Kevin* by derrick barge *Mr. Two Hooks*.

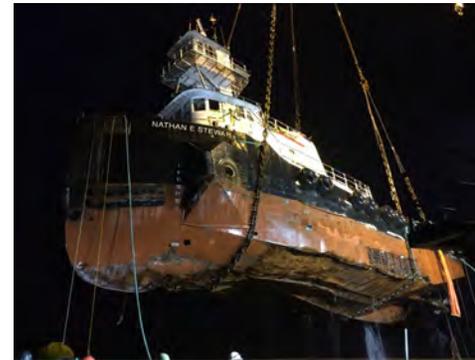
Figure 90: *Nathan E Stewart*, shortly after being hoisted by a crane. PHOTO BY KIRBY OFFSHORE MARINE

age from its bow to its stern—but none of its inner cargo tanks were compromised.

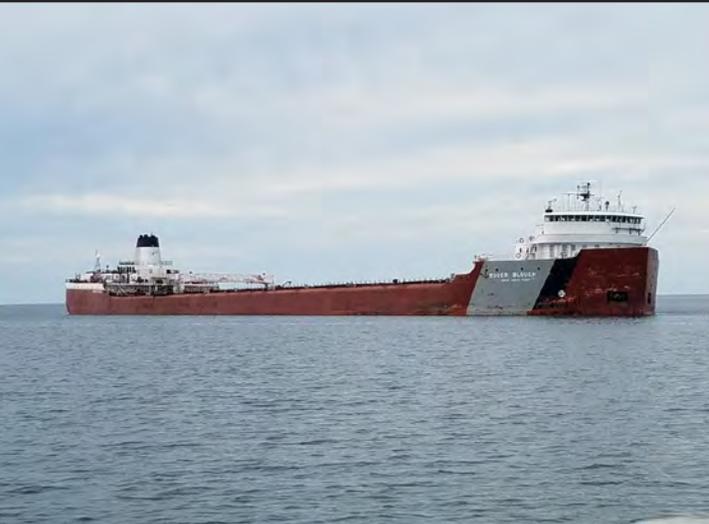
Figure 91: *Roger Blough* aground on Gros Cap Reefs.

■ The NTSB determined that the probable cause of the grounding of the lake freighter *Roger Blough* was the second mate's failure to use all navigational resources to determine the ship's position as it approached shallow water near Gros Cap Reefs. Contributing to the accident was inadequate monitoring of the vessel by VTS St. Marys River.

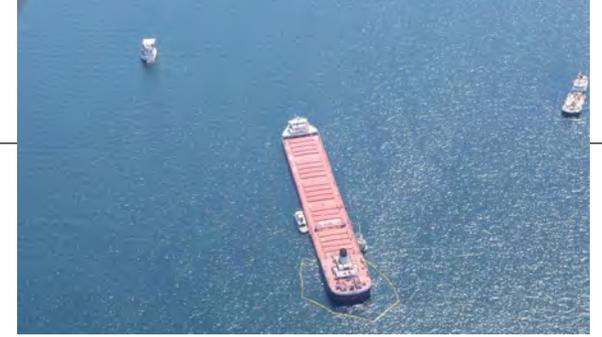
Figure 92: *Roger Blough* aground near the Gros Cap Reefs Light. The distance to the light was 240 yards.

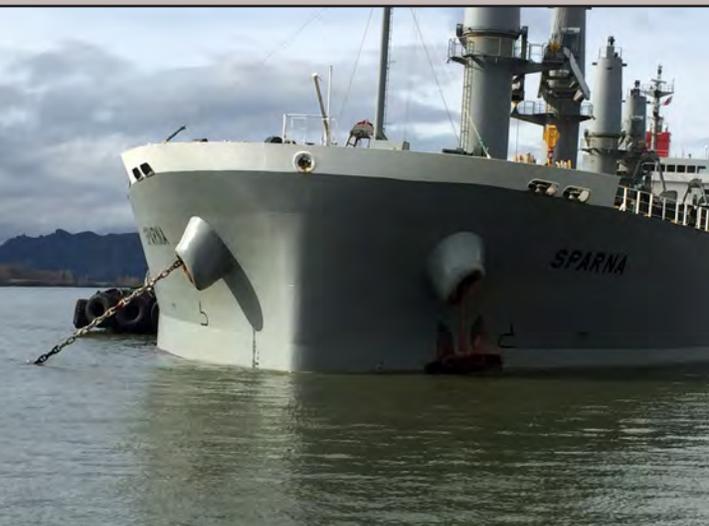
■ The NTSB determined that the probable cause of the grounding of bulk carrier *Sparna* was the failure of the pilot and the bridge team to monitor the helmsman's response to the pilot's rudder orders.

Figure 93: *Sparna* after the accident.
