Marine 2018/06

REPORT ON WORK ACCIDENT ON BOARD THE NORMAND MAXIMUS OFF THE COAST OF BRAZIL ON 21 FEBRUARY 2017

BRAZILIAN NAVY
Directorate of Ports and Coasts
Marine Safety Superintendence
Department of Inquiries and Investigations of Navigation Accidents
ACCIDENT WITH PEOPLES ON BOARD THE MARITIME SUPPORT VESSEL "NORMAN MAXIMUS"
Maritime Safety Investigation Report

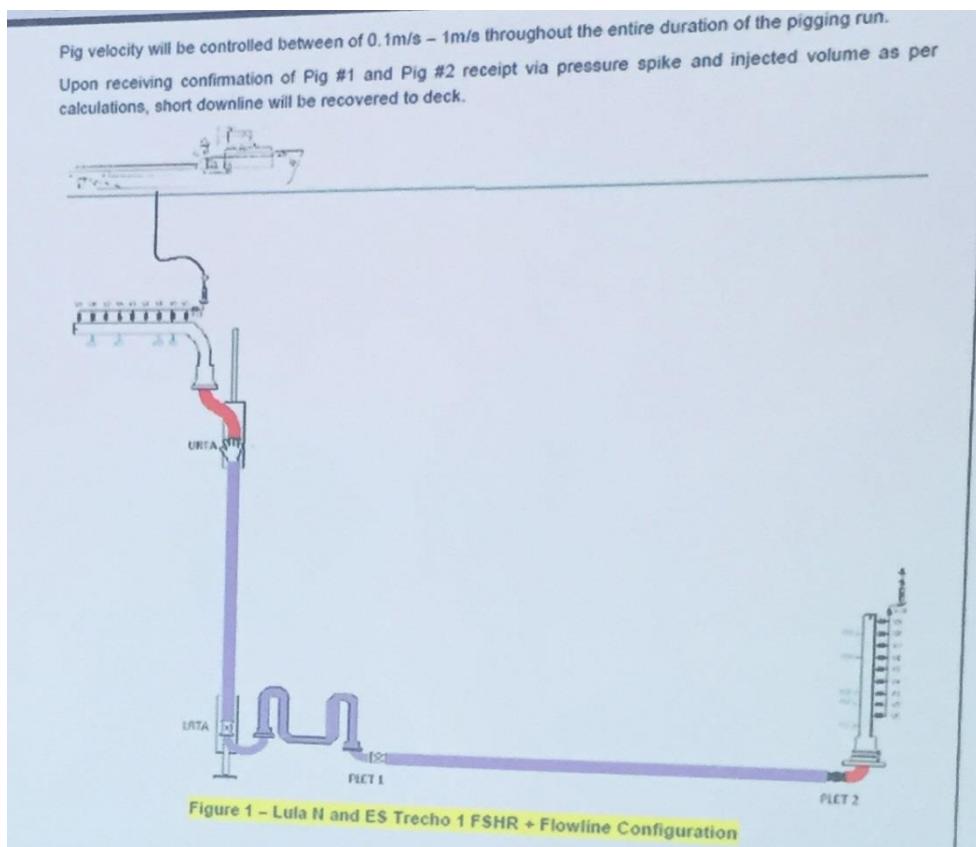
Figure 5: Schematic drawing of the pipeline arrangement placed at a depth of 2,170 metres that was to be pressure-tested using the system installed on the deck of the CSV Normand Maximus.
Source: The Brazilian Navy

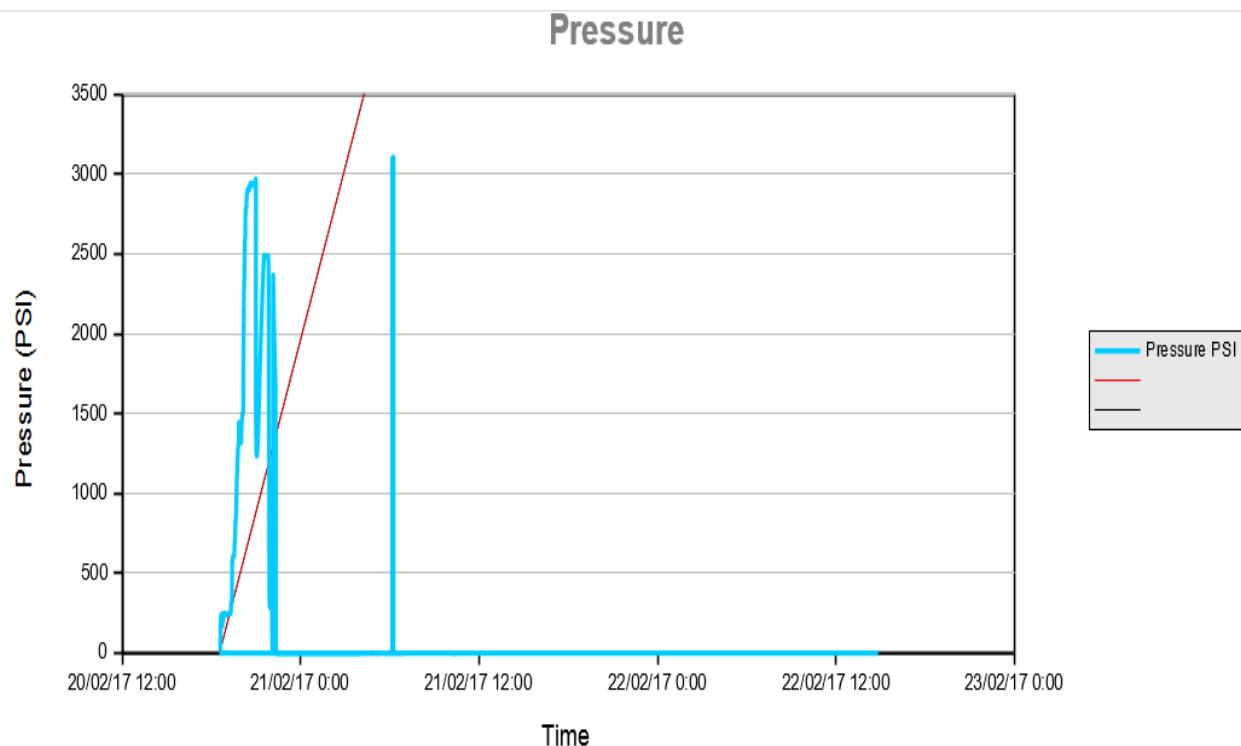
Photo 7: Diagram Pressure (PSI) X time

The control room monitored the conditions of operation and the launch / arrival of the pigs to the deck. The General Supervisor ("Senior Supervisor"), guided by the Control Room, manually depressurized the deck by means of valves. The network operated at local pressure up to 3,916 psi (270 bar). At the time of the accident the system operated at a pressure of 3,188 psi (215 bar).

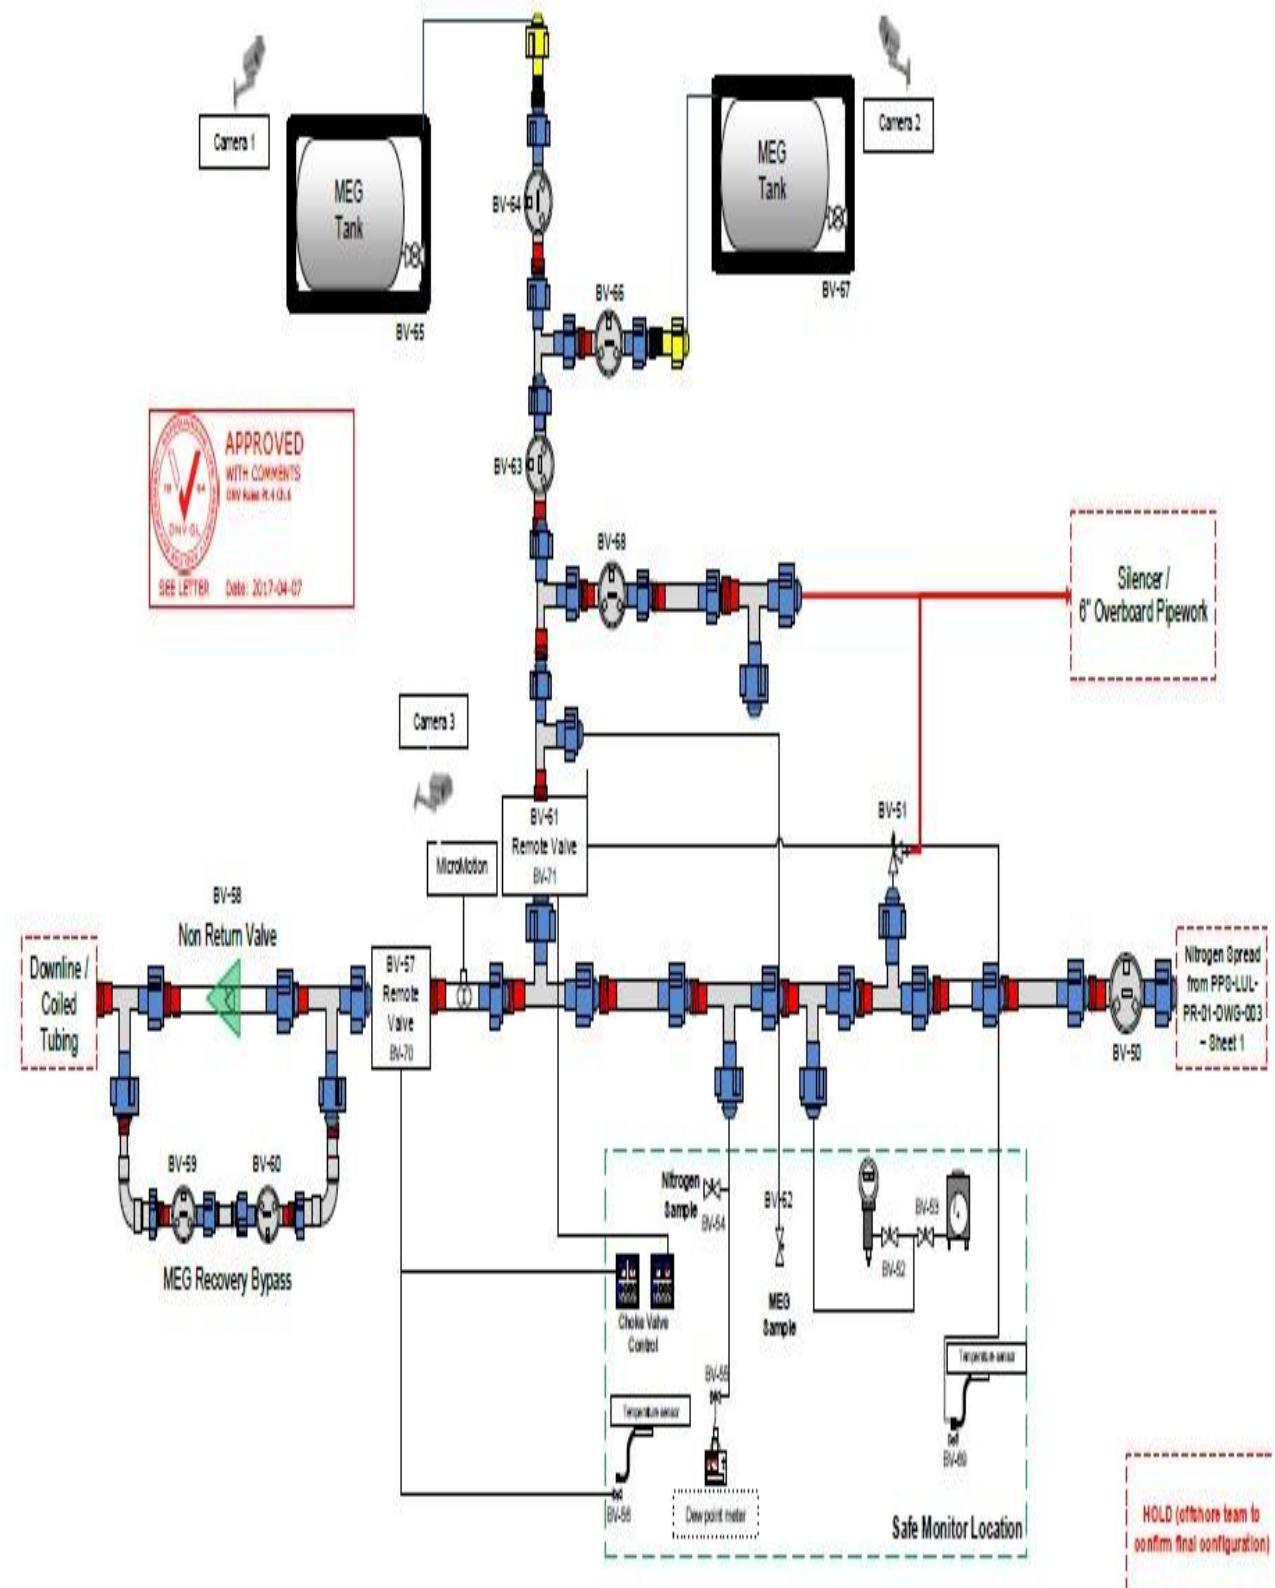
Photo 8: Installation diagram.
