## MARINE SAFETY INVESTIGATION REPORT

**Investigation into the partial flooding of the  
engine-room on board the Bulk Carrier**

***CAPRI***

**MARINE SAFETY INVESTIGATION REPORT NO. 24/2018**

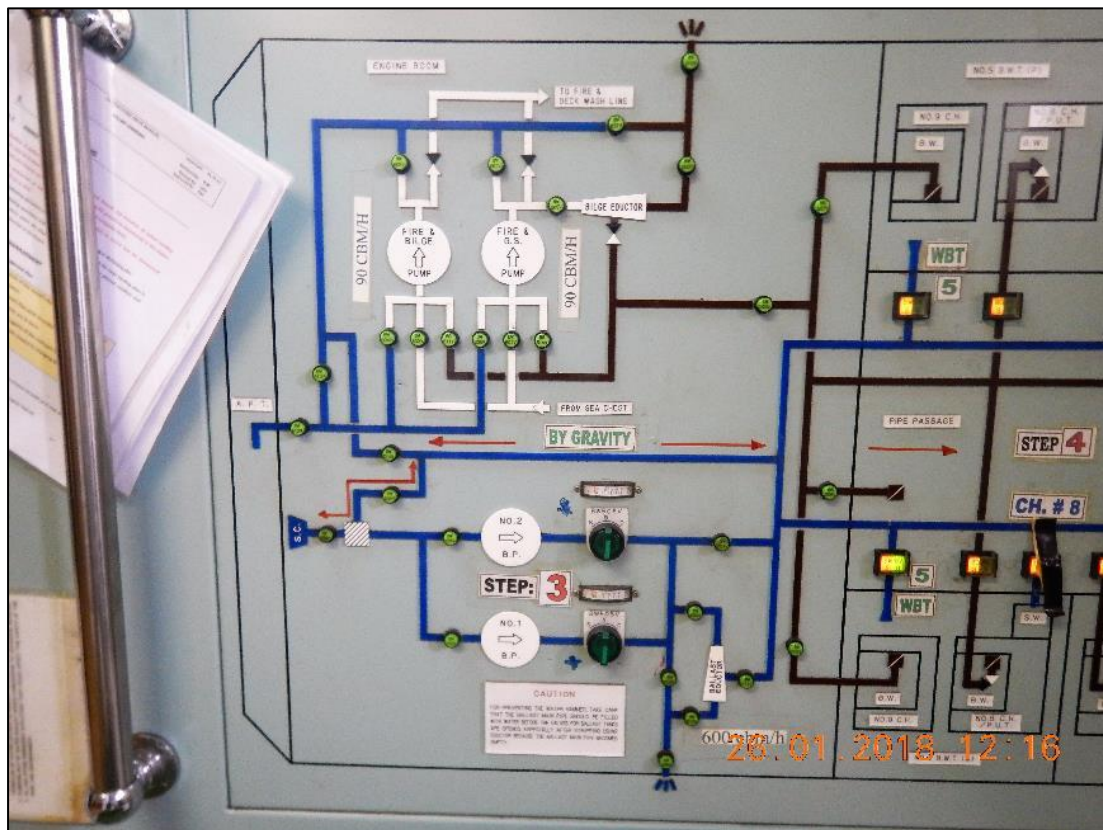
The ballast pumps can be started either locally or remotely from the Ballast Control Board in the ship's office (Figure 2). The ballast pump discharge valves are operated from the ballast control mimic board.

Figure 2: Ballast Control Mimic Board
