CHIRP Maritime

The Maritime Confidential Hazardous Incident Reporting Programme

Annual Digest of Reports, and Insight Articles

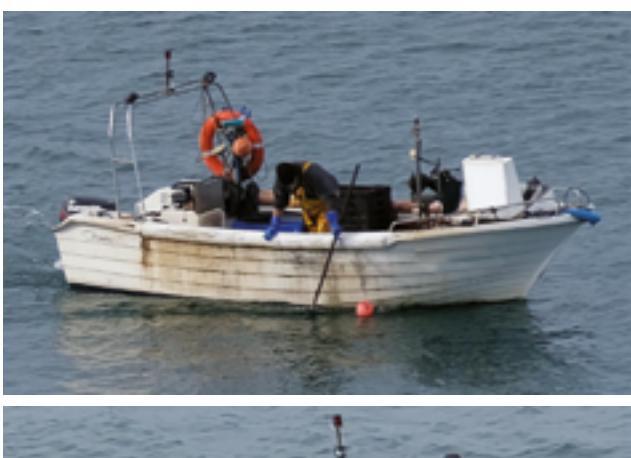
Recently, I observed a local fisherman clearly demonstrating an example of what is wrong with the fishing industry. I attach photographs which help best explain my concern for his safety. In this case the fisherman returned to port safely, but it is sad to see that, despite the efforts to warn fishermen, there is still such a low level of personal safety awareness, not least in working without a lifejacket.

A small fishing vessel – the sole occupant is not wearing any floatation aid.

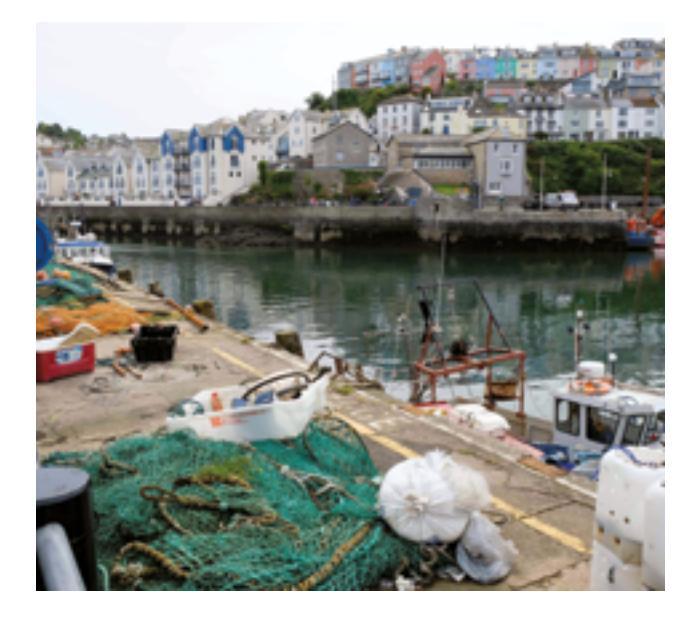
When walking from the ferry landing point, I was aware of the large amount of fishing equipment left discarded around the harbour. I attach photographs showing a mass of fishing equipment on both sides of the access route for passengers using the ferry.

Plenty of housekeeping hazards here - how many can you spot?

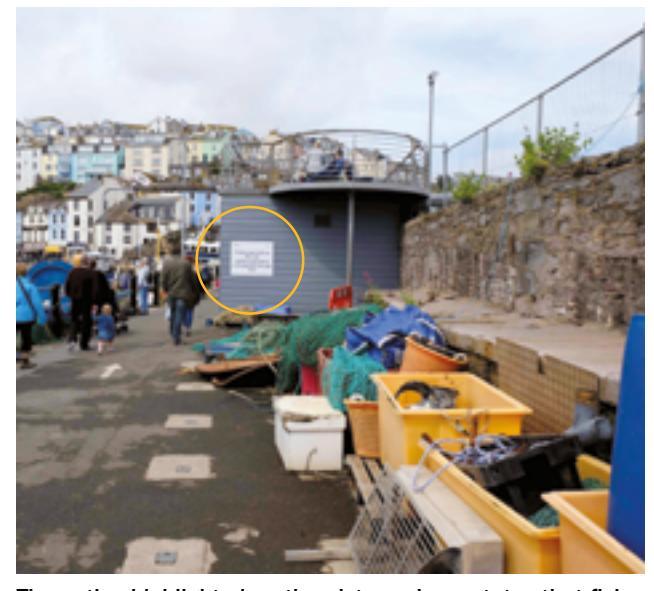
The notice highlighted on the picture above states that fishing gear left here will be removed

The left-hand picture shows a large amount of discarded / old equipment close to the dock edge and the access ladder for crew. Fishing gear is permitted to be stowed there but the manner in which it has been done in this case generates plenty of safety hazards. Fishing gear is not permitted to be stowed in the vicinity of the area shown in the right-hand picture. The Harbour Authority notice was clearly not obeyed by fishermen or enforced by the Harbour Master.

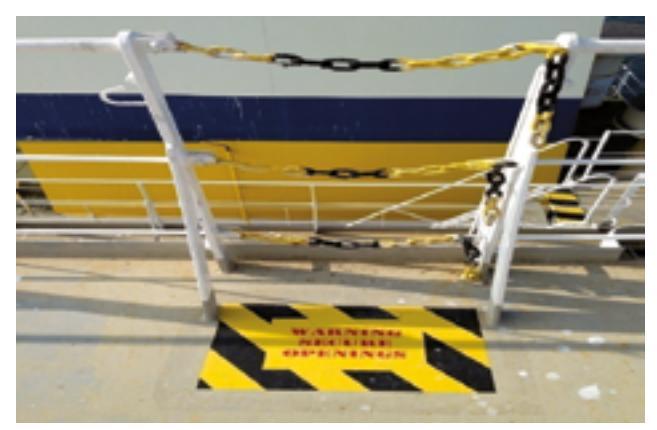
Any safety chains or openings in handrails should be secured at all times when not in use. This ship has highlighted the safety chains and has reminded users to secure the openings after use.

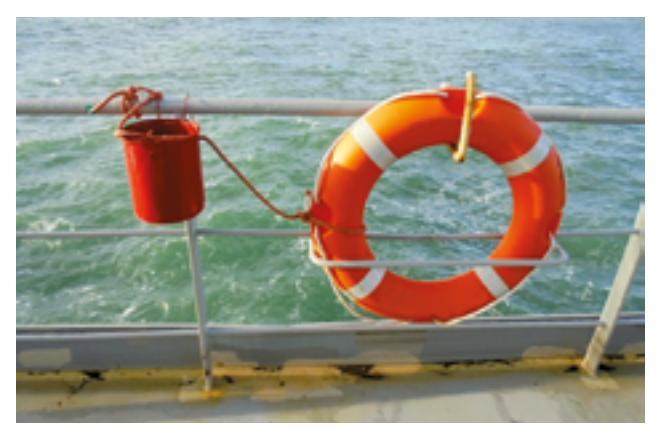
Who hasn't seen lifebuoy lines get into a tangle which would cause problems if the lifebuoy needed to be rapidly deployed? Here is a simple solution where the rope is coiled in a container and "stored" ready for immediate release.

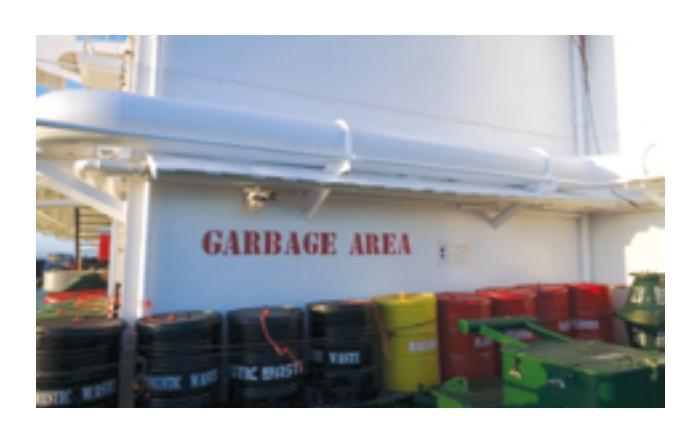
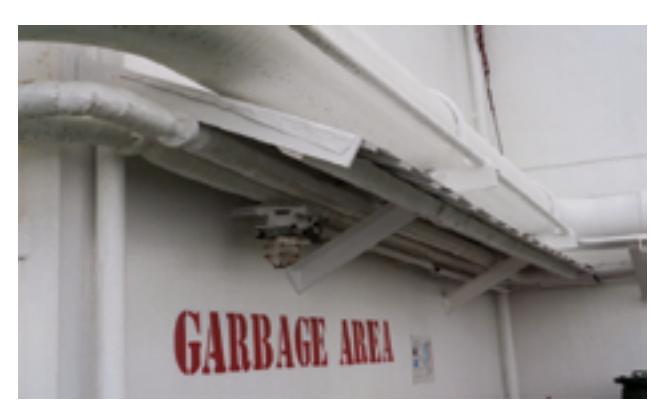
The garbage area on this ship is now highlighted, and they have fitted a small canopy above the drums so that the area is protected from rain and any soot from the funnel. In addition, they have placed additional waste bins in each cabin and public room specifically for plastic, in order to aid segregation.

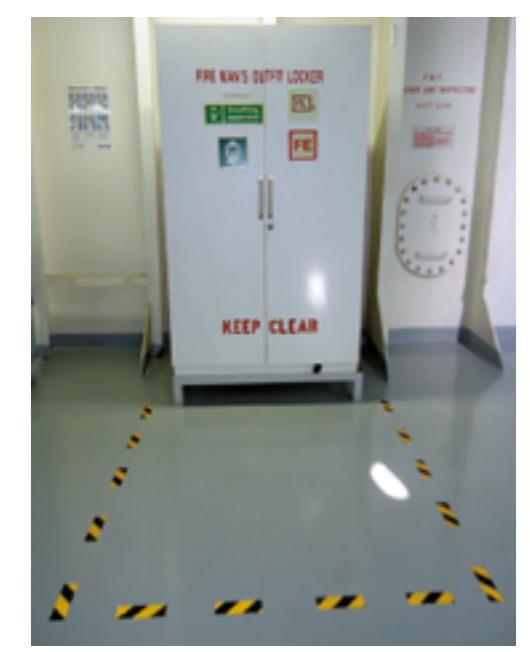
On this vessel, the crew have placed boundary markings and KEEP CLEAR notices beside the Fireman's outfit lockers. The lockers should always be clear from any obstructions and this will asssit in getting access to the fireman's outfit and also gives space to change into the equipment in the event of a fire when time is of the essence.
