## **Collision of the rigid inflatable boat *Tiger One* with a mooring buoy, River Thames, London, England 17 January 2019**

### **SUMMARY**

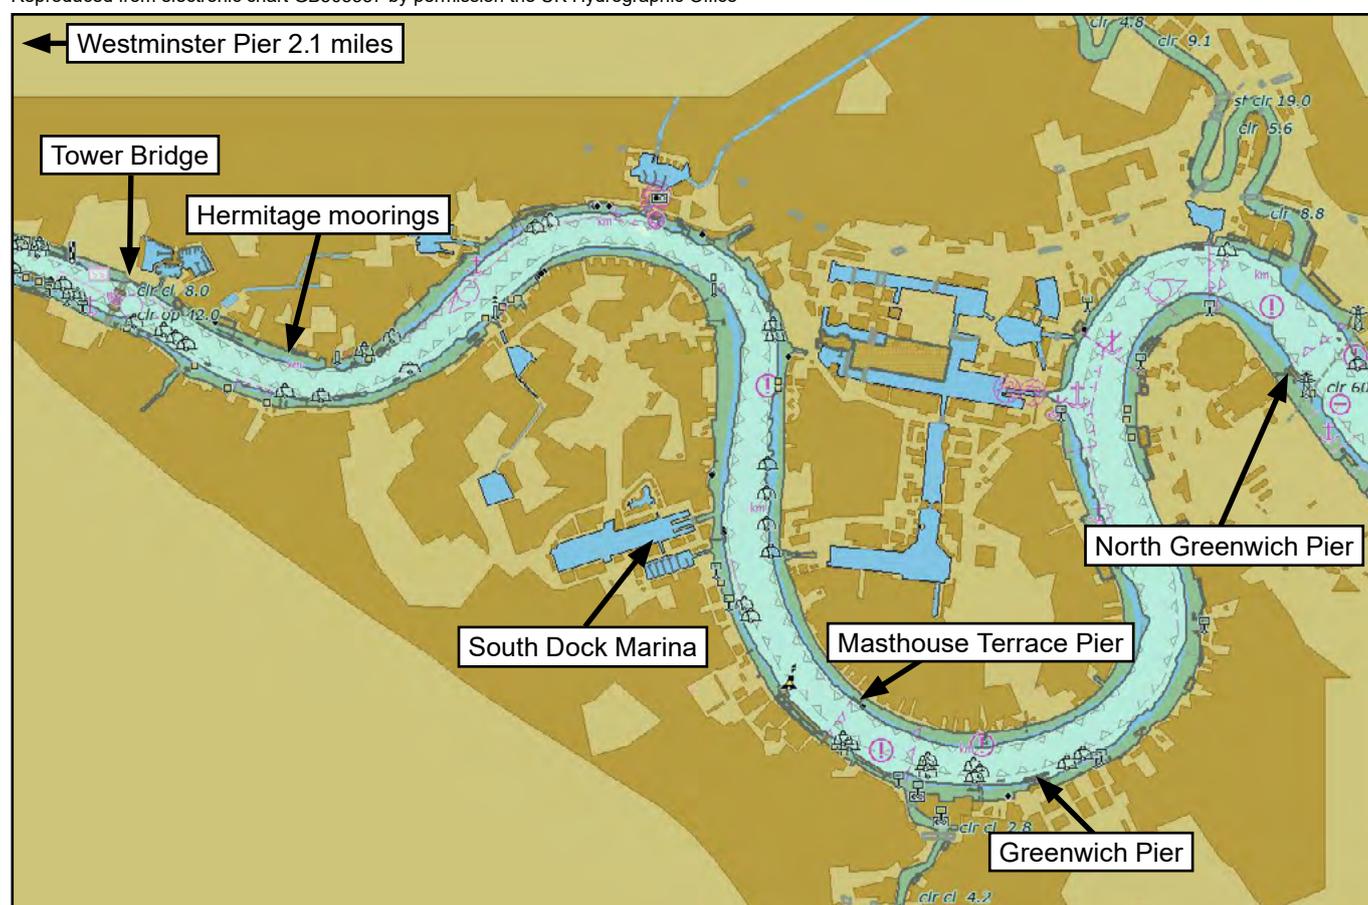
At 1713<sup>1</sup> on 17 January 2019, the rigid inflatable boat (RIB) *Tiger One* departed from Westminster Pier, River Thames, London, for passage to North Greenwich Pier, 8 miles downriver (**Figure 1**). On board were the skipper, a deckhand and six passengers, all of whom were wearing lifejackets and warm clothing. It was a cold, dark evening with good visibility and the riverbanks were brightly illuminated by city lights.

**Figure 1:** Extract of electronic chart GB503337 showing points of interest

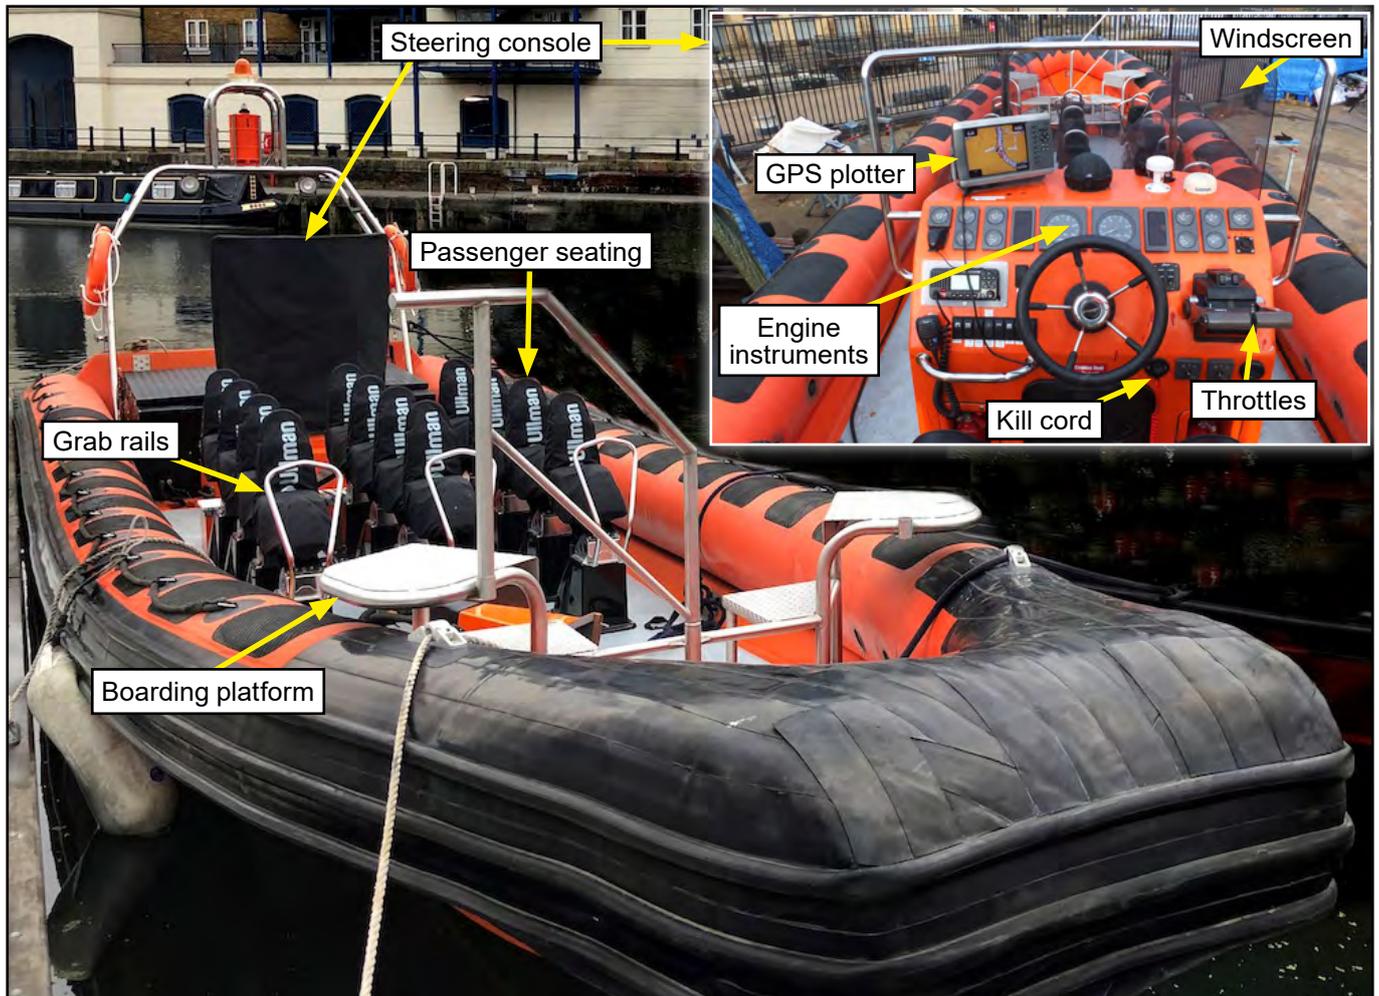
The passengers were seated while the skipper stood behind the steering position (**Figure 2**), from where he could see over the console's windscreen. As soon as the RIB was clear of the pier, the deckhand put on a music soundtrack through the boat's sound system. She then served the passengers champagne.

**Figure 2:** *Tiger One* deck layout

Modifications made before the RIBs entered service on the River Thames in June 2017 included the replacement of bench type passenger seats with 12 individual 'Ullman' suspension seats, each of which was equipped with grab rails. Two rigid jockey type seats were fitted behind the steering console for the crew, and boarding platforms were installed at the bow (**Figure 2**).
