## MARINE TRANSPORTATION SAFETY INVESTIGATION REPORT M18P0230

### GIRDING AND CAPSIZING

Tug *George H Ledcor*

13 August 2018

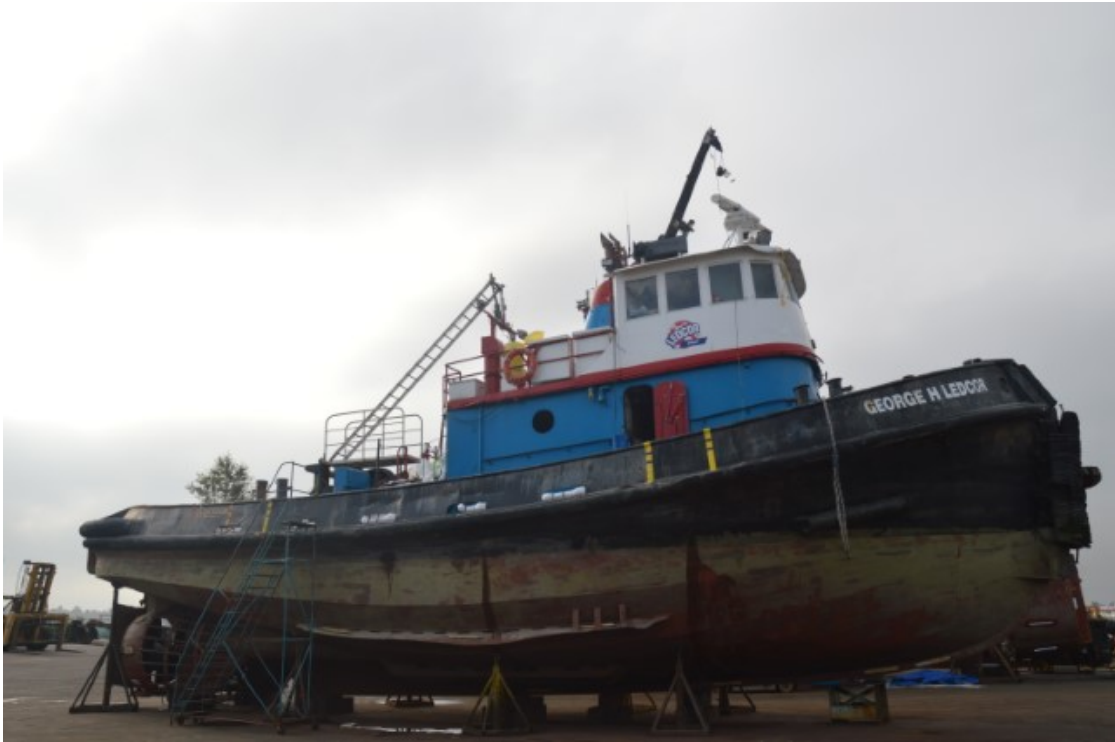
Figure 1. The George H Leducor (Source: TSB)

After the *George H Ledcor* was recovered, it was determined that the tug was still structurally intact, but that electronic navigation equipment, wiring, and machinery had been damaged. The tug was declared a total constructive loss.

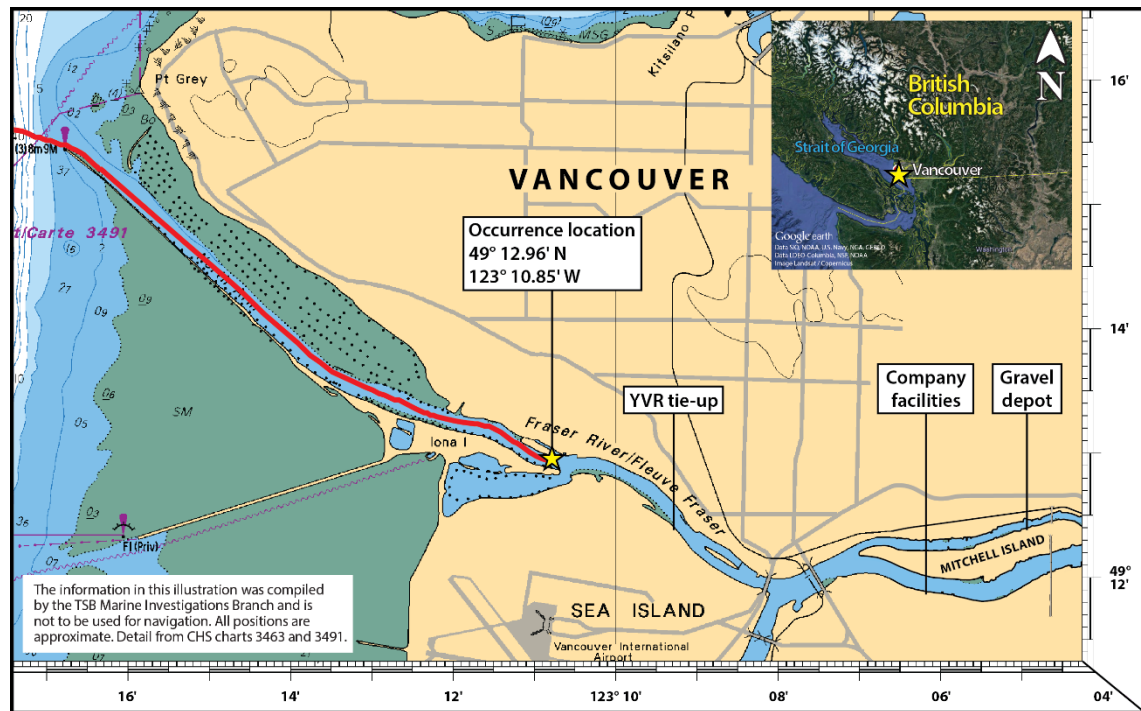
Figure 4. Area of the occurrence, with the vessel's track shown in red (Main image source: Canadian Hydrographic Service charts 3463 and 3491, with TSB annotations. Inset image source: Google Earth, with TSB annotations)

There are a series of natural bends between the entrance to the river and the gravel depot on Mitchell Island. At 2148, the tug and barge navigated the first of these bends, then navigated the second bend a few minutes later. The tug and barge approached the third bend, which was slightly larger, at a speed of 6 knots. At 2208, the master initiated a course alteration of 31° to port. Within a minute, the master on the *George H Ledcor* noticed that the barge was not responding to the course alteration. He then called the master on the *Westview Chinook* by very high frequency radiotelephone and told him to stop pushing the barge, which he then did. The master on the *George H Ledcor* then applied more port rudder, but the barge continued on a straight course.

The towline connecting the *George H Ledcor* and the *Evco 55* pulled over to the tug's starboard side as the barge began to overtake the tug, which caused the tug to develop a starboard heel and placed it in a girded position.<sup>5</sup> The master attempted to reposition the tug in front of the barge by increasing the throttle to full and applying full starboard rudder. This action increased the starboard heel of the tug.
