Transport Accident
Investigation
Commission

Final Report

***Marine Inquiry MO-2018-202
Accommodation fire on board
Fishing trawler Dong Won 701
Timaru
9 April 2018***

December 2019

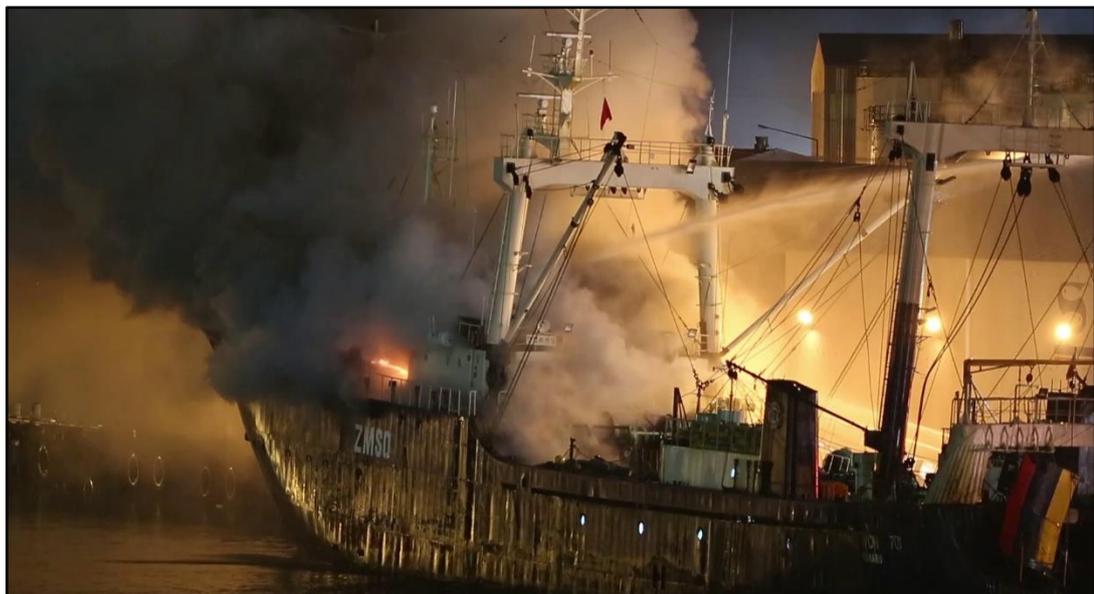
Figure 3: The Dong Won 701 on fire

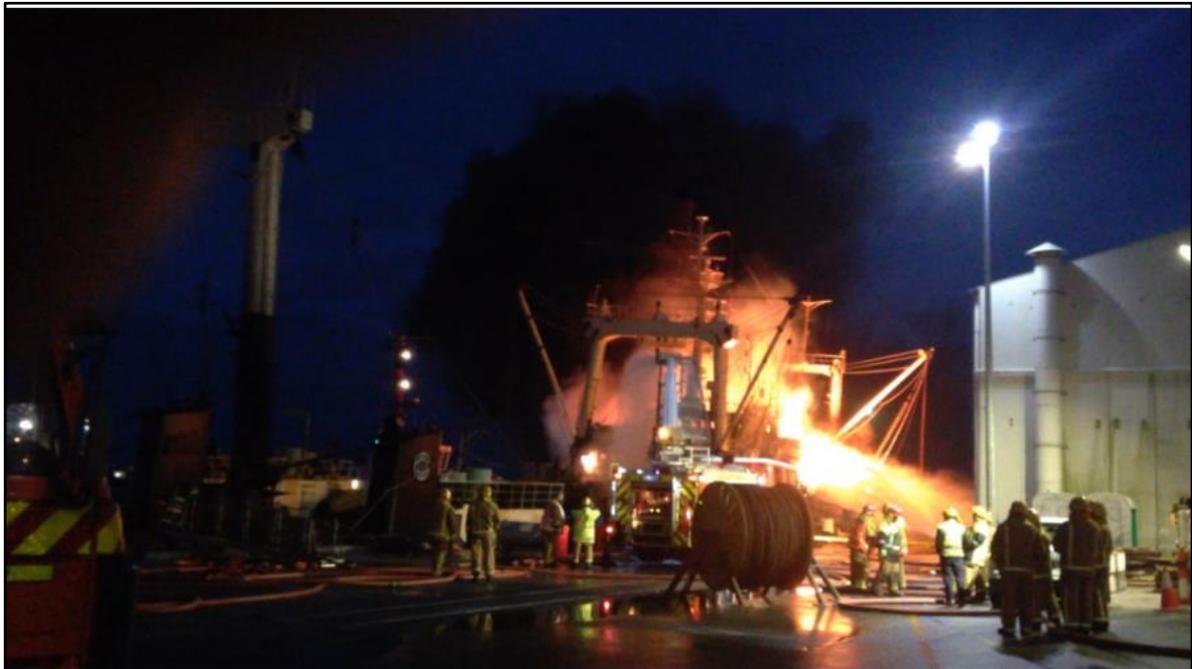
- 2.14. At about 2125 a member of the public notified FENZ of the fire. FENZ arrived on the scene at about 2132. By this time the fire was well established and the vessel's accommodation superstructure was engulfed in flames.

Figure 4: FENZ firefighters on the scene at 2132

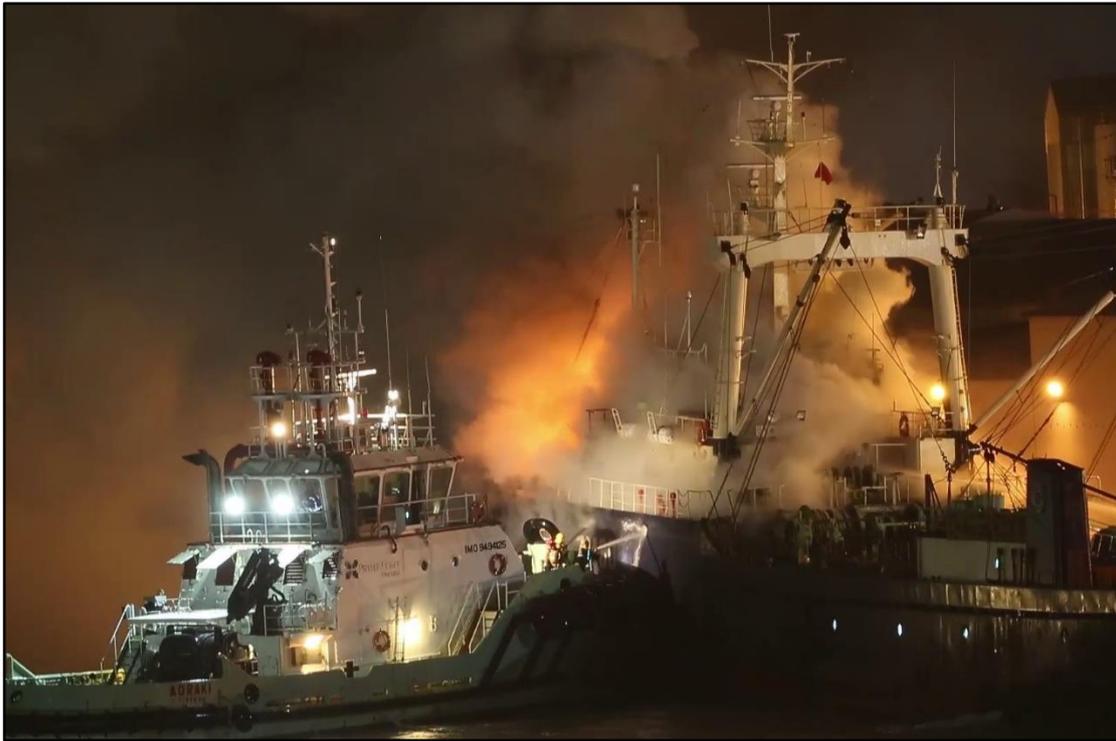
Figure 5: Tug *Te Maru* boundary cooling on the port side of the *Dong Won 701*

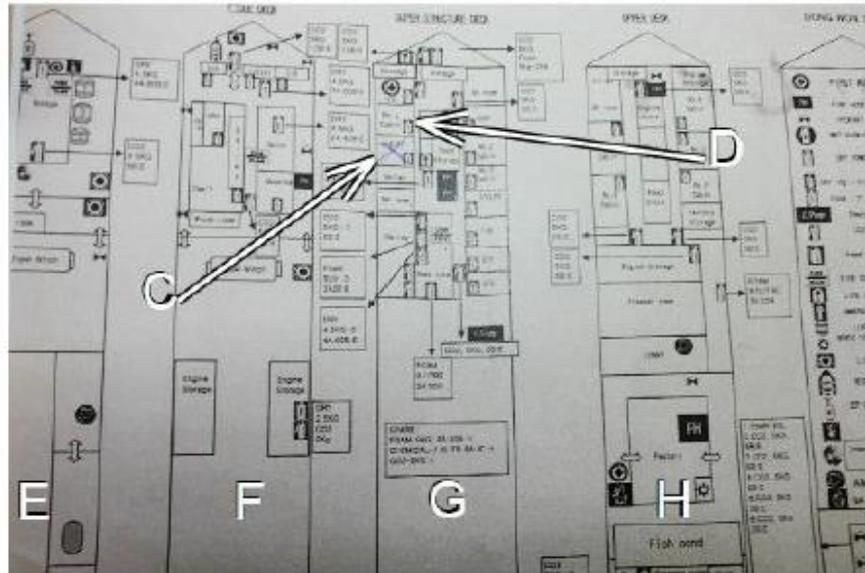
Photo 3: 'C' shows the location of the First Engineer's cabin and 'D' shows the cabin forward where a crewman was on the phone and noticed some smoke. 'E' is the Bridge level. 'F' is the Captain's Living Quarters. 'G' is the Officers' Living Quarters. 'H' is the Seamen's Living Quarters.

To the left of the cylinders (port side) there was an open space that was obviously living quarters. I knew this due to the debris that remained. I was able to identify the remains of fridges, oil column heaters and electrical equipment. By examining the ventilation ducting and aligning that with the steel droppers that were part of the structure that the hardboard walls would have been fixed to, I was able to determine where each cabin was. After referring to the vessel's map that was supplied to me by Maritime NZ, I was then able to confirm the area to the port side of the cylinders that lay in the passageway was the cabin of the first engineer. (Refer to photo 3).

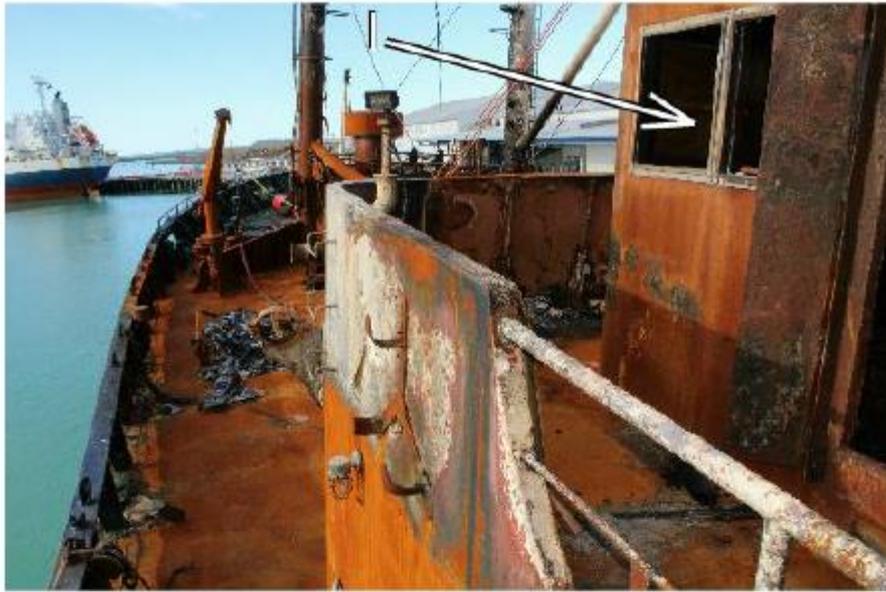
The Superstructure and the deck area in front of it showed extreme effects of heat. The buckling and oxidization of the steel on both were evidence of this. There was also extensive warping to the gunnel in front of the bridge windows. (Refer to photo 5 and 6). The rear of the Superstructure was less effected as identified by the remaining paint and no warping of the deck or gunnel.

Photo 5: Photo taken looking toward the front of the vessel while standing beside the bridge port entrance. 'I' indicates the bridge.

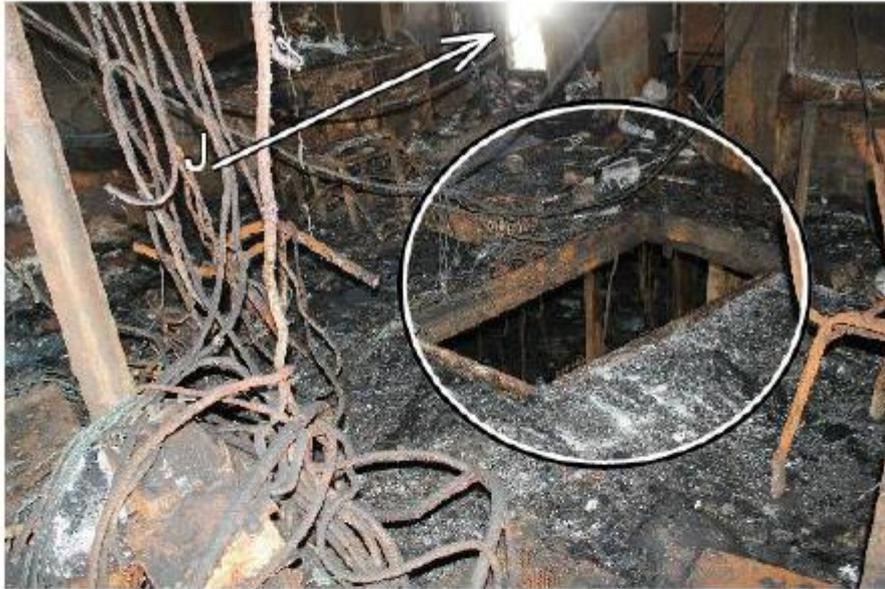
Photo 7: Looking across the bridge from the port side entrance the circle identifies where the ladder was that gave access to lower levels. 'J' shows the rear entrance on the starboard side.
