# WORLD BORA & RABA

Marine accident report on collision

19 FEBRUARY 2019

**MARINE ACCIDENT REPORT ON COLLISION WITH  
WORLD BORA AND RABA ON 19 FEBRUARY 2019**

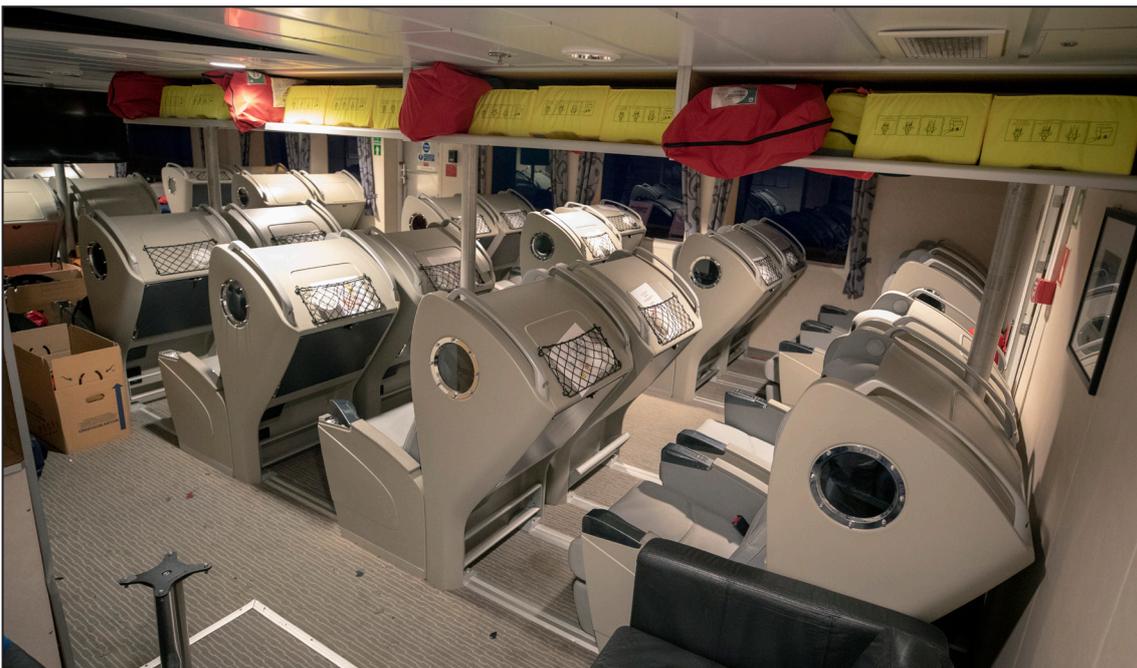
Figure 3: Lounge on WORLD BORA  
Source: DMAIB

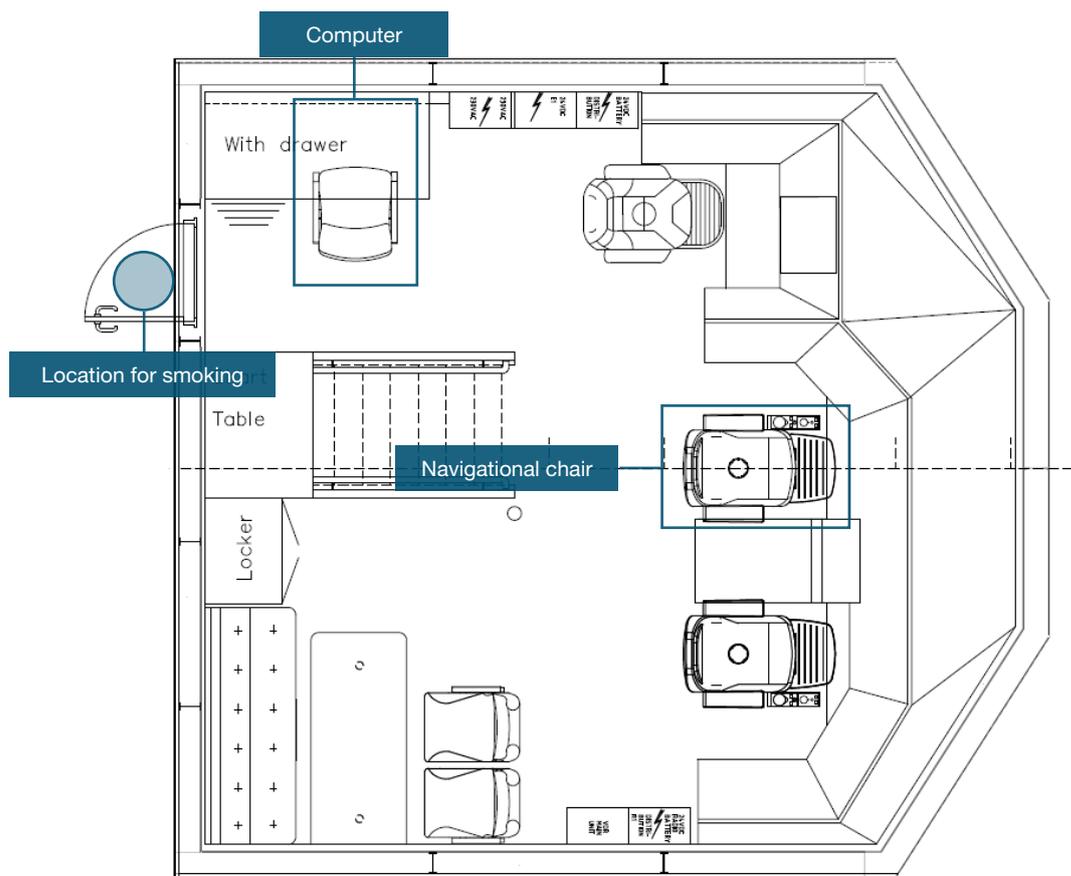
The master felt the need for a cigarette and went out on the aft upper deck. By the door on the aft part of the bridge, an ashtray was mounted – outside on the bulkhead just next to the door – and from this spot he could see out of the front windows and listen to the VHF radio (figure 4). When he had finished his cigarette, it occurred to him that he had to make some changes to the hotel booking for one of the ABs signing off later that day. The master wanted to check up on this matter, and he sat down by the computer located on a desk by the door.

Figure 4: Bridge layout  
 Source: World Marine Offshore/DMAIB

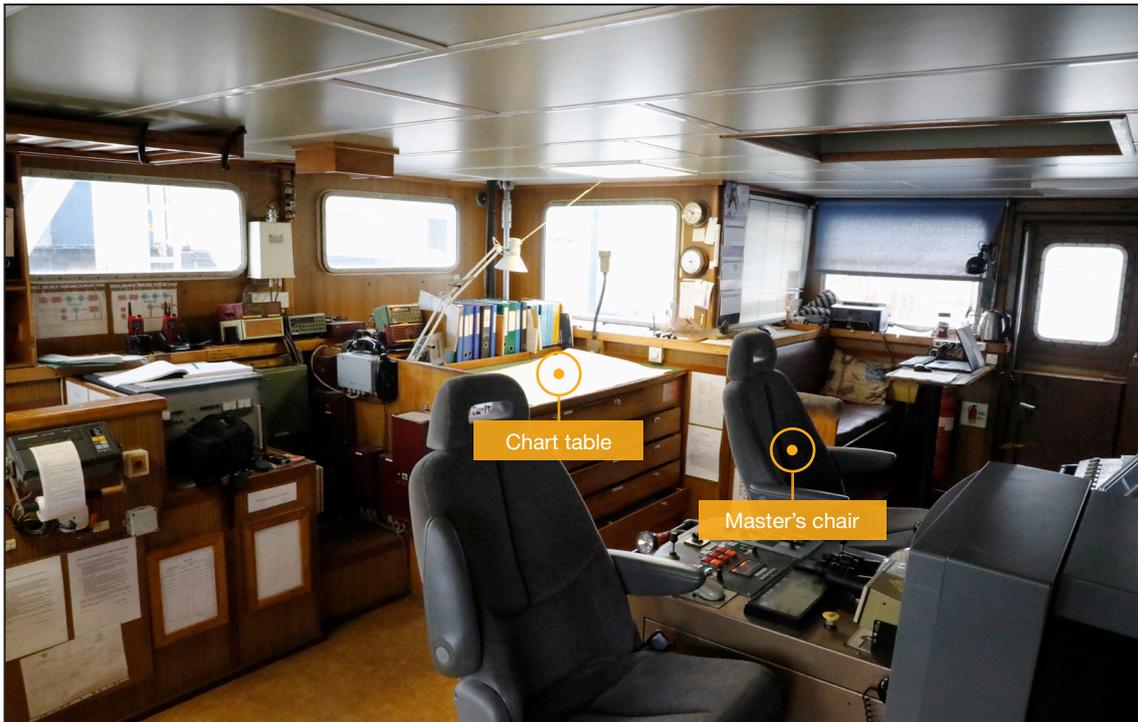
In the morning of 19 February 2019, RABA was en route to Szczecin. At 0600 am, the master came to the bridge (figure 5, next page) and took over the watch. On the bridge was also an AB on watch.

Figure 5: Bridge on RABA  
Source: DMAIB, 2019

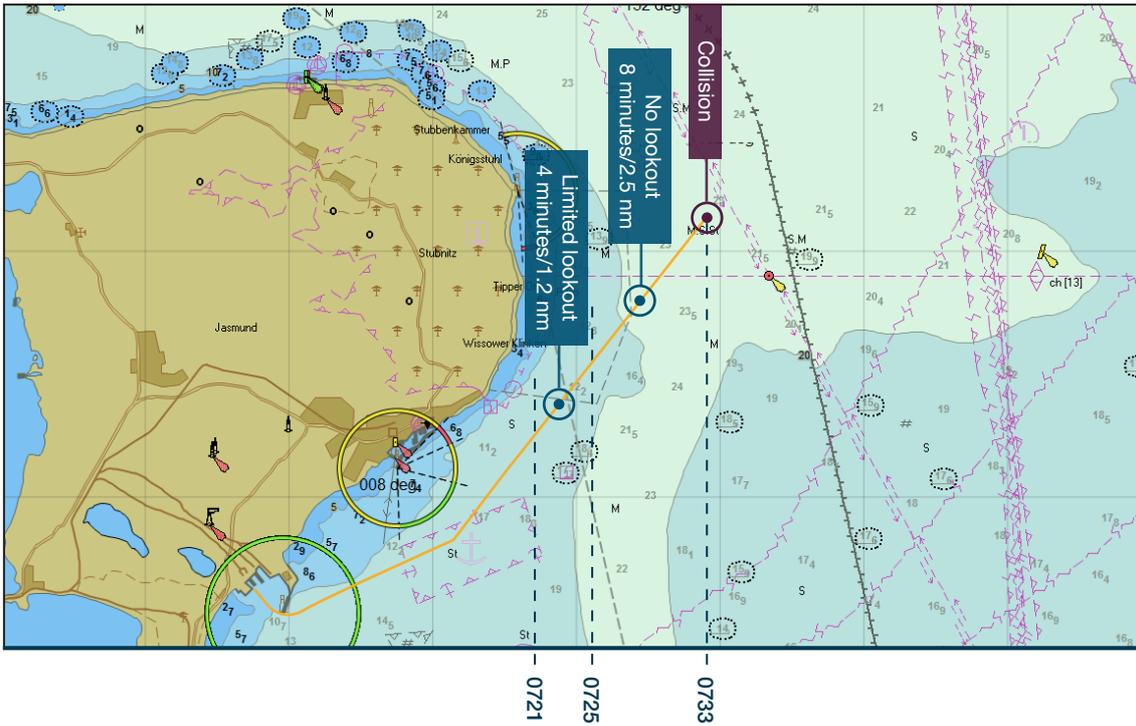
When the master had finished his cigarette, he went directly to the computer located near the exit to the aft deck where he had been smoking and did not pass the radar. As the master had not observed any change in the traffic situation while smoking, he deemed that the current traffic rendered him time to briefly carry out some administrative work. At this point RABA was within radar coverage, but the master's lookout was impaired by the distance to the radar and the blind angles on the bridge.

The master estimated that he was at the computer for 1-2 minutes before the collision, however, logs from the computer show that the master was active on the computer from 0725 am to 0733 am, when the collision occurred. It is likely that the master lost his sense of time while being caught up by computer work and hence did not realise that lookout was not kept for 8 minutes, neither on the radar nor visually (figure 8, page 13). During the 8 minutes with no lookout, WORLD BORA travelled a distance of 2.5 nm. Hence, the master did not see RABA approaching on a collision course.

Figure 8: Lookout on World Bora before the collision  
 Source: © Made Smart Group BV 2019; © C-map Norway AS 2019 /DMAIB

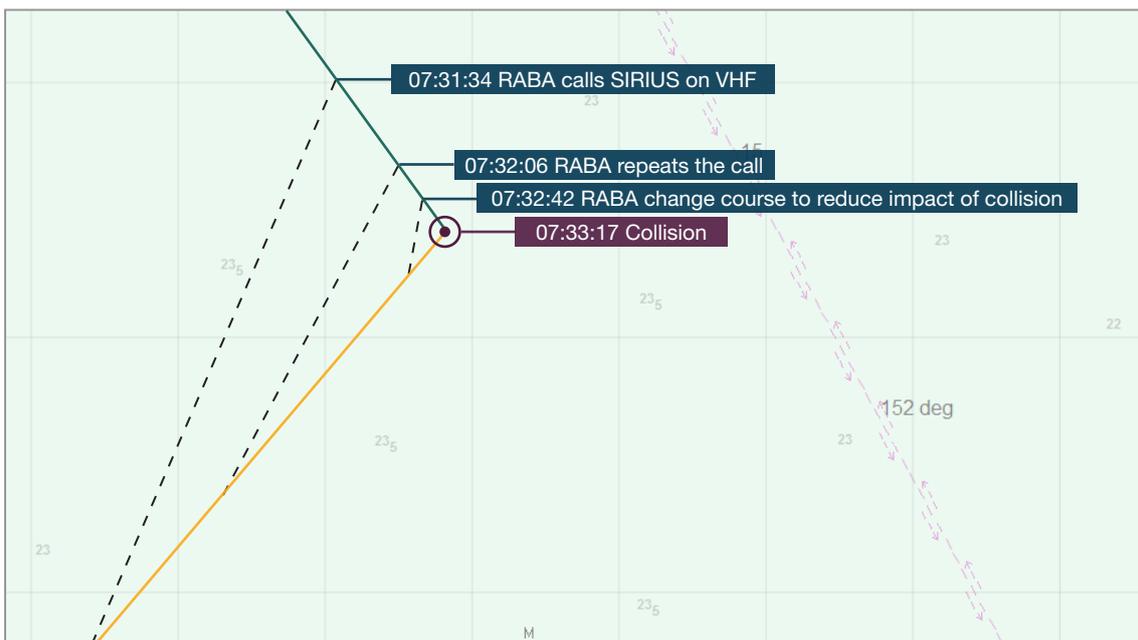
During these 30 seconds, the distance between the two ships was reduced to 0.4 nm. Again, he waited 38 seconds for a reply from the other vessel, but now realising that a collision was inevitable, he altered RABA's course to port to minimise the impact of the collision (figure 11). Figure 12, next page, shows the angle of impact.

Figure 11: : Reduction of distance between the WORLD BORA and RABA during the attempt to avoid the collision.  
Source: © Made Smart Group BV 2019; © C-map Norway AS 2019 /DMAIB
