Report on the investigation of
the collision between the ro-ro passenger ferry

Red Falcon

Greylag

in Cowes Harbour, Isle of Wight

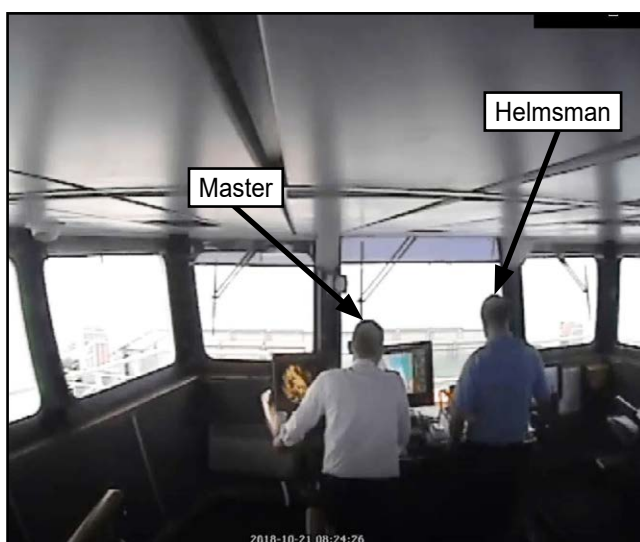
Figure 5a: Master and helmsman position entering Cowes

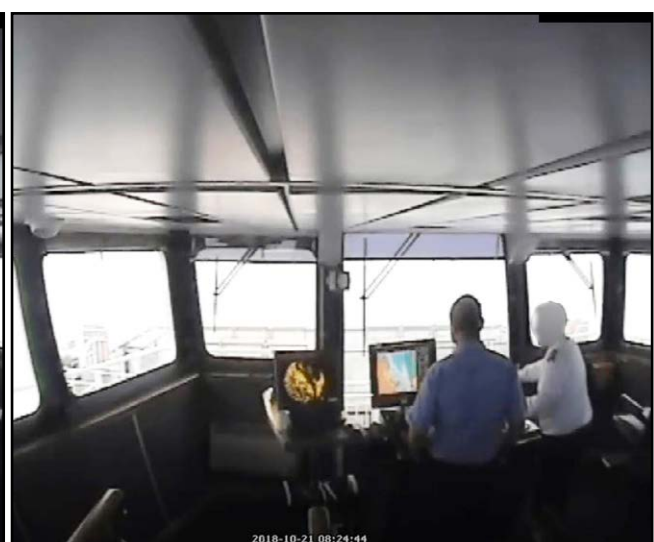
Figure 5b: Master and helmsman position after master took over control

when the master took over from the helmsman he could no longer see the radar display (**Figure 5b**). It was therefore much more likely that the swivel mounted ECS display closer to the VSP controls would be used for navigation.

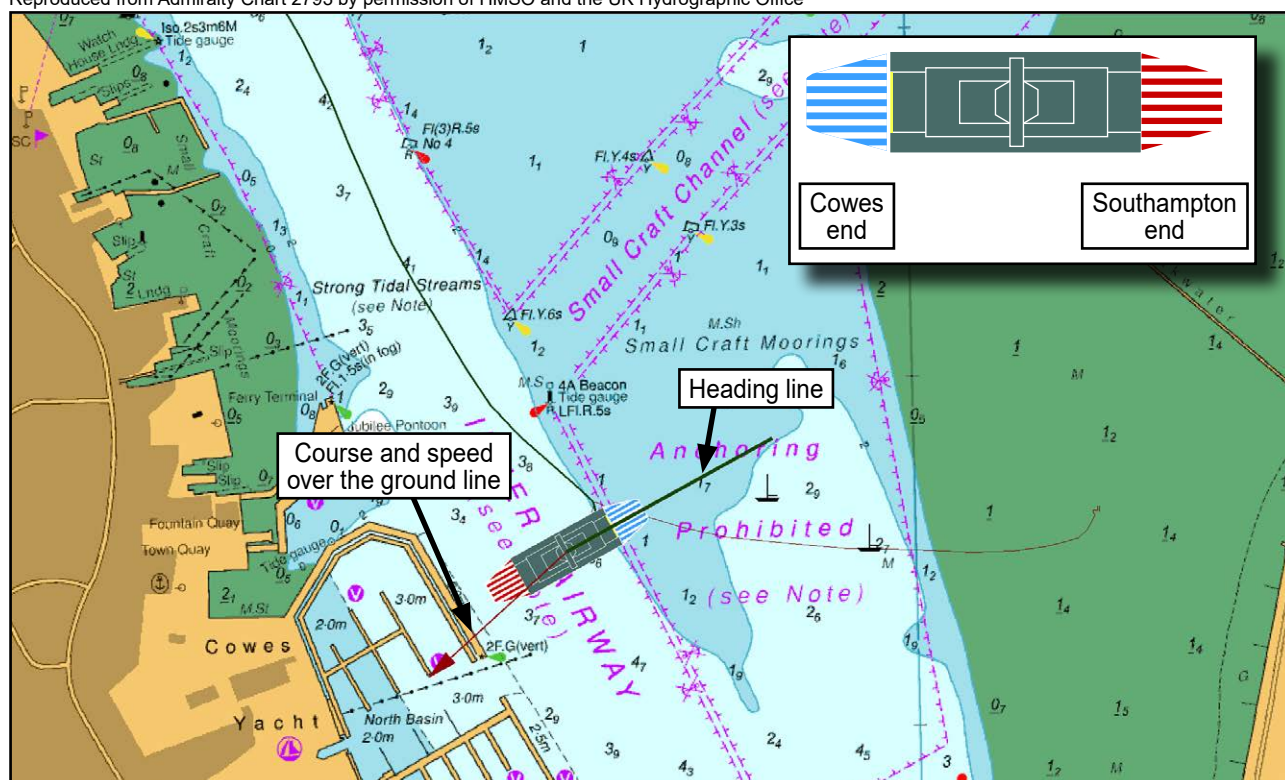
At 0809:30, with *Red Falcon* perpendicular to the inner fairway, the master stopped the vessel's forward momentum and continued to swing it to port (**Figure 7**). At 0810:20 the Cowes end passed clear of the No.4a beacon by less than 10m.

Figure 7: Red Falcon perpendicular to the inner fairway

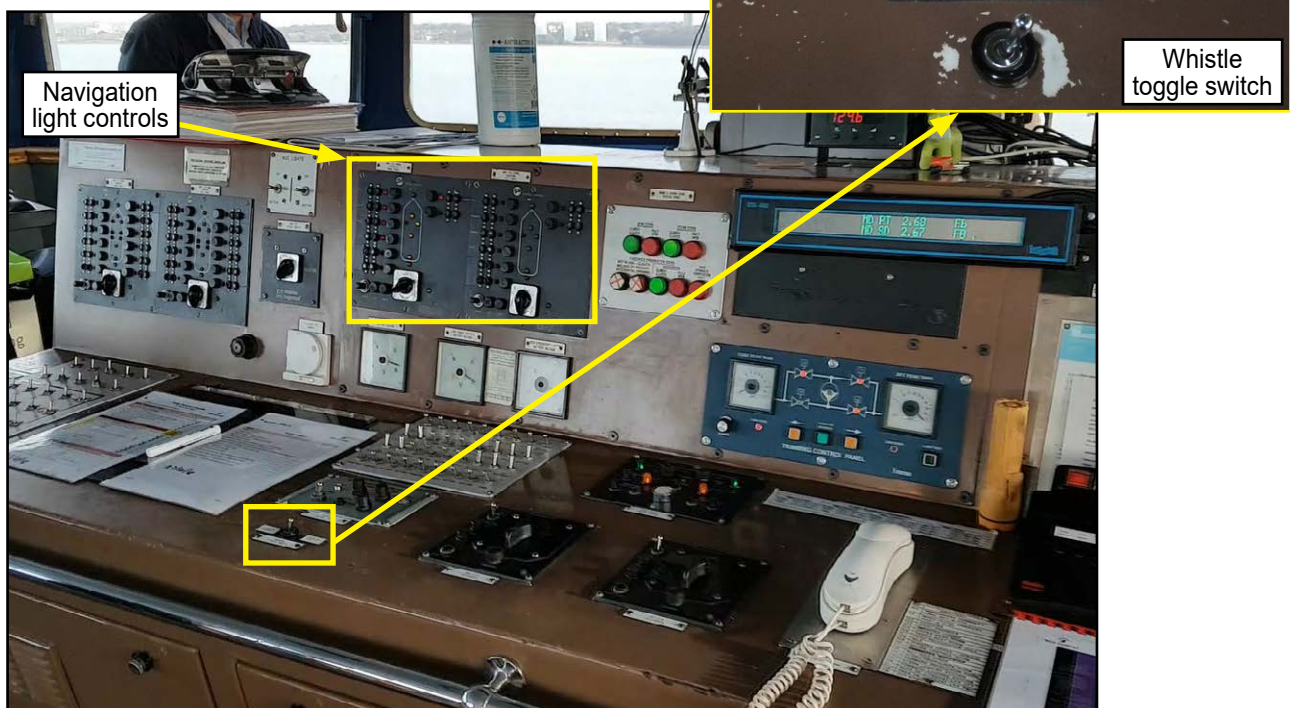
Because *Red Falcon* was fitted with one ECS unit and slave displays, the heading line, and therefore orientation of the ship shape, was manually changed each time the ferry changed direction in Southampton or Cowes. The heading signal was linked electronically to the whistle toggle switch (labelled *Whistle*) located on the central administration console (**Figure 16**). When the whistle was switched from one end of the vessel to the other, this also changed the heading line orientation on the ECS.

Figure 16: Whistle toggle switch and navigation lights controls

The bridge departure checklist included prompts to switch over the whistle and navigation lights to coincide with the vessel's orientation. It did not refer to the orientation of the heading line on the ECS.

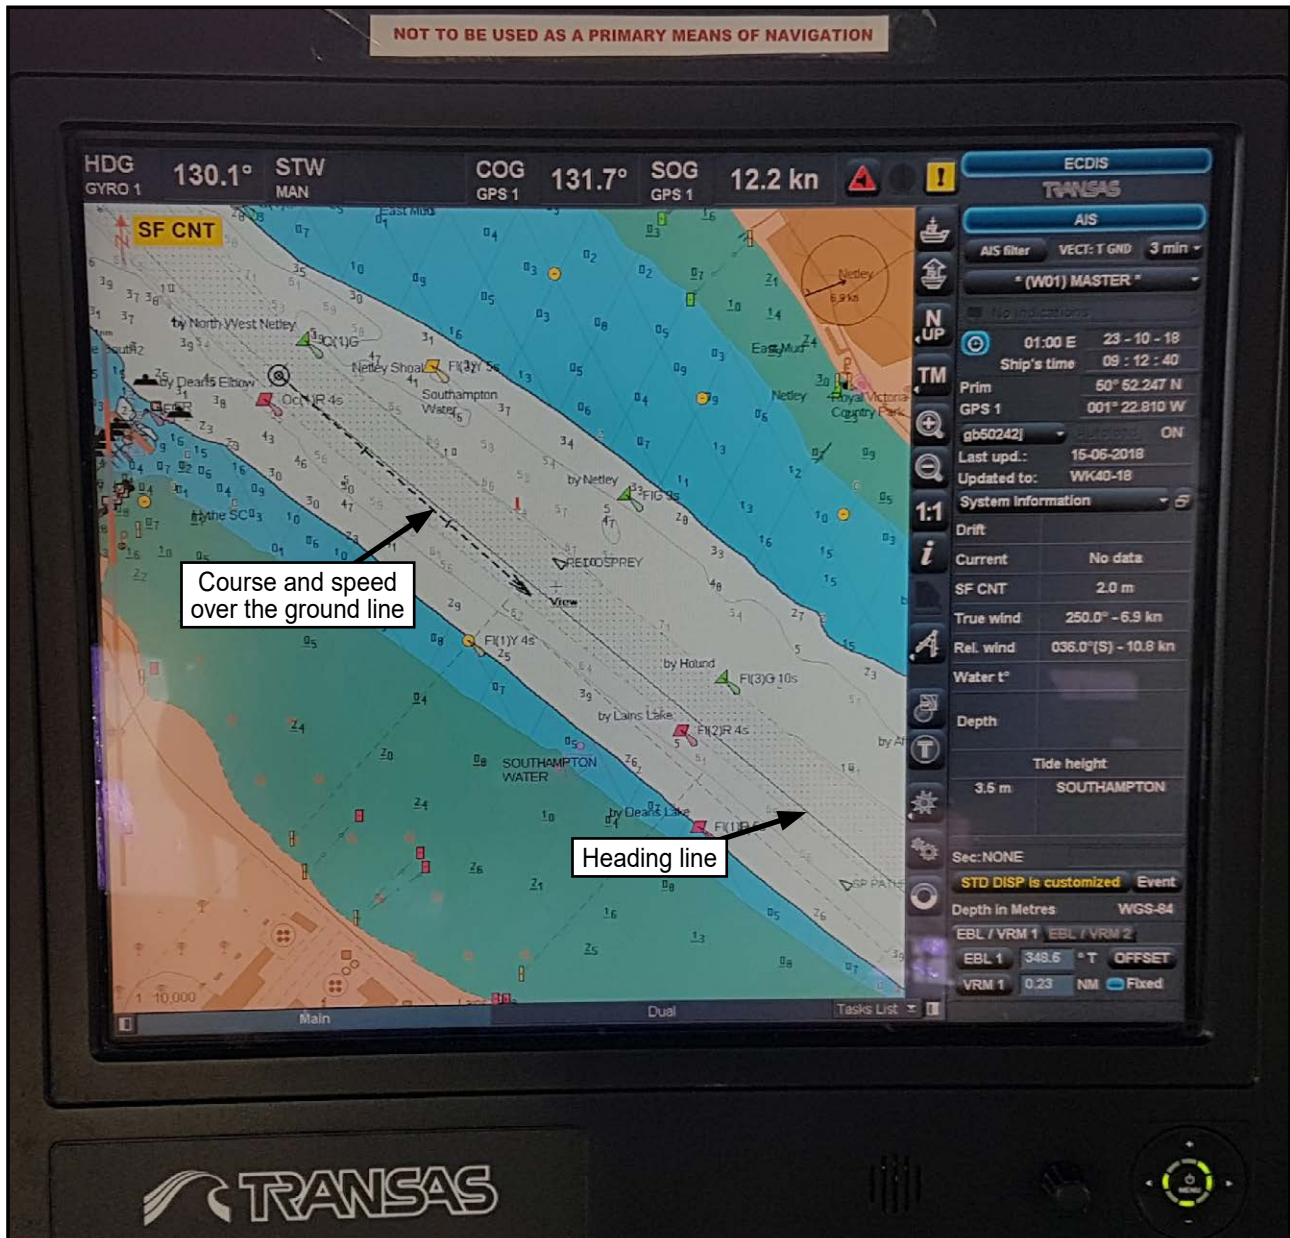
Due to the nature of the information received from the satellite systems and the time taken to display the processed information, there was a short time lag of about 1 second between the information being received and it being displayed on the ECS screens. This resulted in the ship's shape moving across the screen with a motion that was not smooth.

Similar to the radar display, each ECS display screen presented the position, heading, COG and SOG digitally (**Figure 17**), and the COG arrow appeared once the ferry was making way and grew in length as the SOG increased.

Figure 17: Electronic Chart System display
