MARINE ACCIDENT
INVESTIGATION BRANCH

SAFETY DIGEST

**Lessons from Marine
Accident Reports
1/2020**

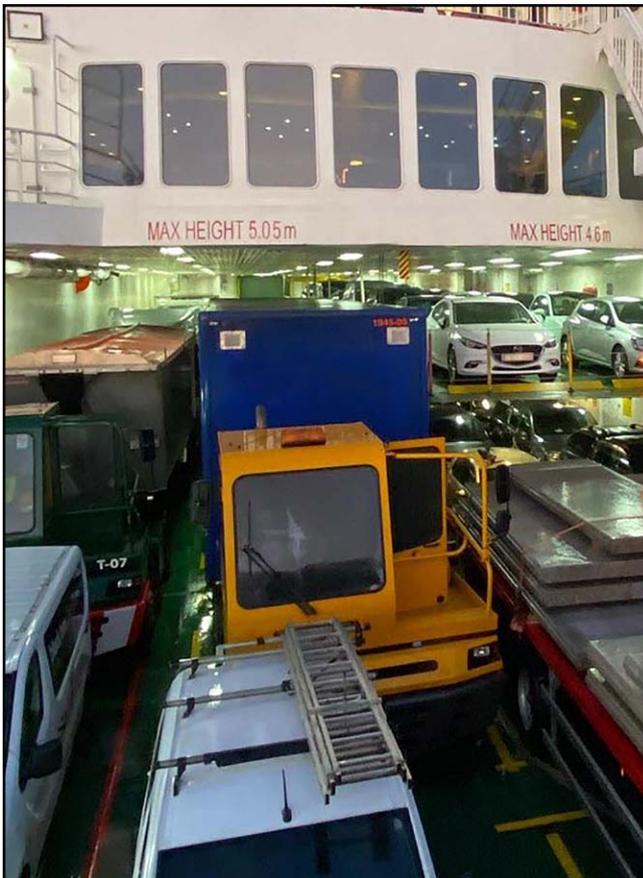
Figure 1: The tug master unit and lorry trailer on board the ferry

When the ferry arrived in port, the local fire service attended to assess the situation. The tug master unit was extensively fire damaged internally (Figure 2); however, there was no damage to the vessel and no passengers or crew were injured.

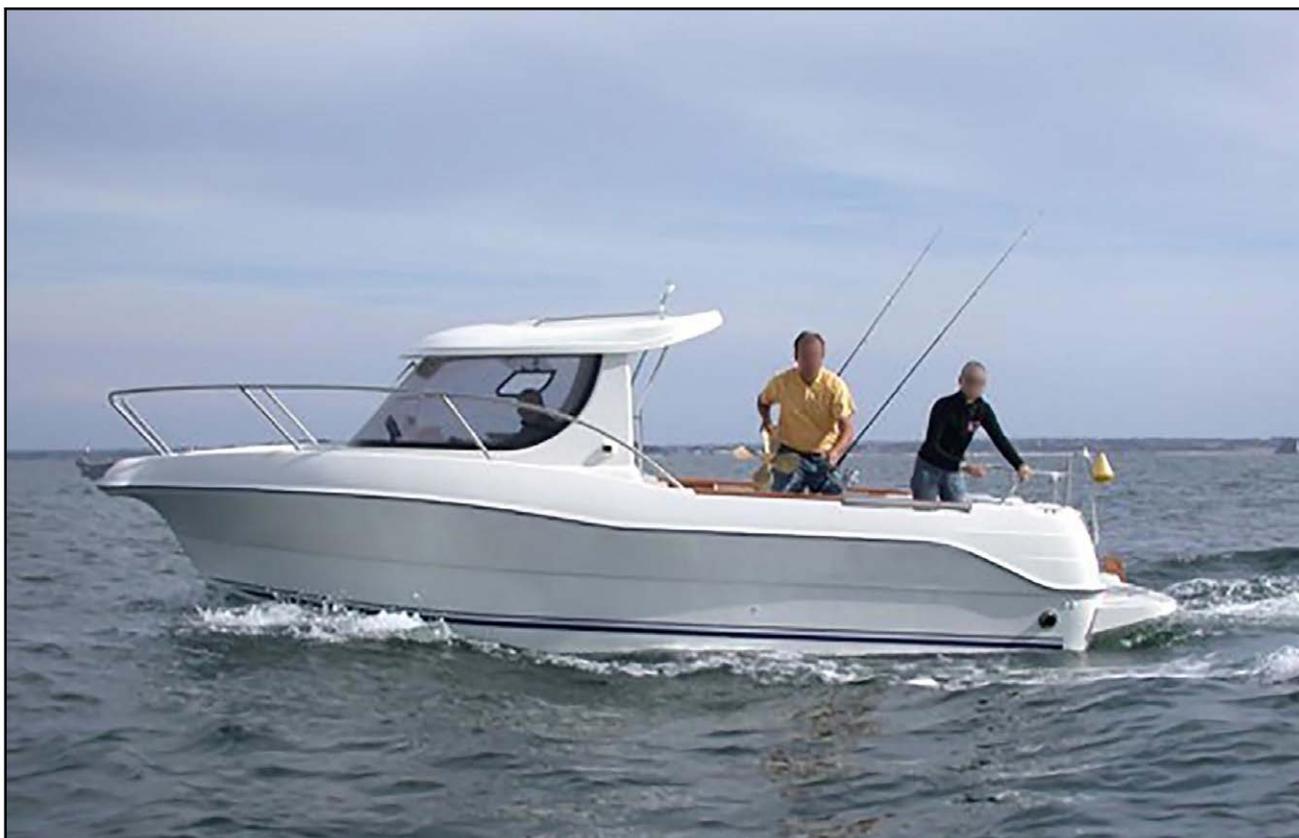
It was not possible to determine the cause of the sinking with certainty. However, the most likely cause is thought to have been catastrophic failure of the engine cooling water hose or hull fitting.

Figure: Similar boat

3. The flooding was most likely caused by the catastrophic failure of the engine cooling water system hose or a hull fitting. It is essential that boat owners ensure that these items are inspected regularly and consider trying suitably sized bungs to through hull fittings and valves. If a failure does occur while underway the outcome, as in this case, can be unwelcome.

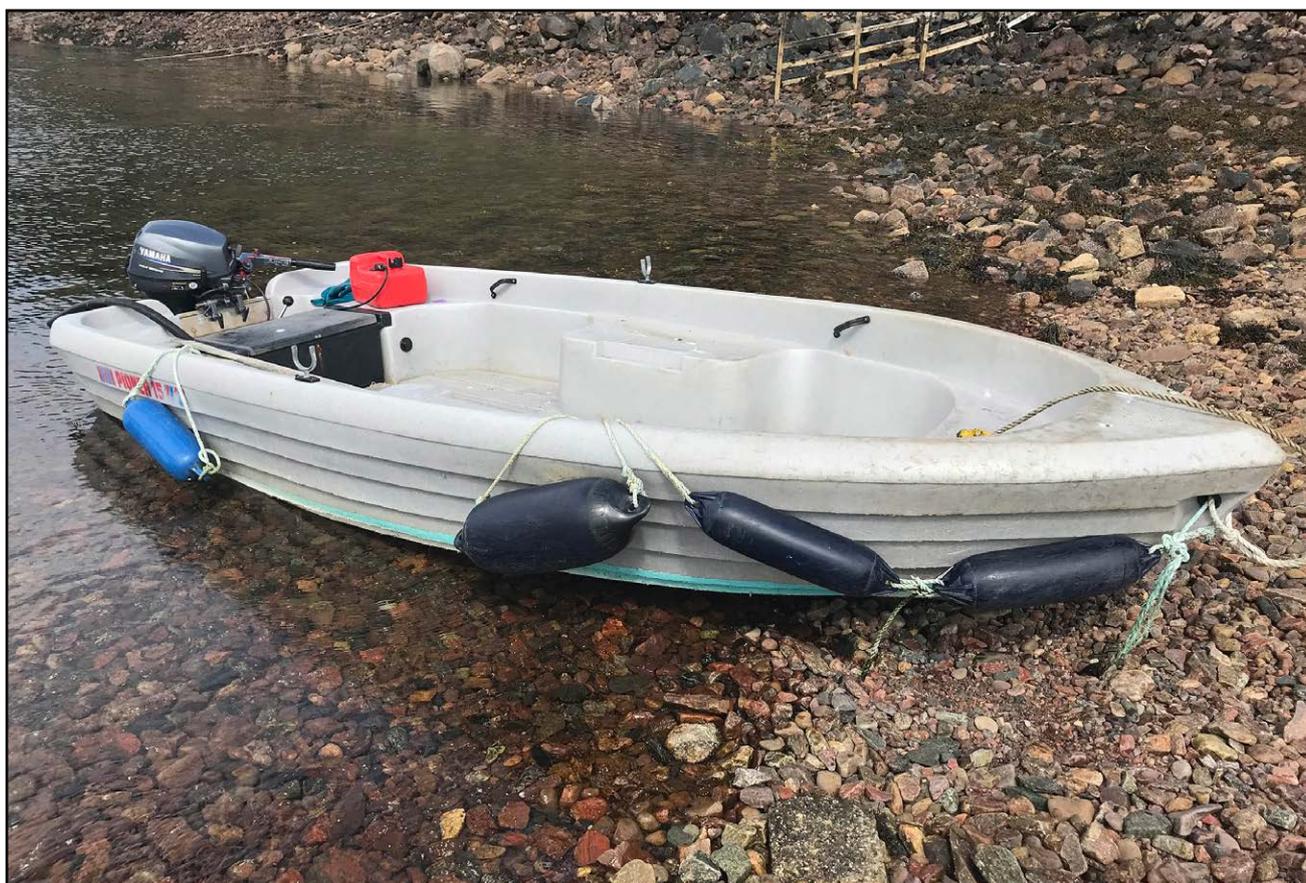
Figure: The tender

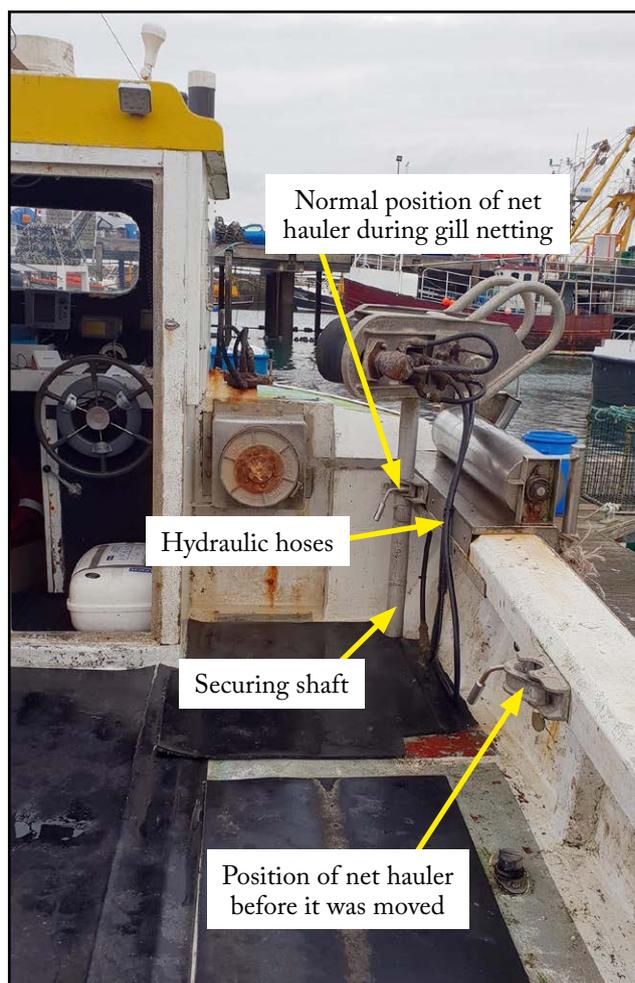
Figure 1: Fishing gear

As it fell, the securing shaft caught the skipper between his legs, carrying him overboard as well.

The skipper managed to grab hold of the hauler's hydraulic hoses and rested his knees on the hauler body, which was suspended by them below the surface of the water. He was wearing oilskins, steel toed wellingtons and a winter jacket. He was not wearing a lifejacket and did not carry a personal locator beacon. He stayed in this position for nearly an hour while the boat made its way towards harbour. As the vessel approached the pier, he let go and started swimming to safety. The vessel continued ahead and made heavy contact with the pier.

3. Moving heavy equipment, such as a hauler, should preferably be done in port, and not when alone at sea when there is no one around to help if you suffer an accident.

4. Make sure the deck is fitted with good quality rubber matting with non-slip backing.

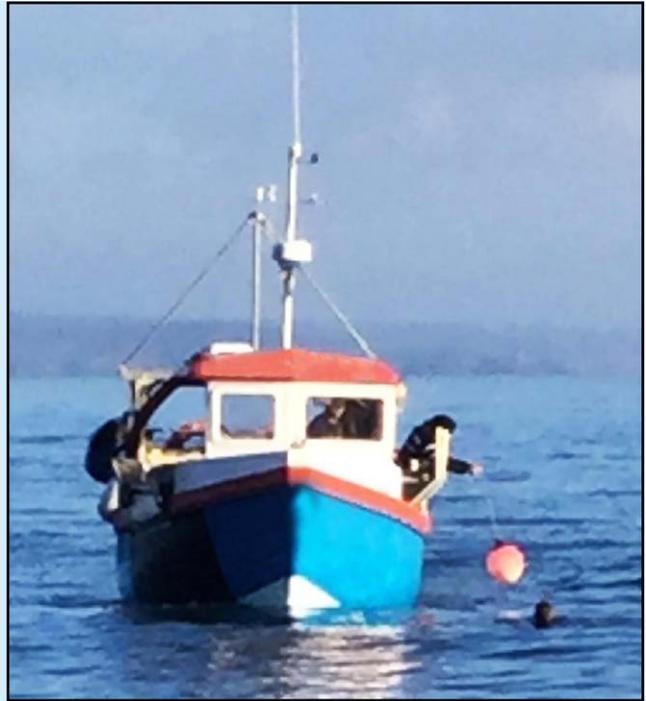
Seeing the vessel with its bow hard against the pier, the skipper of another fishing vessel in the harbour attempted to make contact. He was unaware that the skipper was in the water. Not getting a response, the fishing vessel's crew alerted the local lifeboat station. They then spotted the skipper in the water and went to his aid, throwing him a lifeline and helping him to maintain his head above the water (Figure 2).

Figure 2: Skipper being rescued

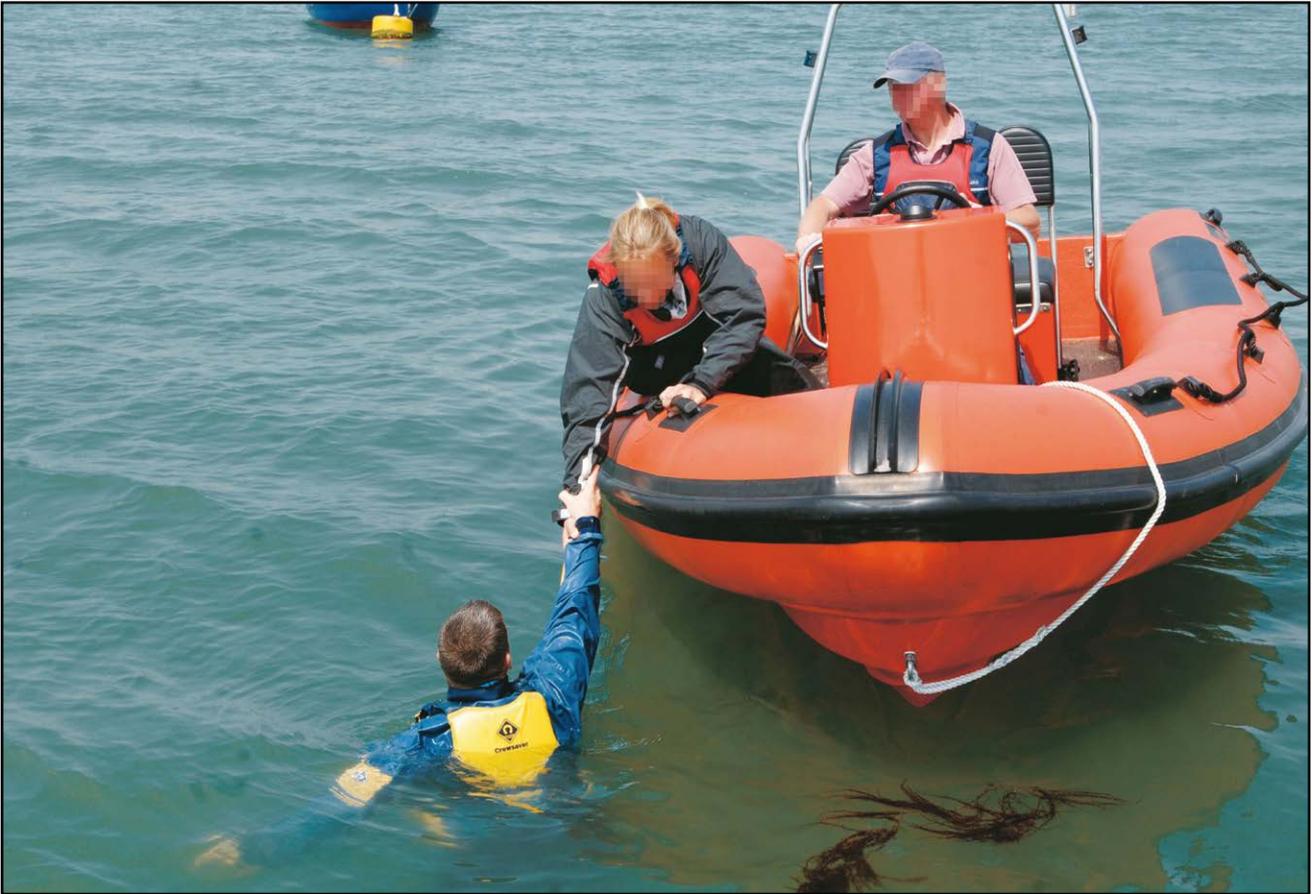
Figure 1: Safety boat crew member wearing a buoyancy aid

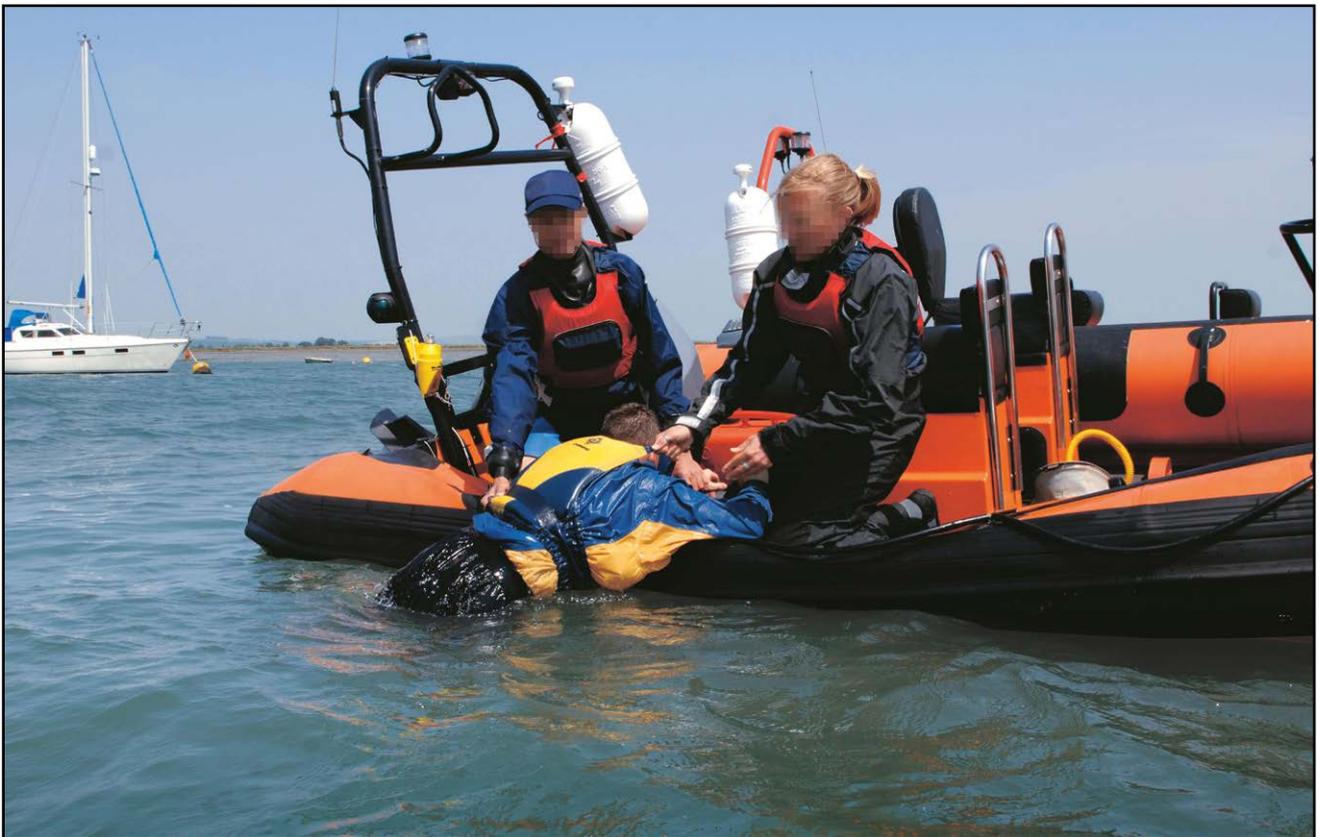
Figure 2: Safety boat crew member wearing dry suit and buoyancy aid

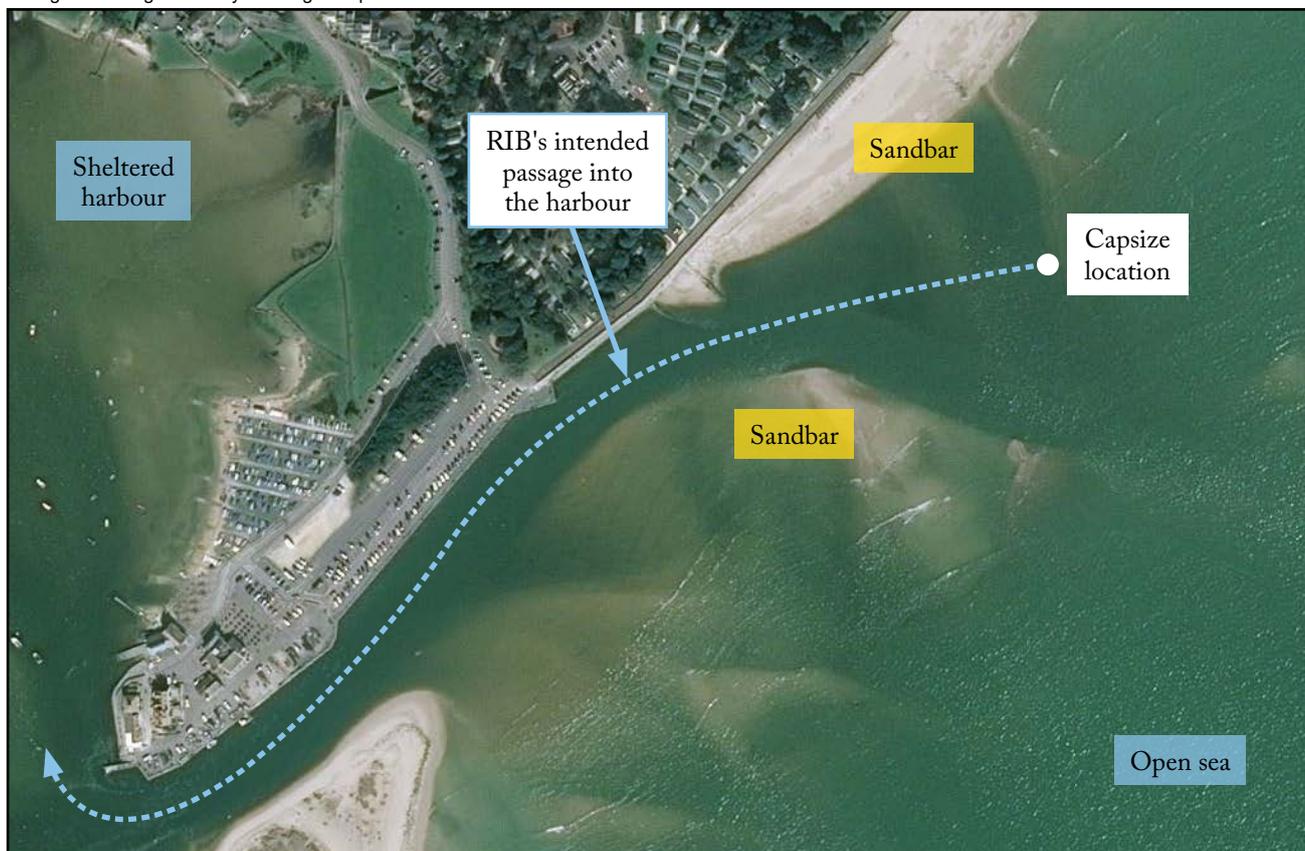
Despite the wait, as the 4.9m RIB entered the channel, a large breaking wave approached from the stern and began to lift it, so the instructor told the student helmsman to increase speed. However, this corrective action came too late and the wave continued to lift the stern of the RIB, resulting in a capsizing,

Figure 1: Satellite imagery of the harbour entrance showing the sandbars and narrow entrance

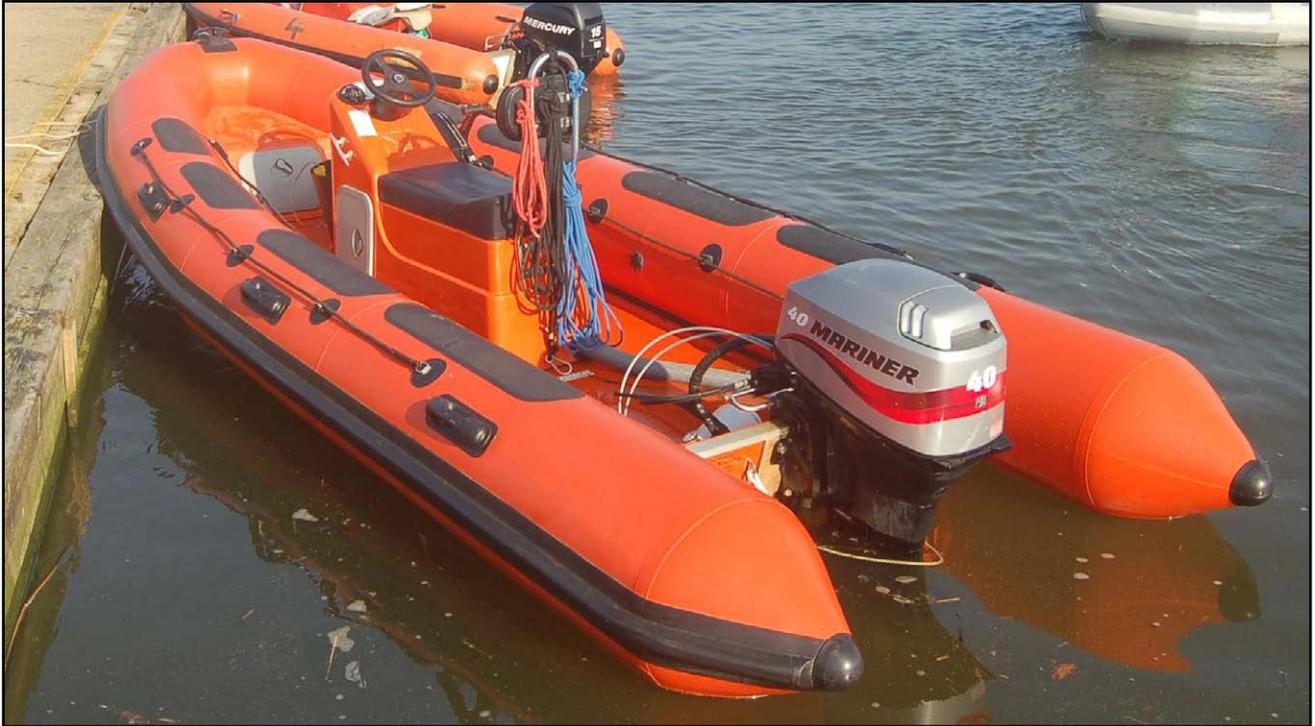
The instructor in the following 4.5m RIB witnessed the accident and raised the alarm immediately by making a “Mayday” call on

VHF channel 16. The instructor in the 4.5m RIB then decided to beach his boat on the adjacent sandbank and rescue those in the water using a throw line. Very soon, the crew of the capsized RIB were safe, cold but uninjured.

Figure 2: The 4.9m RIB involved in the capsized
