National Transportation Safety Board

Marine Accident Brief

Overpressurization and Rupture of Cargo Tank on Cargo Vessel *Fairchem Filly*

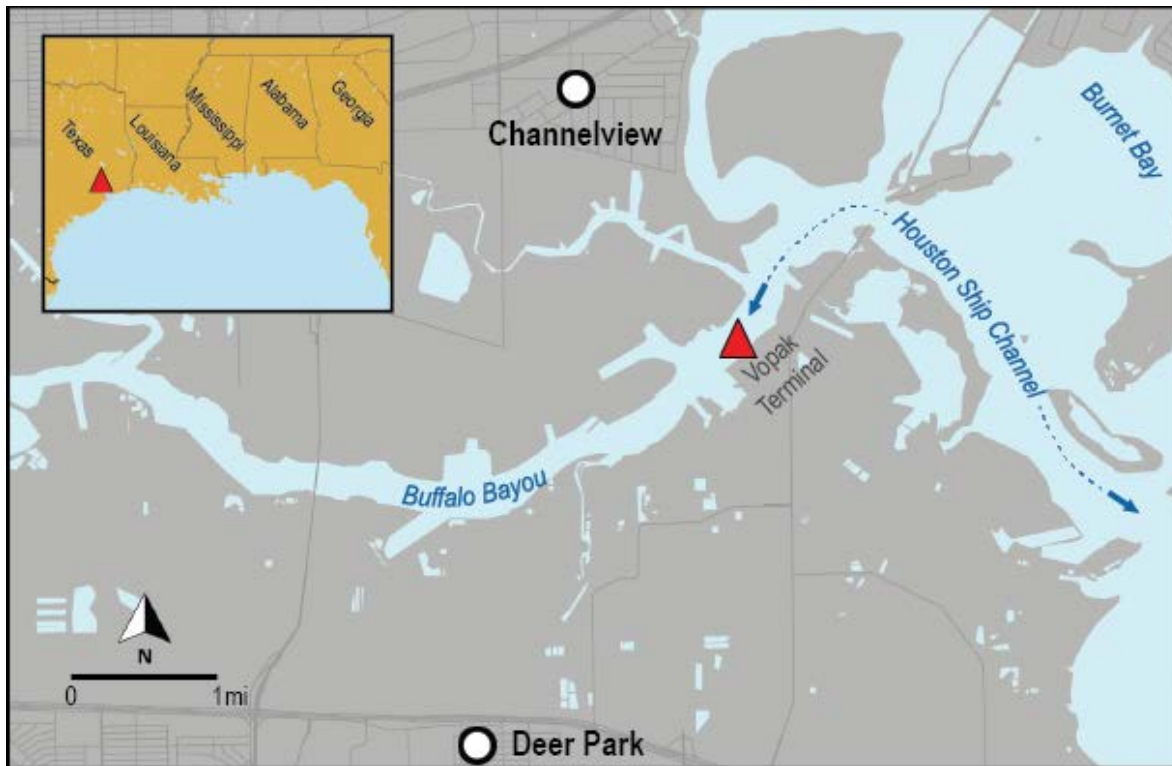
Area of accident where one of the *Fairchem Filly*'s cargo tanks ruptured during discharge operations. (Background source: Google Maps)

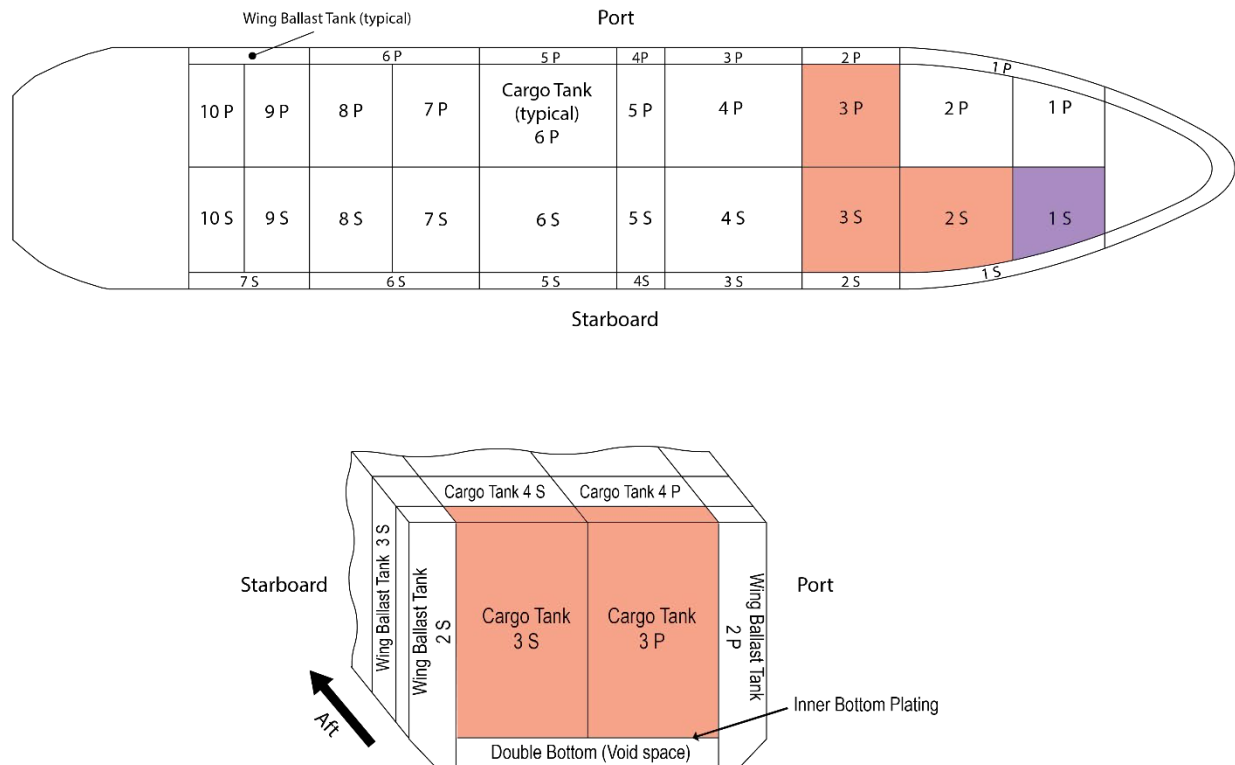
The tanker's number 1 starboard (1S), number 2 starboard (2S), and number 3 port and starboard (3P and 3S, respectively) cargo tanks contained product and were all scheduled to be discharged to the terminal. Tank 1S was approximately 38% full and contained 65,171 gallons of methyl isobutyl ketone (MIBK) in a liquid state. Tanks 2S, 3P, and 3S were each 93% full and, combined, contained about 914,563 gallons of liquid hexene. All other cargo tanks aboard the *Fairchem Filly* were empty.

Simplified diagram of the cargo tanks and wing ballast tanks on board the *Fairchem Filly*. The cargo tanks carrying hexene are marked in orange, and the cargo tank carrying MIBK is marked in purple.
