MARINE TRANSPORTATION SAFETY INVESTIGATION REPORT M17C0179

BOTTOM CONTACT AND SUBSEQUENT FLOODING

Passenger vessel *Island Queen III*
Kingston, Ontario
08 August 2017

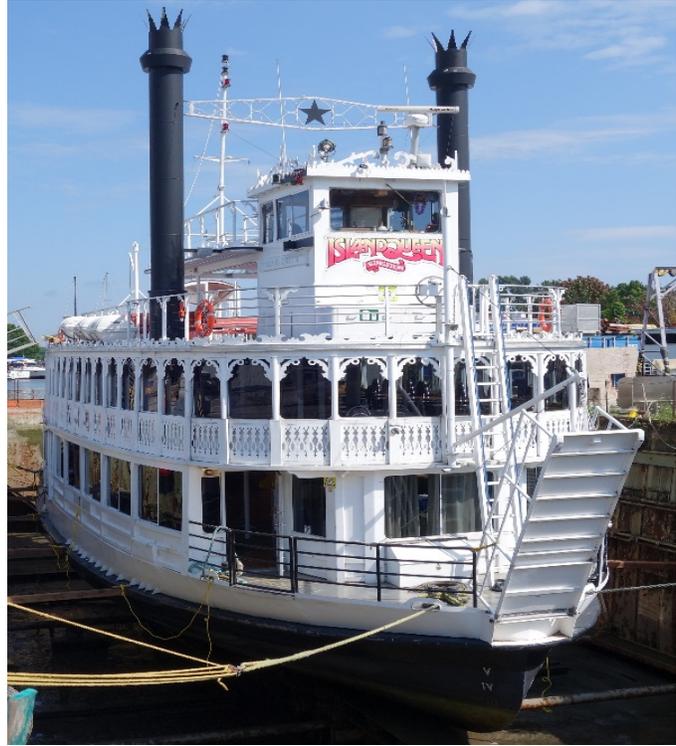
Figure 1. The *Island Queen III* (Source: TSB)

The *Island Queen III* (Figure 1) is a triple-decked passenger vessel with a decorative paddle wheel located at the stern and a functional gangway at the bow. The general arrangement of the vessel is shown in Appendix A.

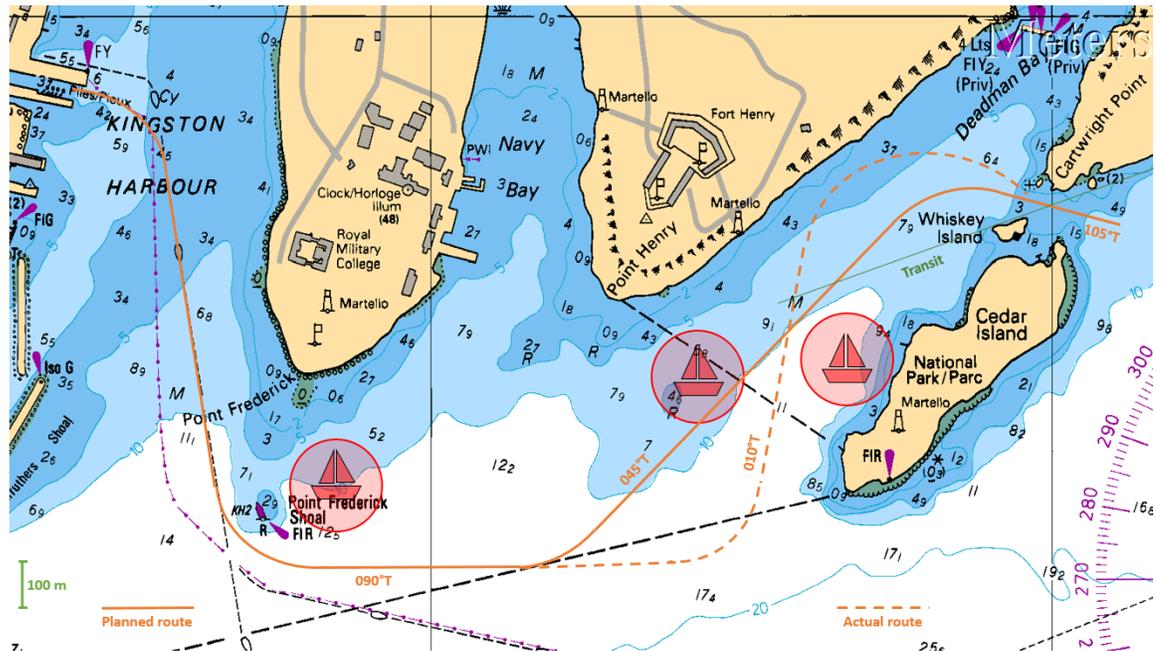
At approximately 1240, as the vessel approached Point Frederick Shoal (Figure 2), the mate entered the wheelhouse. Both the mate and the master observed a fleet of sailing school dinghies (shown as red boats in Figure 2) to the vessel's port side and clear of the planned route.

Figure 2. The Island Queen III's track from Kingston Harbour to Cartwright Point (shown in orange) and the sailing school dinghies (indicated by red boats) (Source: Canadian Hydrographic Service Chart 2017, Kingston Harbour and Approaches, with TSB annotations)
