Report on the investigation of the loss of
42 containers from the container ship

Ever Smart

700 miles east of Japan, North Pacific Ocean

30 October 2017

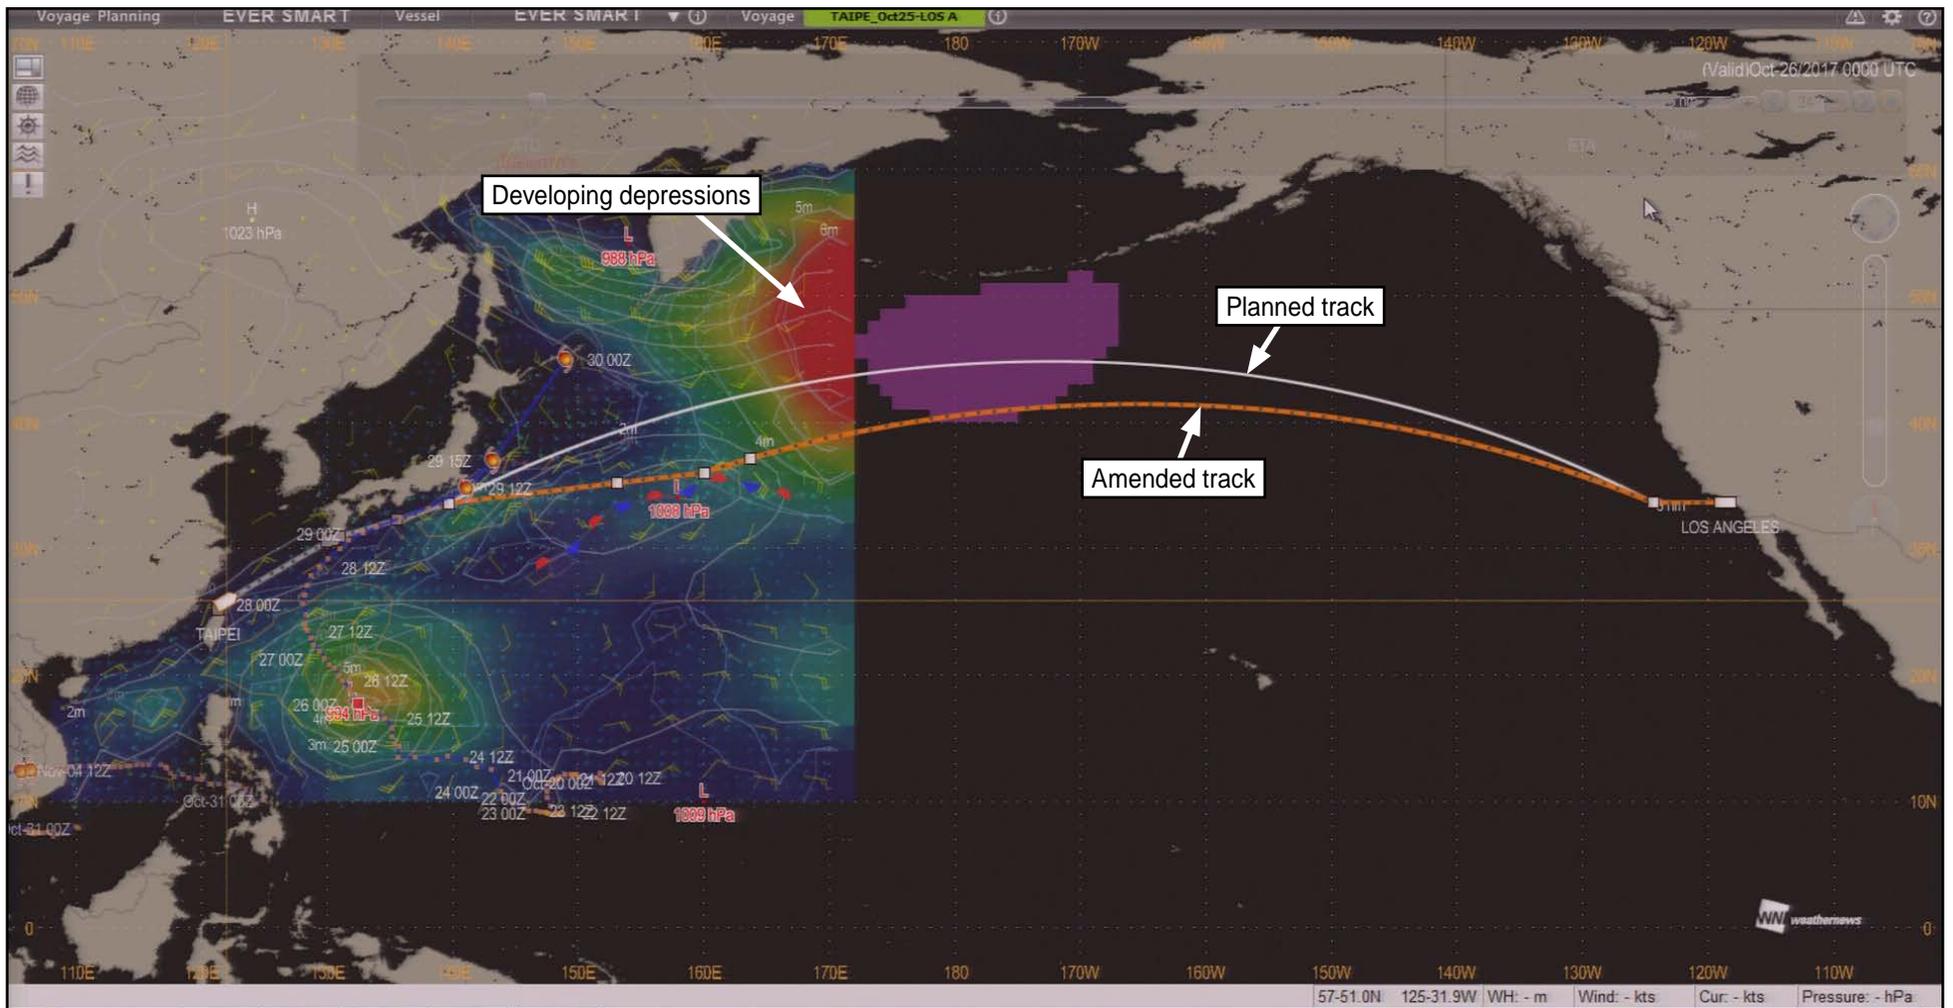
The following morning (27 October), *Ever Smart's* master checked the ship's weather routing computer again. Concerned about two developing depressions to the north, he sent an email to the company's service provider, Weathernews Inc. (WNI), and requested a routing assessment. WNI advised the master that a more southerly course should be steered to avoid the worst of the weather to the north (**Figure 1**). The master accepted WNI's advice and instructed the officer of the watch (OOW) to amend the passage plan. At 1445, *Ever Smart's* course was altered from 069° to 077° to follow the revised route.

Figure 1: Snapshot of *Ever Smart's* weather routing computer display screen showing developing depressions with original and amended tracks

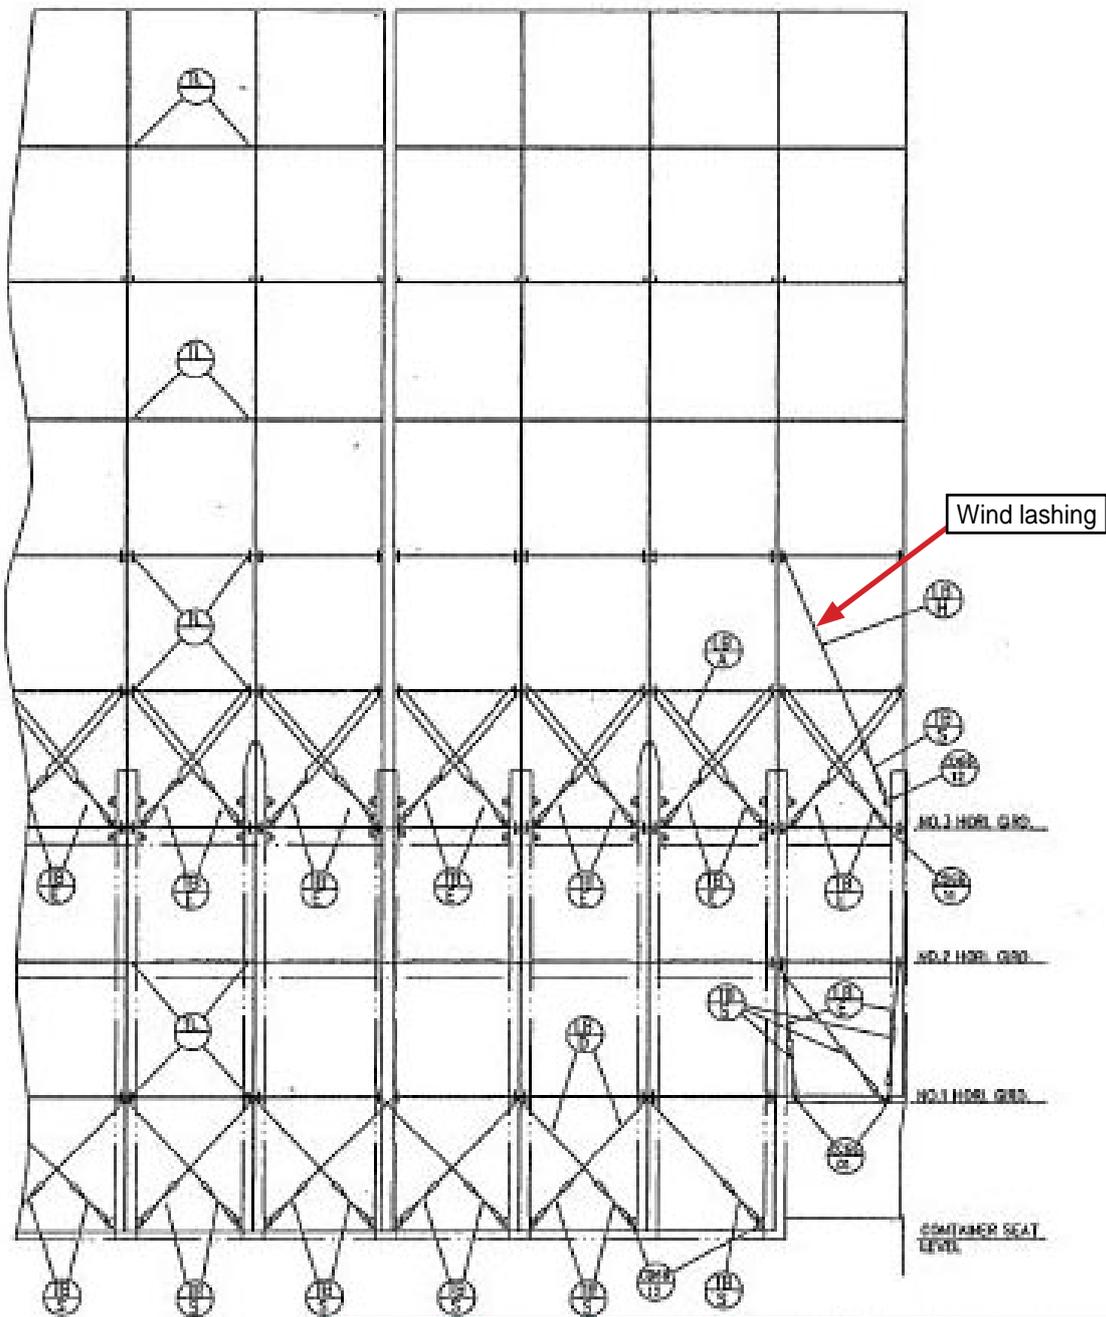
Figure 8: Cargo securing manual location of fixed securing devices drawing for bay 70 when outer stack is loaded eight containers high (to tier 9)

In case of 8 tiers on the side most row, only 8ft 6in container can be stowed (Figure 8).

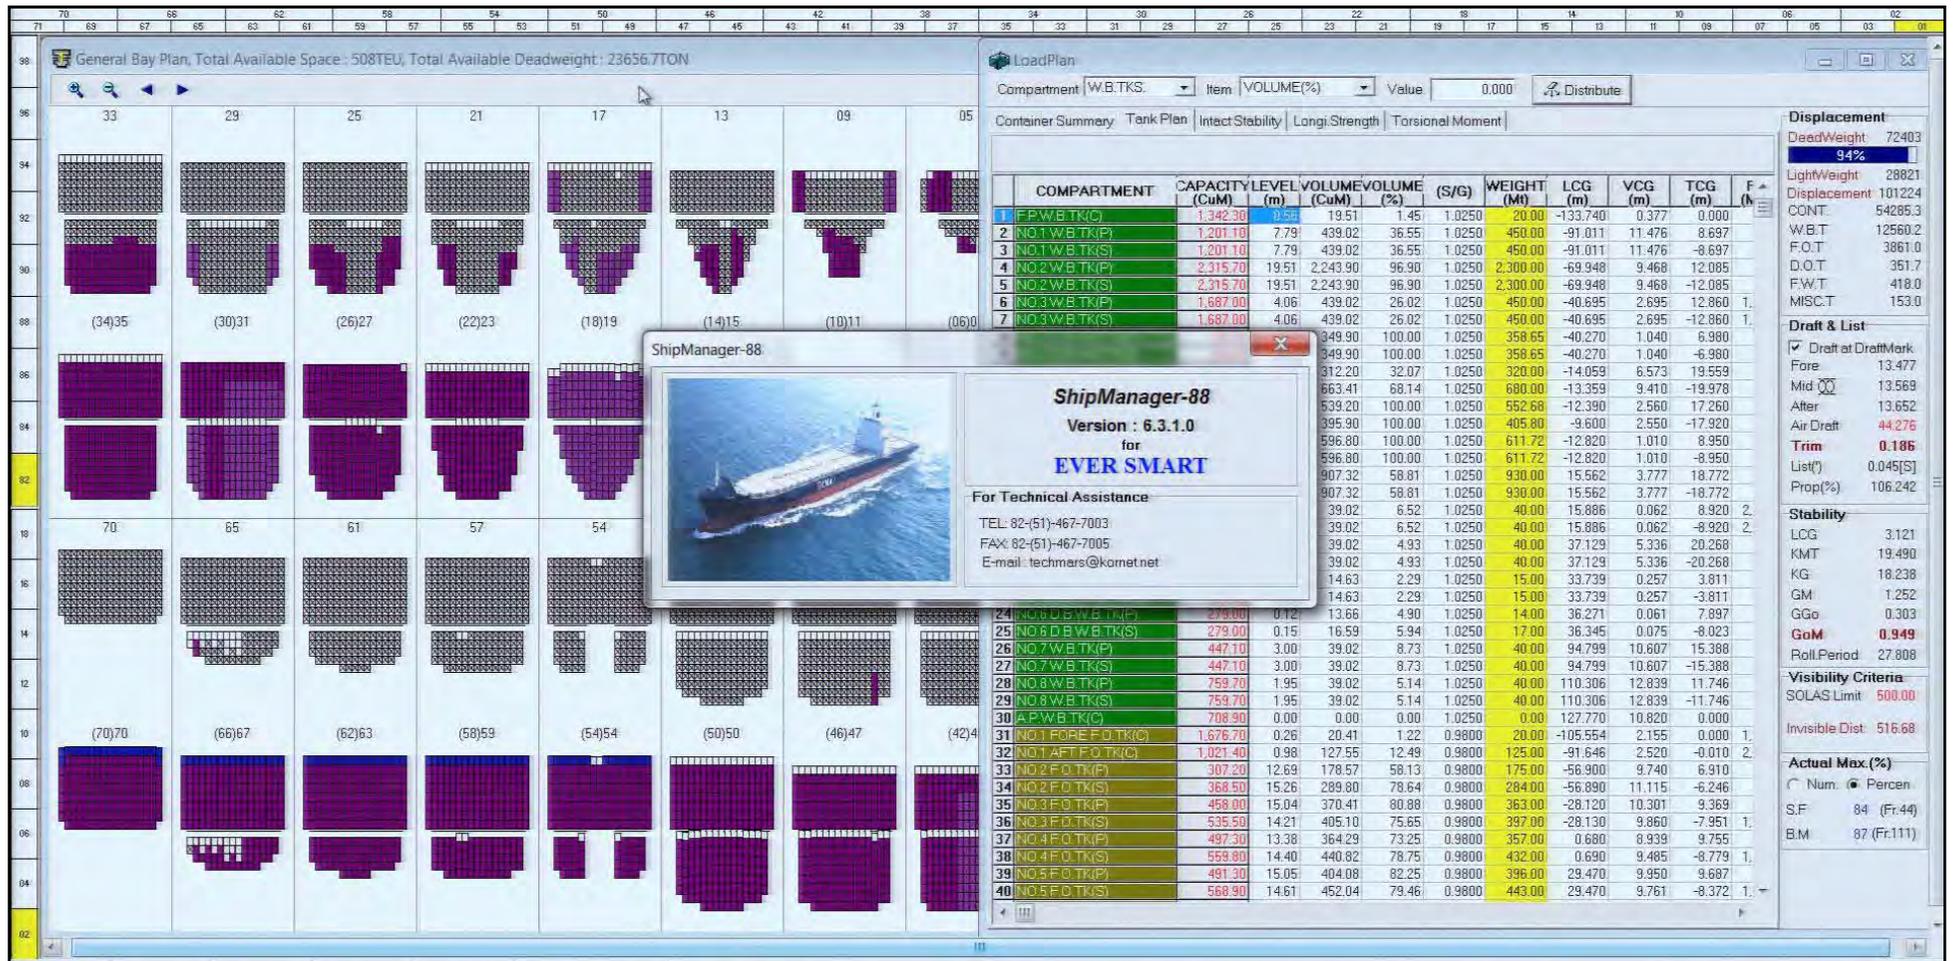
The C/O used the loading computer's verifications functions to assess the departure conditions for Kaohsiung and Taipei. The draught, hull stresses, GM, total stack weights and hatch loading values were all found to be within the ship's departure limits. The calculated mean departure draught and GM for Taipei were 13.57m and 0.949m respectively (**Figure 10**). The observed departure draught was 13.90m. The discrepancy between calculated and actual draughts was not uncommon, and was not resolved by the C/O. Post-departure, the GM was not checked by timing the ship's actual roll period⁶ and comparing it to the loading computer's calculated roll period of 27.8 seconds.

Figure 9: Ever Smart's stability computer – condition for departure Taipei

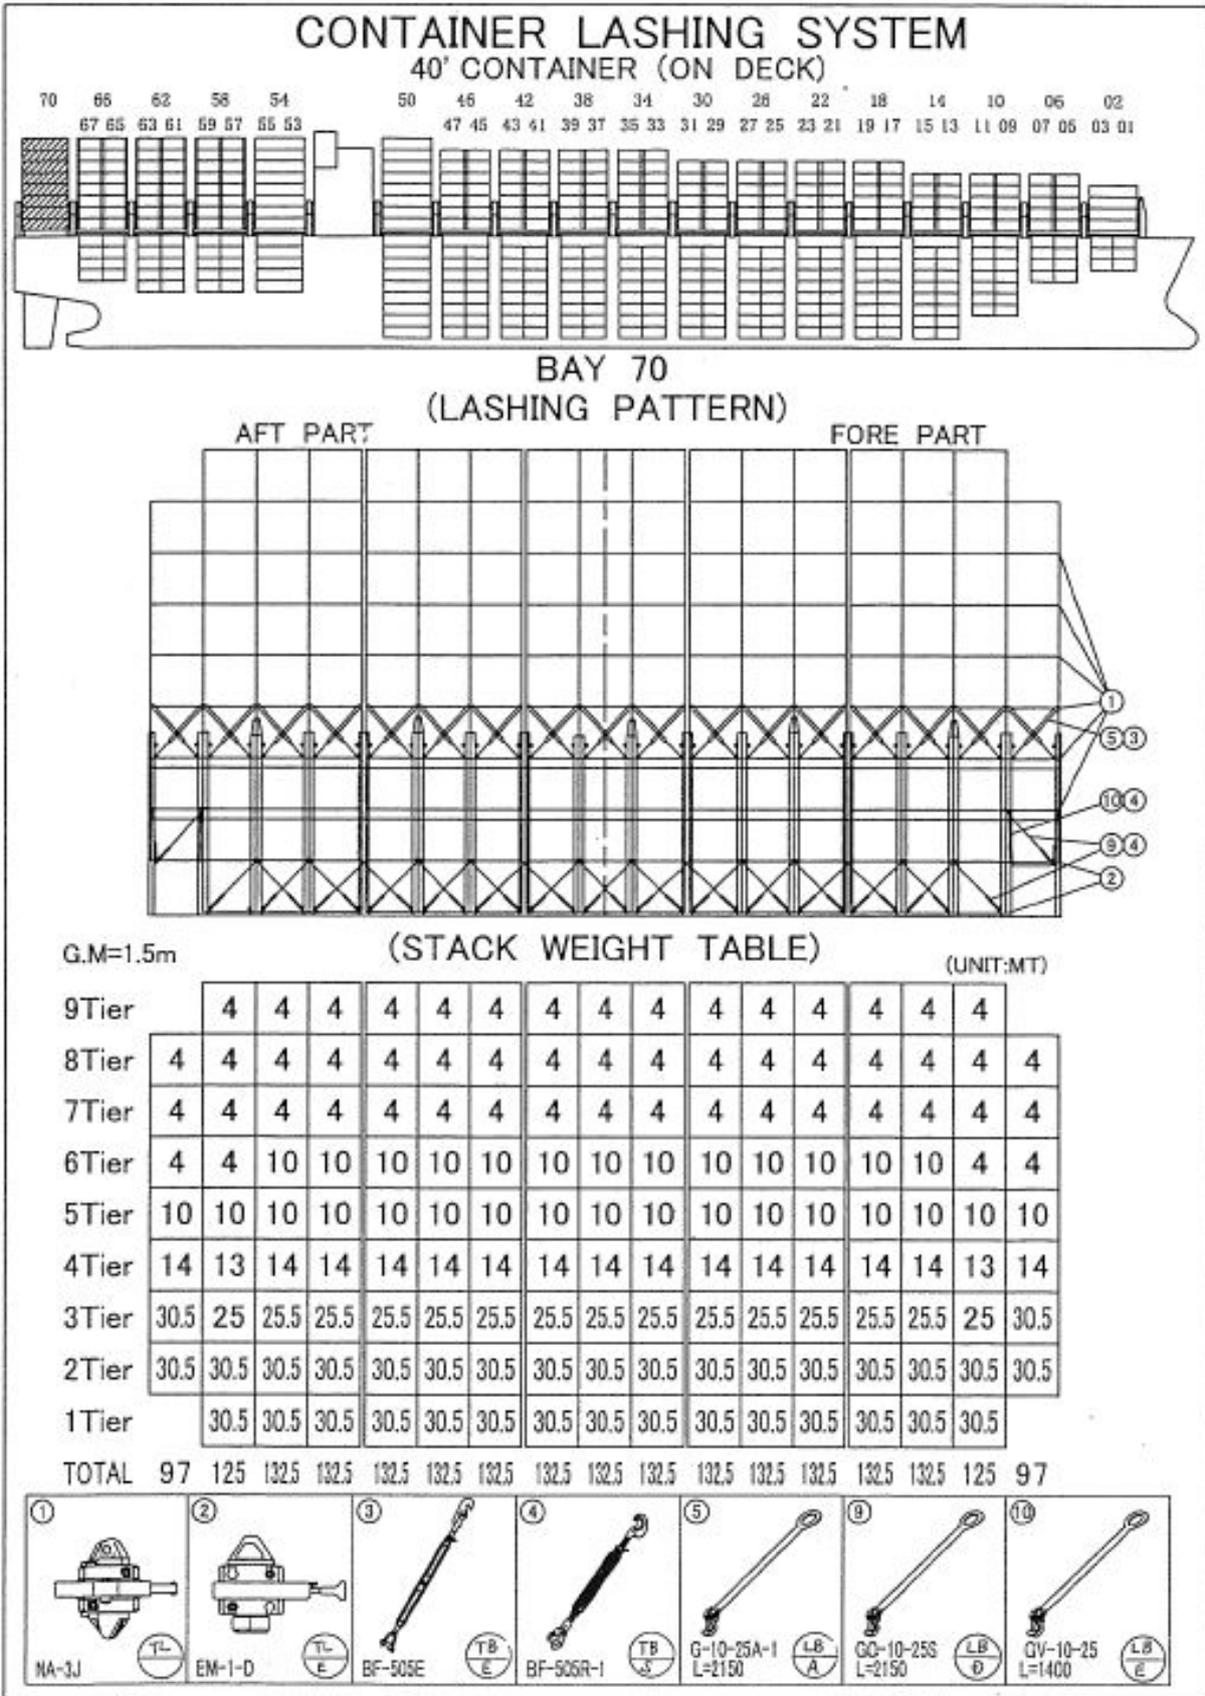
Figure 11: Container lashing system manufacturer's container lashing pattern and stack weight table for bay 70 for GM 1.50m

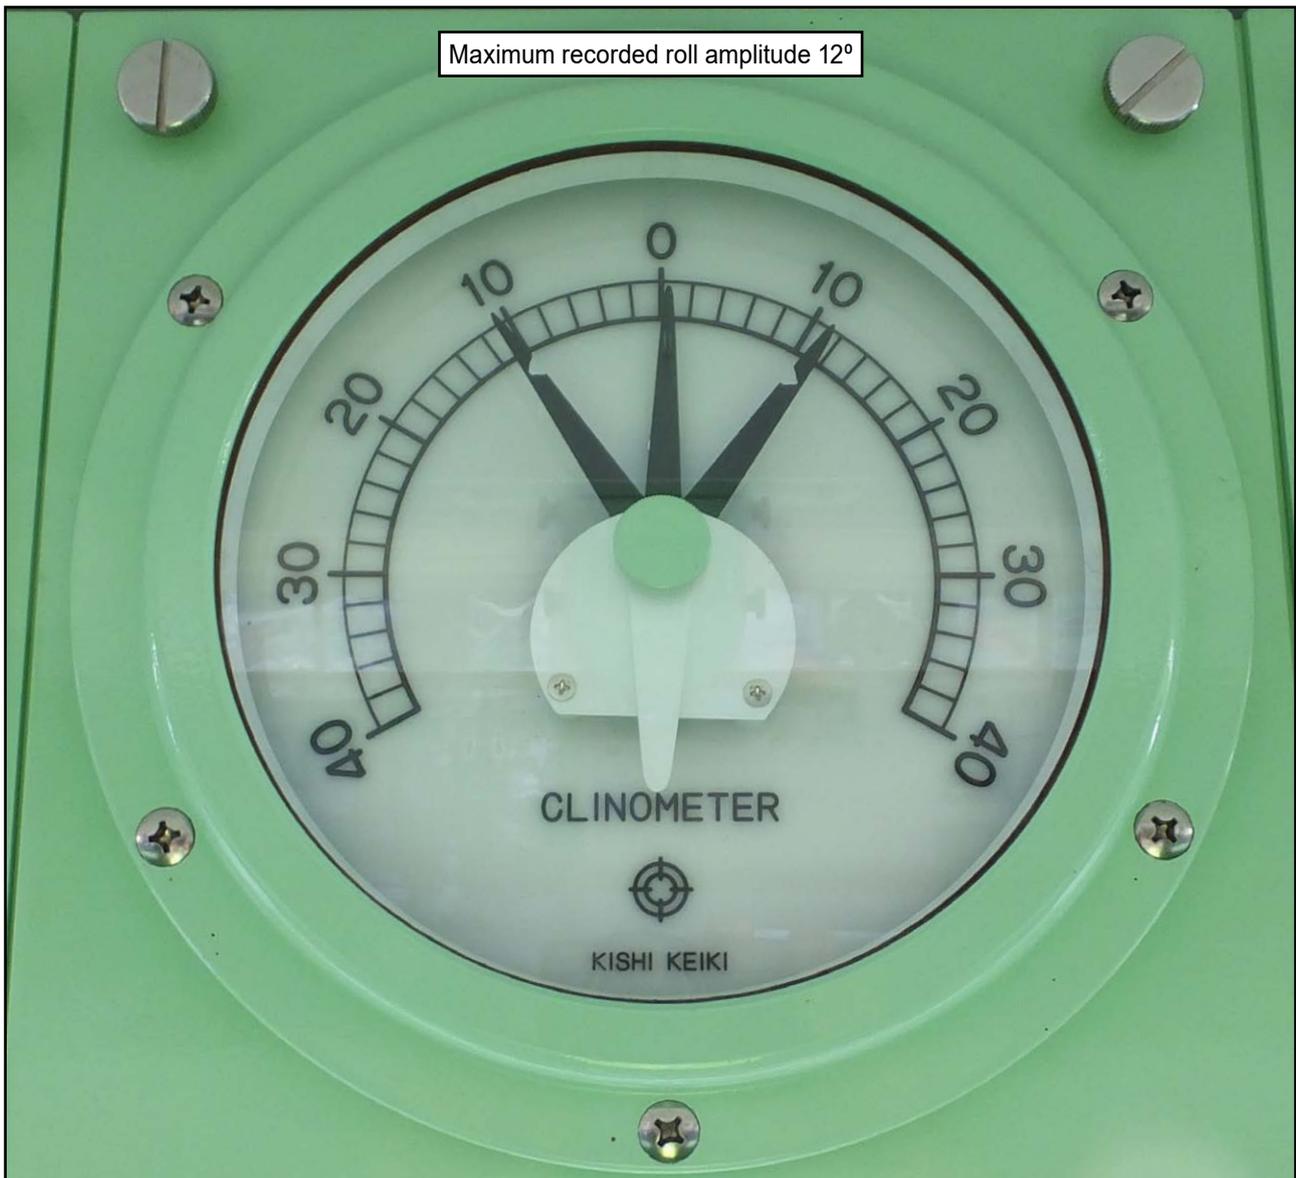
Ever Smart had an inclinometer on the bridge to indicate roll angle (**Figure 25**). There were no other instruments or sensors to help the bridge team to gauge ship movement or assess the acceleration forces acting on the cargo.

Figure 25: Bridge inclinometer

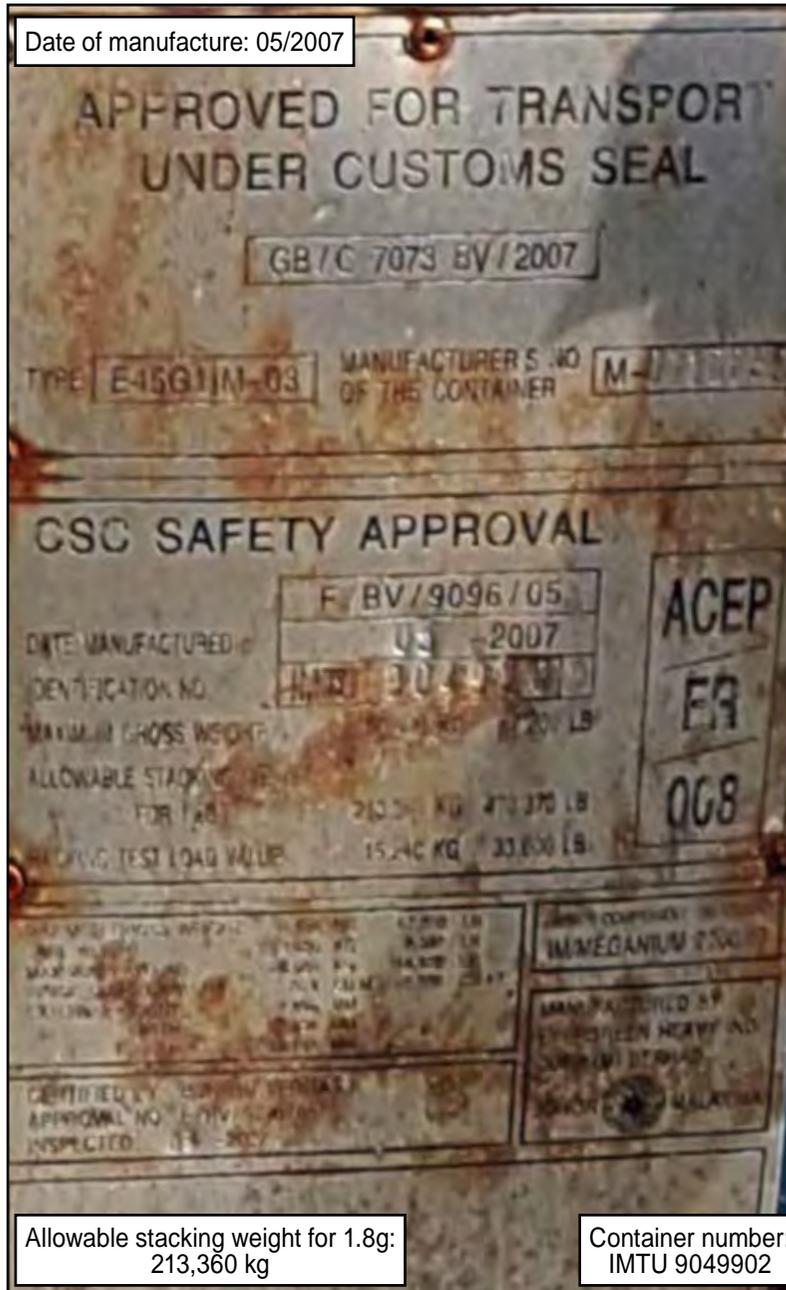
Figure 26: CSC plate and Classification Society approval certificate for the container stowed at the bottom of Bay 70's starboard outer stack

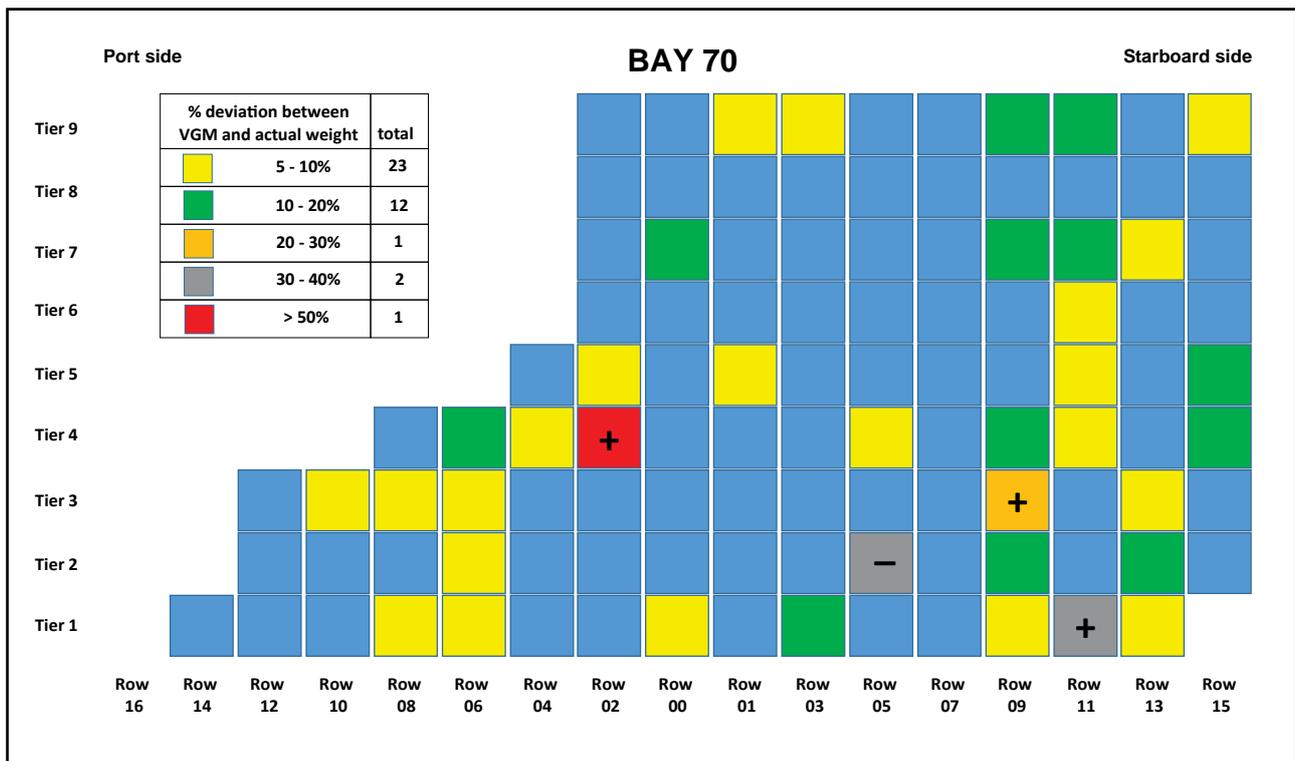
The container that had a variance greater than 50% was 4.6t heavier than the declared VGM, and was located at row 02 tier 4. The locations of the other mis-declared VGMs with variances greater than 5% are shown in **Figure 28**.

Figure 28: Locations of containers with declared and actual weight deviations greater than 5%
