National Transportation Safety Board

Marine Accident Brief

Flooding and Subsequent Sinking of Unnamed Deck Barge and Moored Towing Vessels *Chattie Sue Smith*, *Mary Fern*, and *Mary-R*

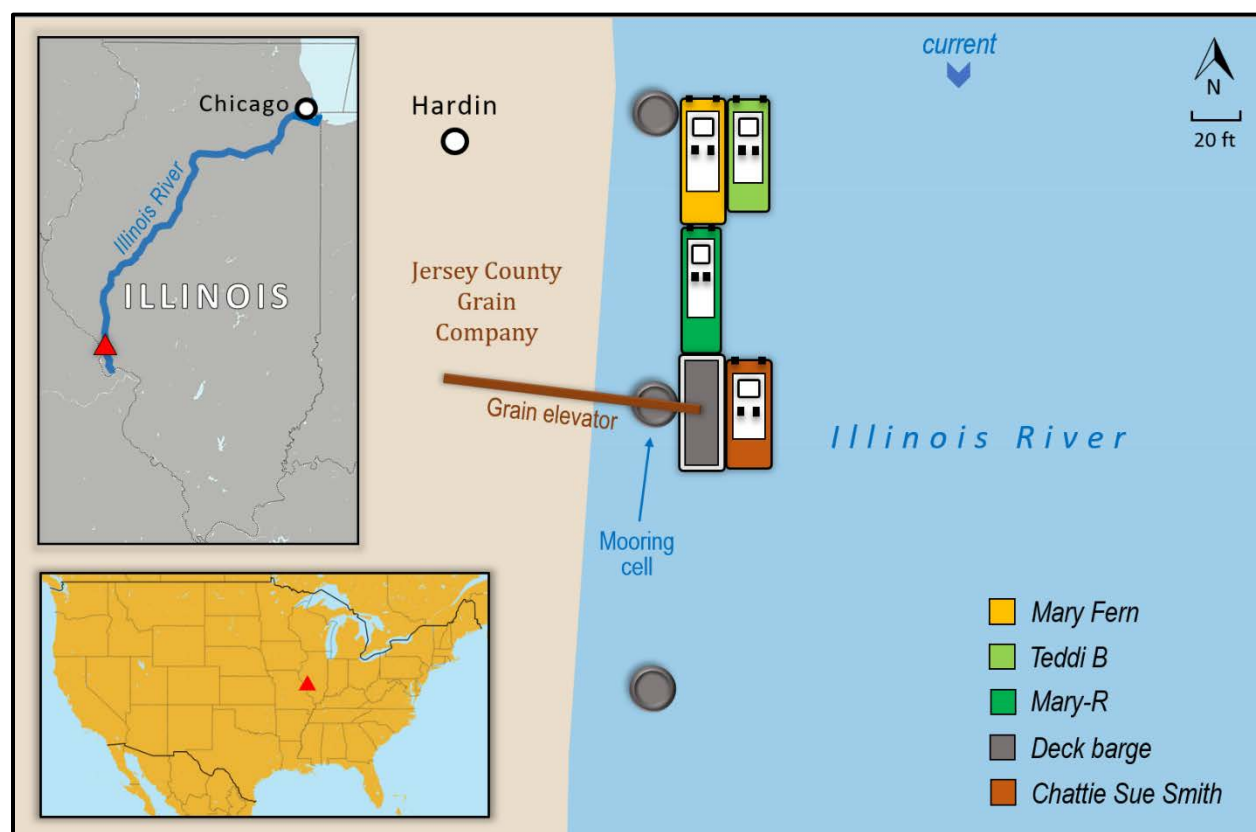
Location where the three towing vessels and deck barge sank while moored on the Illinois River in Hardin, Illinois, as indicated by the red triangle. The mooring arrangement at the time of the accident is depicted with approximate positions. (Background source: Google Maps)
