TORM MAREN

Marine accident report on loss of rescue boat

**MARINE ACCIDENT REPORT ON LOSS OF RESCUE
BOAT ON TORM MAREN ON 1 APRIL 2020**

The report is issued on 31 August 2020.

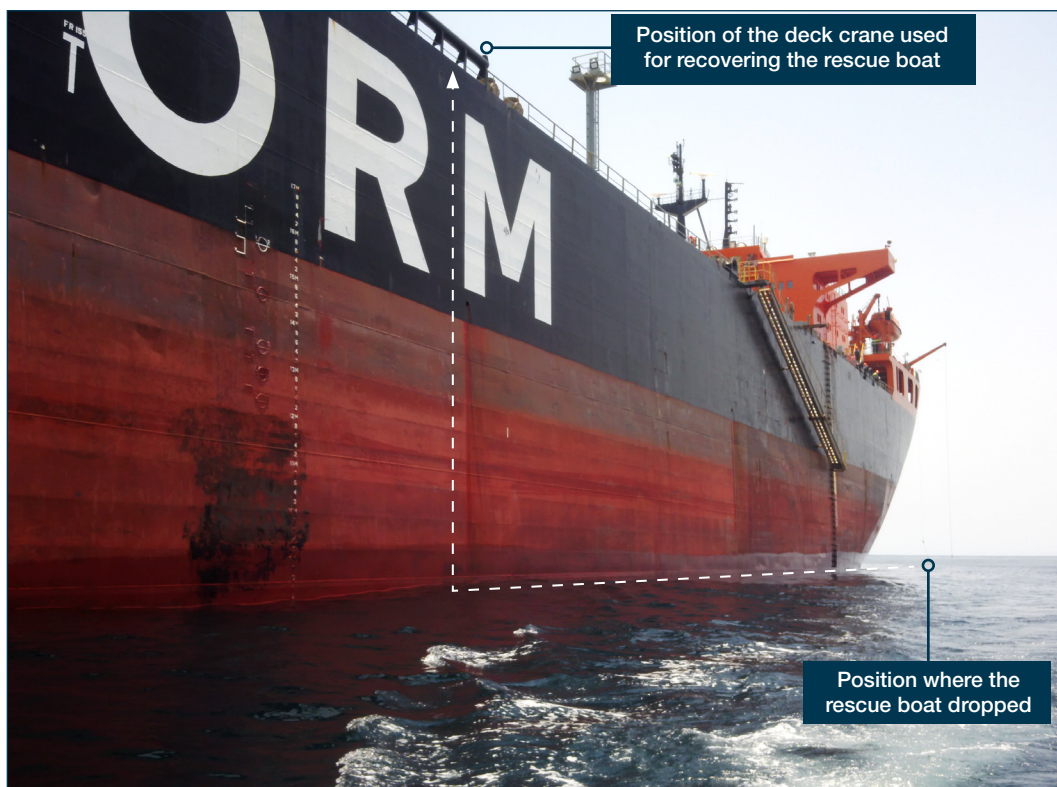
Figure 4: Recovery of the rescue boat with injured crewmembers
Source: TORM A/S

At 1556, approximately twenty minutes after the boat fell down, the rescue boat was hoisted up and landed on the main deck. The chief officer immediately started examining the injured crew members to assess which one to bring to the ship's hospital first given that the hospital only had one bed.
