National Transportation Safety Board

Marine Accident Brief

Explosion aboard Barge *IB1940*

Accident type	Fire/Explosion	No. DCA20FM002
Vessel name	<i>IB1940</i>	
Location	Chicago Sanitary and Ship Canal, Illinois Marine Towing facility, Lemont, Illinois 41°40.99' N, 87°59.37' W	
Date	November 4, 2019	
Time	0929 central standard time (coordinated universal time – 5 hours)	
Injuries	None	
Property damage	\$1,750,000	
Environmental damage	None	
Weather	Visibility 10 miles, overcast, winds light at 10 mph from the west southwest, air temperature 38°F	
Waterway information	The Chicago Sanitary and Ship Canal is a waterway linking the south branch of the Chicago River with the Des Plaines River at Lockport, Illinois. The canal is 30 miles long and has a minimum width of 160 feet, a minimum depth of 9 feet, and 2 locks.

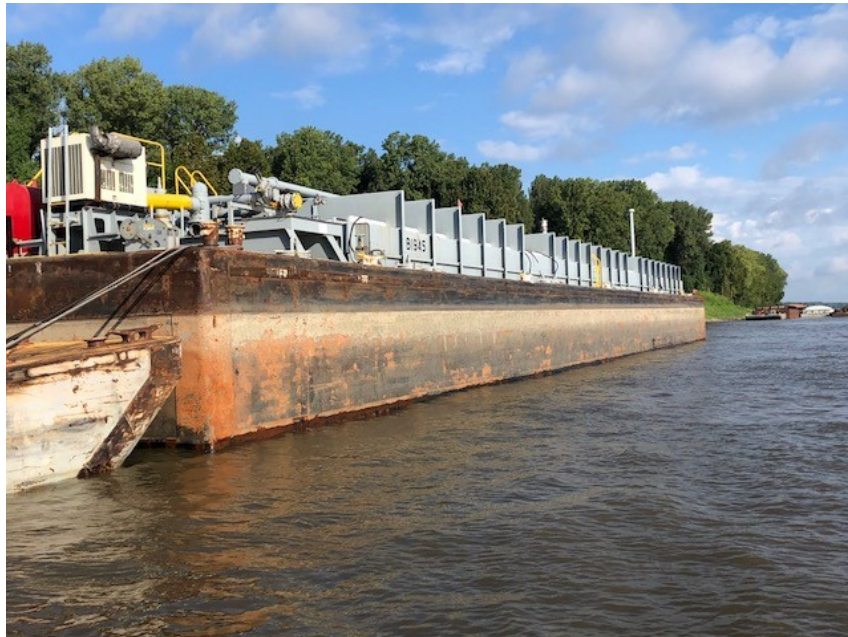
Similar barge *IB1945*. (Source: Ingram Barge Company)

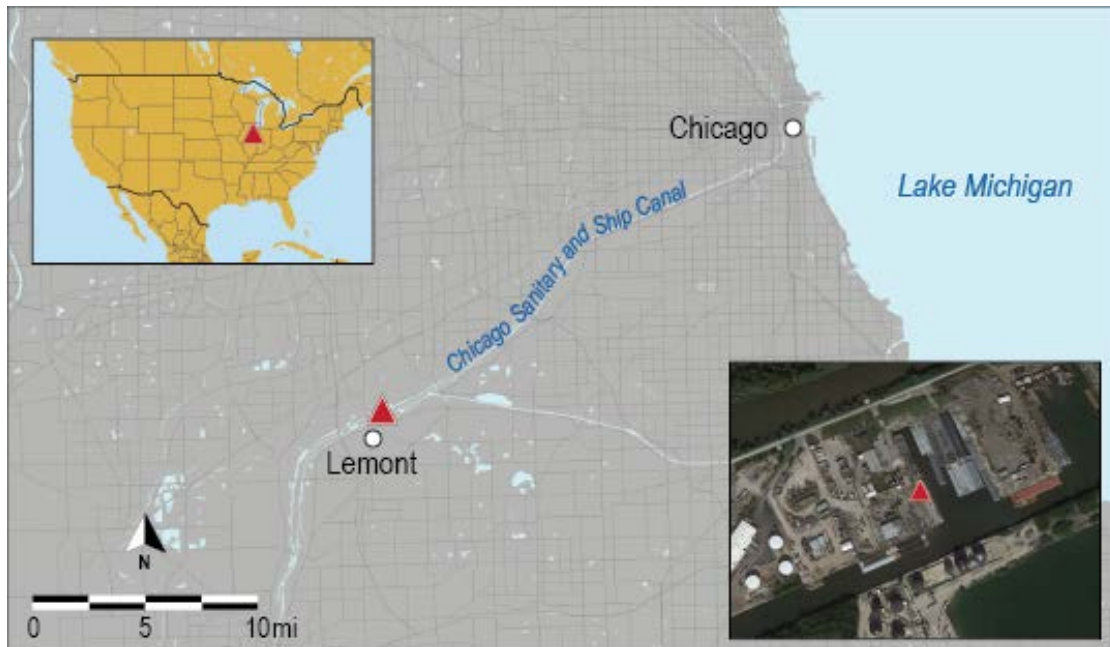
Area where the explosion on the barge *IB1940* occurred, as indicated by the red triangle. (Background source: Google Maps)
