# National Transportation Safety Board

## Marine Accident Brief

### Engine Room Fire aboard Towing Vessel *City of Cleveland*

<b>Accident type</b>	Fire	<b>No.</b> DCA20FM014
<b>Vessel name</b>	<i>City of Cleveland</i>	
<b>Location</b>	Lower Mississippi River, mile 348, near Natchez, Mississippi <sup>1</sup> 31°24.43' N, 091°28.24' W	
<b>Date</b>	February 26, 2020	
<b>Time</b>	1600 central standard time (coordinated universal time – 6 hours)	
<b>Injuries</b>	None	
<b>Property damage</b>	\$2 million est.	
<b>Environmental damage</b>	None	
<b>Weather</b>	Visibility 10 miles, mostly cloudy, winds 10 mph from northwest by north, gusts up to 18 mph, air temperature 49°F	
<b>Waterway information</b>	The Lower Mississippi River near mile 348 was 1.1 miles wide, and the current was estimated at 3 mph. The nearest river gage at Natchez, Mississippi (mile 363.3), read 58 feet, 10 feet above flood stage, and was rising.

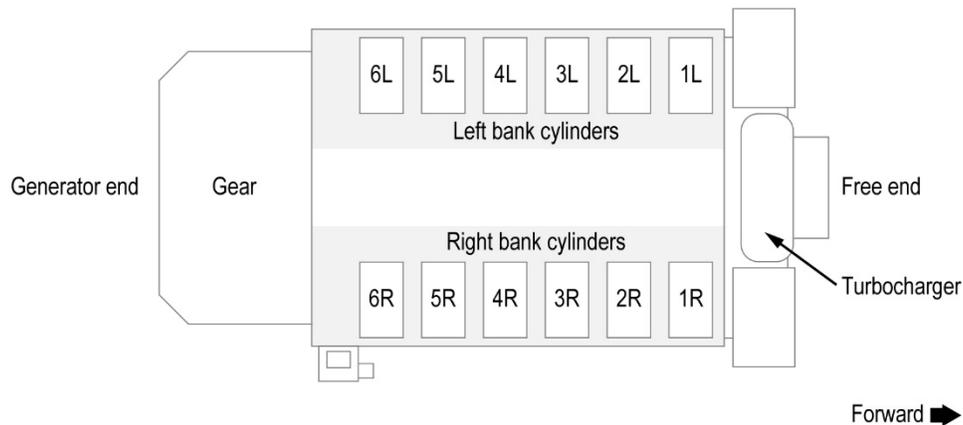
The *City of Cleveland*'s propulsion system included twin General Electric 7FDL12, 12-cylinder, 4-stroke diesel engines.<sup>2</sup> These engines consisted of two banks of six cylinders and rods, left and right, with the cylinders numbered forward to aft. Each connecting rod assembly included a master connecting rod on the left bank, as viewed from aft, fastened around the crankshaft with a connecting rod clamp. Articulating connecting rods on the right bank connected at a 45-degree angle to a pin in the master connecting rod.

**Simplified General Electric 7FDL12 main engine arrangement. (Source: General Electric)**

A postaccident examination of the port engine showed extensive damage: the no. 4 right cylinder crankcase inspection cover had been knocked off, and the no. 4 right piston head was found on the deck along with the connecting rod clamp, inboard (to starboard) of the engine. A

large hole was found in the crankcase at the no. 4 left cylinder crankcase inspection cover. The no. 4 left master connecting rod was lying on the deck with the piston pin bolt missing, outboard (to port) of the engine with the bent no. 4 right articulating arm still attached to it.

During a postaccident examination of the wreckage, the no. 4 left and right cylinder master connecting and articulating rods were found still attached to each other outside the crankcase, and the piston pin and connecting rod clamp were missing. Therefore, the initial failure was likely with the connecting rod clamp or the bolt that held the piston pin. Regardless, the force of the driven loose connecting rods inside the engine was enough to puncture a hole in the side of the crankcase on the port side and eject the piston head through the no. 4 right cover on the starboard side.
