SAFETY INVESTIGATION REPORT

REPORT NO.: 03/2021

MT VALTAMED **Fatality in the pump room** **at Ceyhan OPL Anchorage, Turkey,** **in position 36° 20.6' N 035° 09.66' E** **03 February 2020**

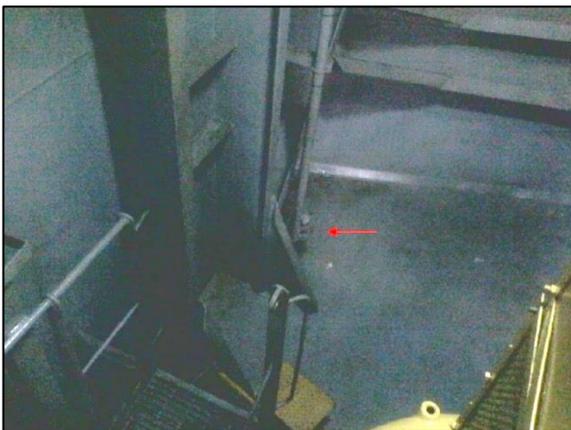
Figure 4: Port side bilge alarm sensor (red arrow), as seen from the lowest pump room gratings

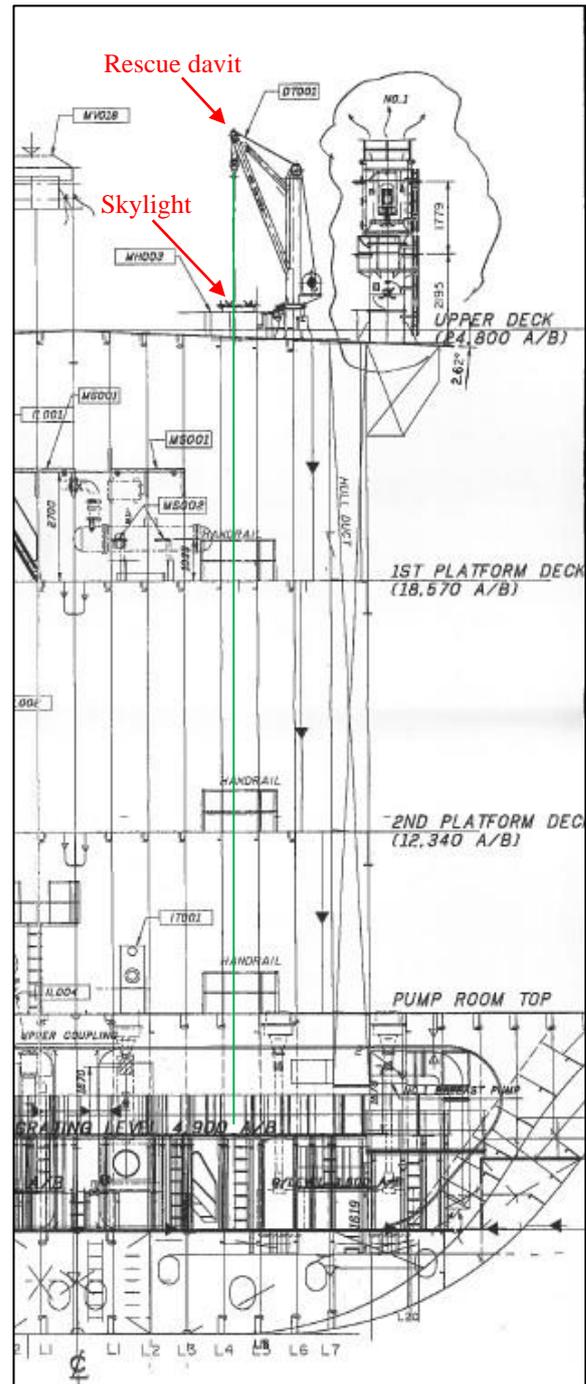
For emergency cases, say, when recovery of a person would be necessary, the pump room was fitted with a rescue davit at the top, the hook and wire of which could be passed through a skylight vertically down to the lowermost gratings (Figure 8).

Figure 8: Rescue davit (green line indicates direction through which its wire passes)

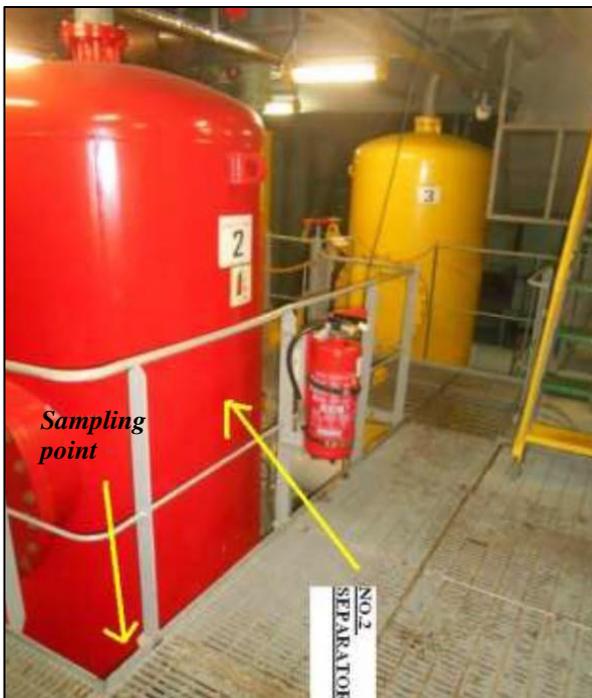
Figure 9: Location of LEL and O₂ sampling point

- one in each of the exhaust vent ducts to measure the LEL;
- on either side above the lowest gratings to measure the LEL;
- at the pump room's bottom, in way of the separator of cargo pump no. 2, to measure the LEL and O₂ (Figure 9); and
- at the pump room's bottom, in way of the separator of cargo pump no. 1, to measure the LEL and H₂S (Figure 10).

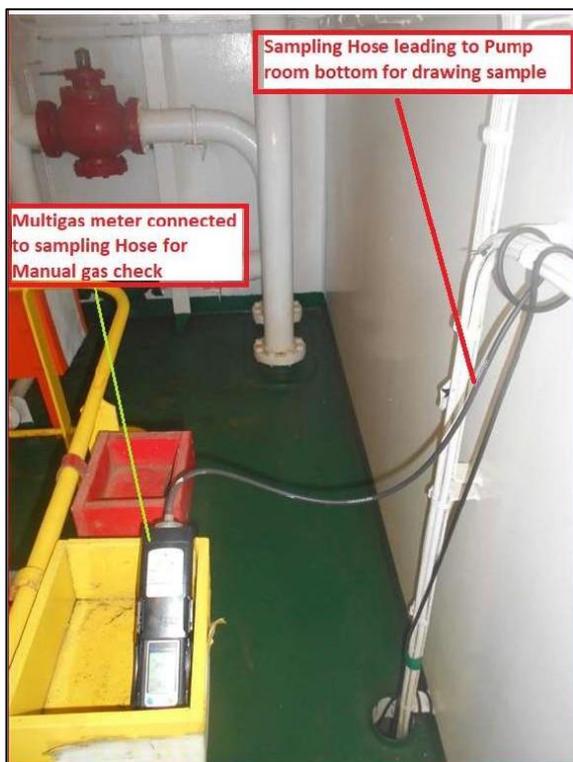
In addition to the fixed gas detection system, a personal multi gas detector (Figure 12) was placed at the entrance to the pump room, with its sampling tube extending down to the bottom of the pump room.

Figure 12: Personal multi gas detector placed at the pump room's entrance

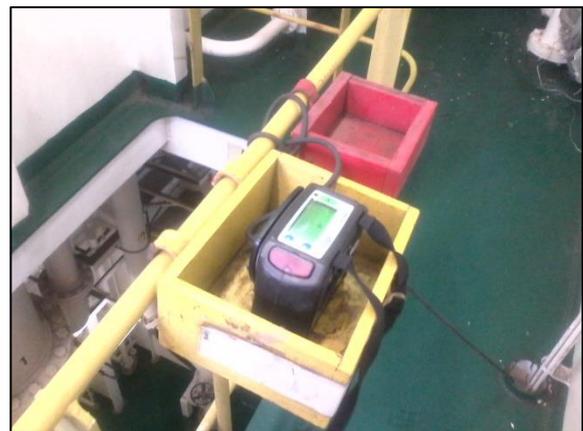
In line with on board procedures, after the initial checks of the pump room atmosphere from above, the person entering the pump room would carry the personal multi gas detector and replace it with a portable gas detector (Figure 13) capable of measuring O₂ and Hydrocarbons / LEL in percentages.

Figure 13: Portable gas detector replacing the personal multi gas detector
