## Fatal accident to a fish farm worker involving the workboat *Beinn Na Caillich* Ardintoul, Glenshiel, Scotland 18 February 2020

### SUMMARY

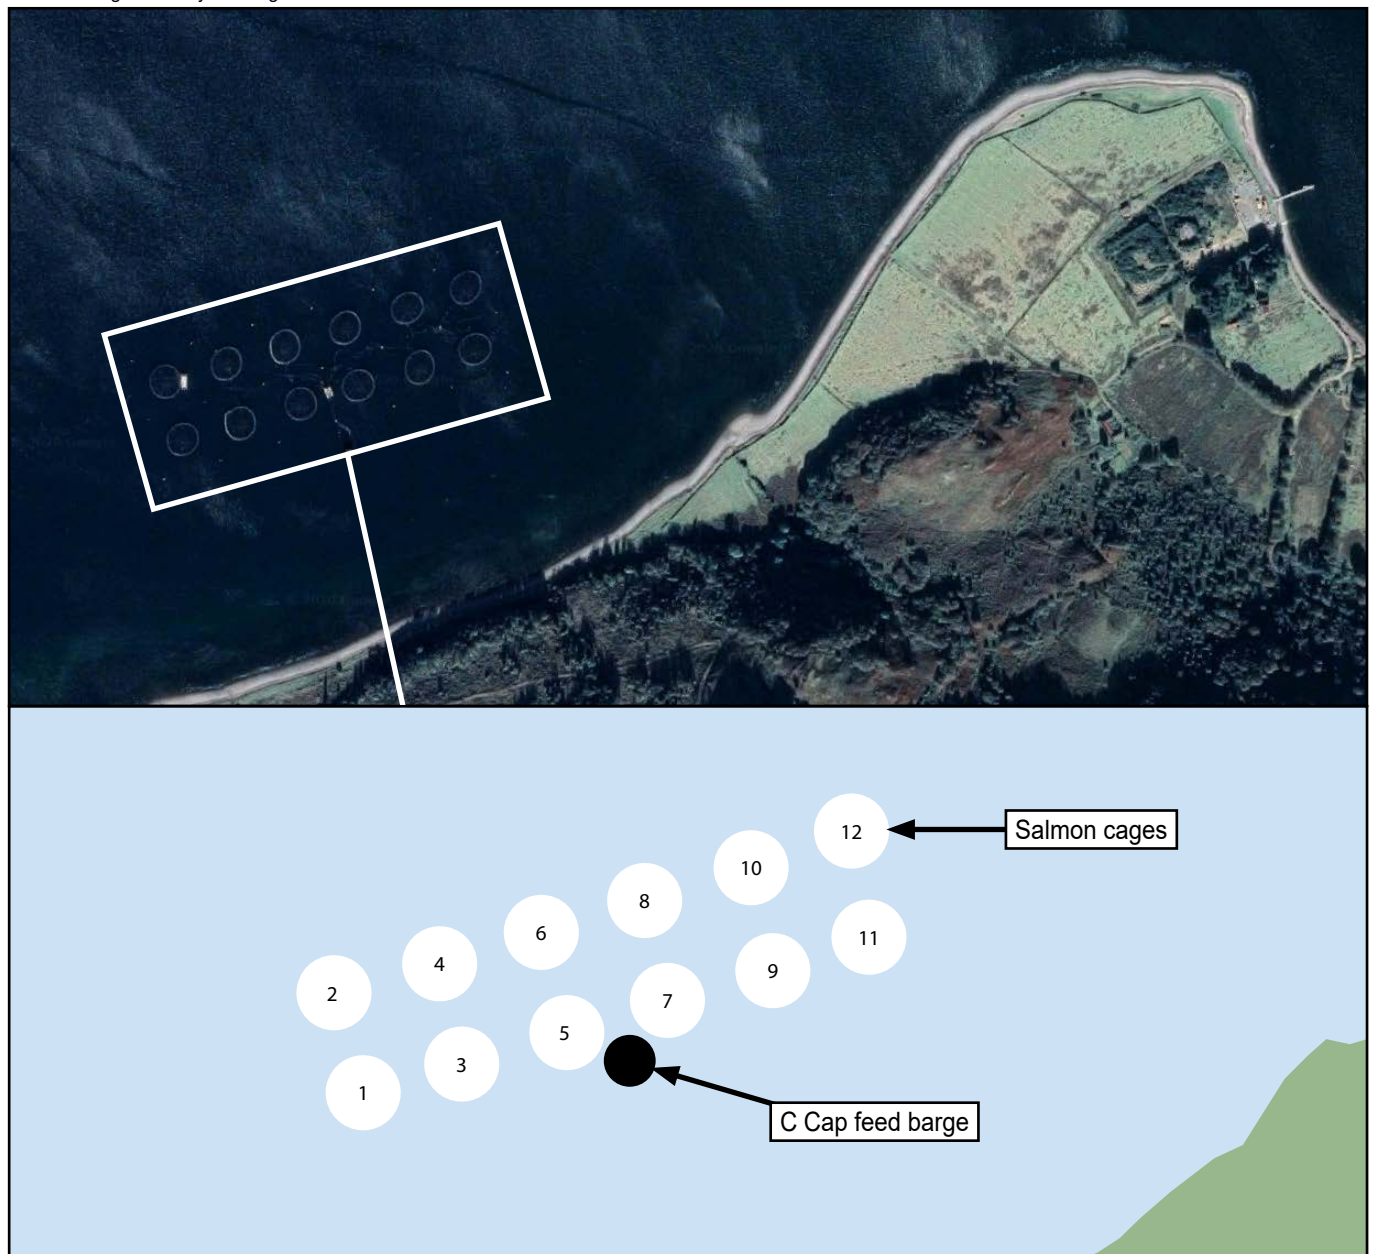
**Figure 2:** Satellite image with plan of the Ardintoul fish farm

At about 0700 on 18 February 2020, the workboat *Beinn Na Caillich* sailed from Kyle of Lochalsh, Scotland and headed for the Mowi (Scotland) Ltd (Mowi) Ardintoul fish farm site (**Figure 1**). On board were its skipper and a deckhand. *Beinn Na Caillich* arrived at the site about 30 minutes later and moored alongside its salmon keep cage 10 (**Figure 2**). Another workboat, *Beinn Bhreac*, was already moored on the cage.

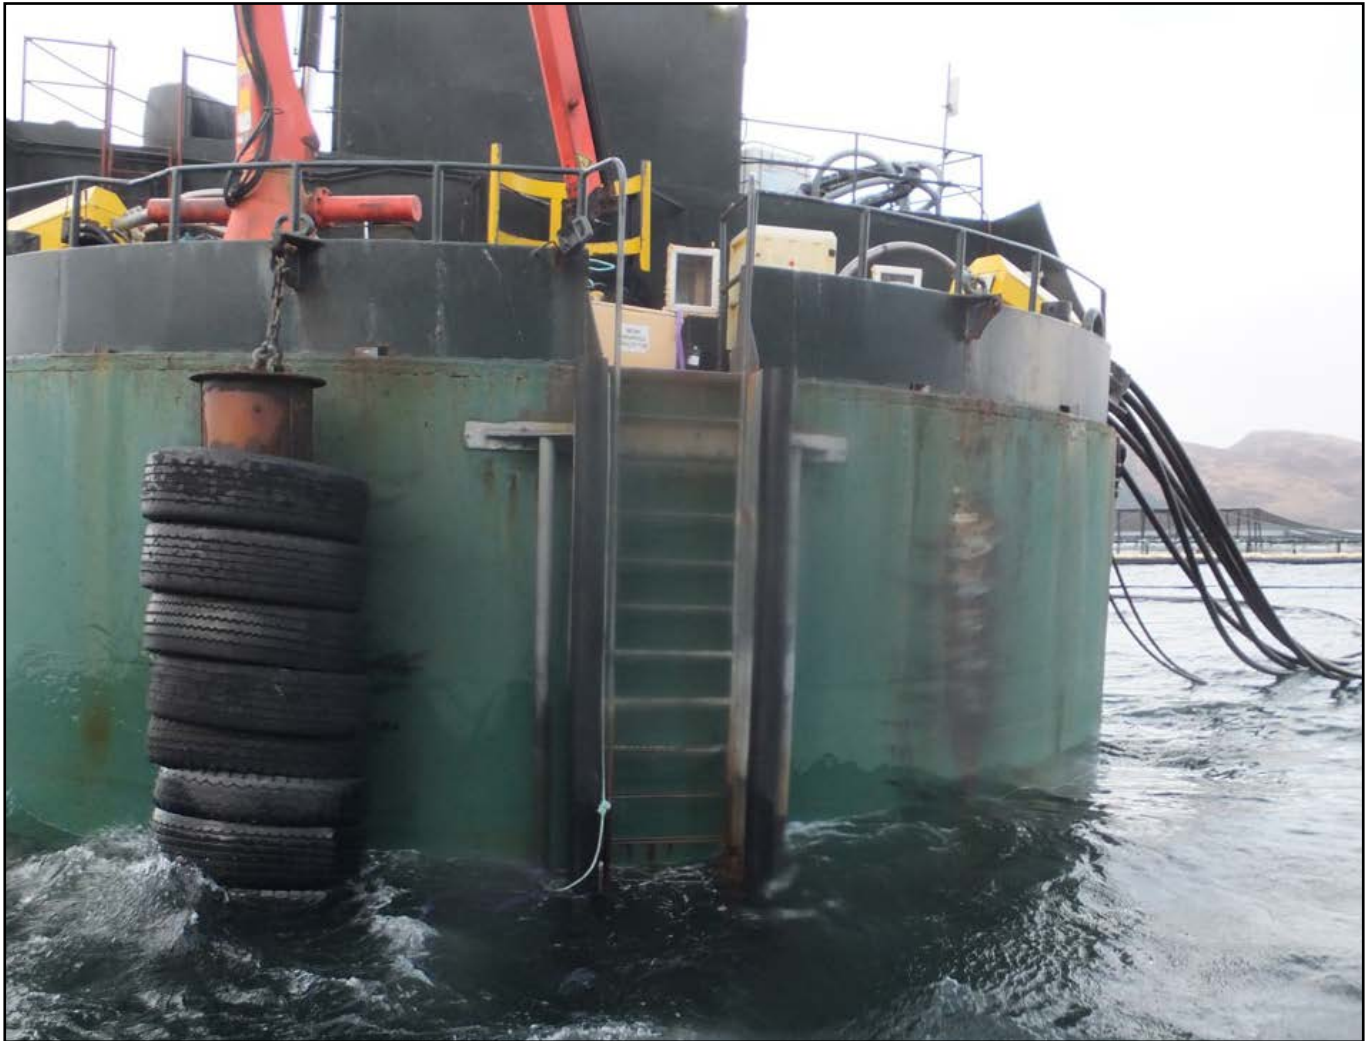
**Figure 3:** C Cap feed barge

On completion of the task, the four technicians boarded the remaining RBB and left the salmon cage. One of the technicians was transferred to the fish farm's feed barge (the barge) (**Figure 3**); the other three moved on to salmon cage 4. The assistant manager remained on cage 10 to monitor the chemical treatment.

The primary means of access to the barge was via an 800mm wide vertical fixed ladder (**Figure 6**) with double reinforcing bar rungs and handrails. The ladder was protected on either side by steel structures with rubber D-shaped fenders, and the depth from the ladder rungs to the outside edge of the D fenders was 375mm. On either side of the ladder there should have been a vertical rubber tyre fender arrangement designed to provide protection when larger vessels were mooring alongside. However, the vertical fender on the right-hand side of the ladder was missing after becoming detached following a heavy contact during a feed delivery on 8 February 2020.
