Report on the investigation of  
the foundering of the whelk potter

***Nicola Faith (BS58)***

resulting in three fatalities  
in Colwyn Bay, North Wales

REPORT NO 8/2022

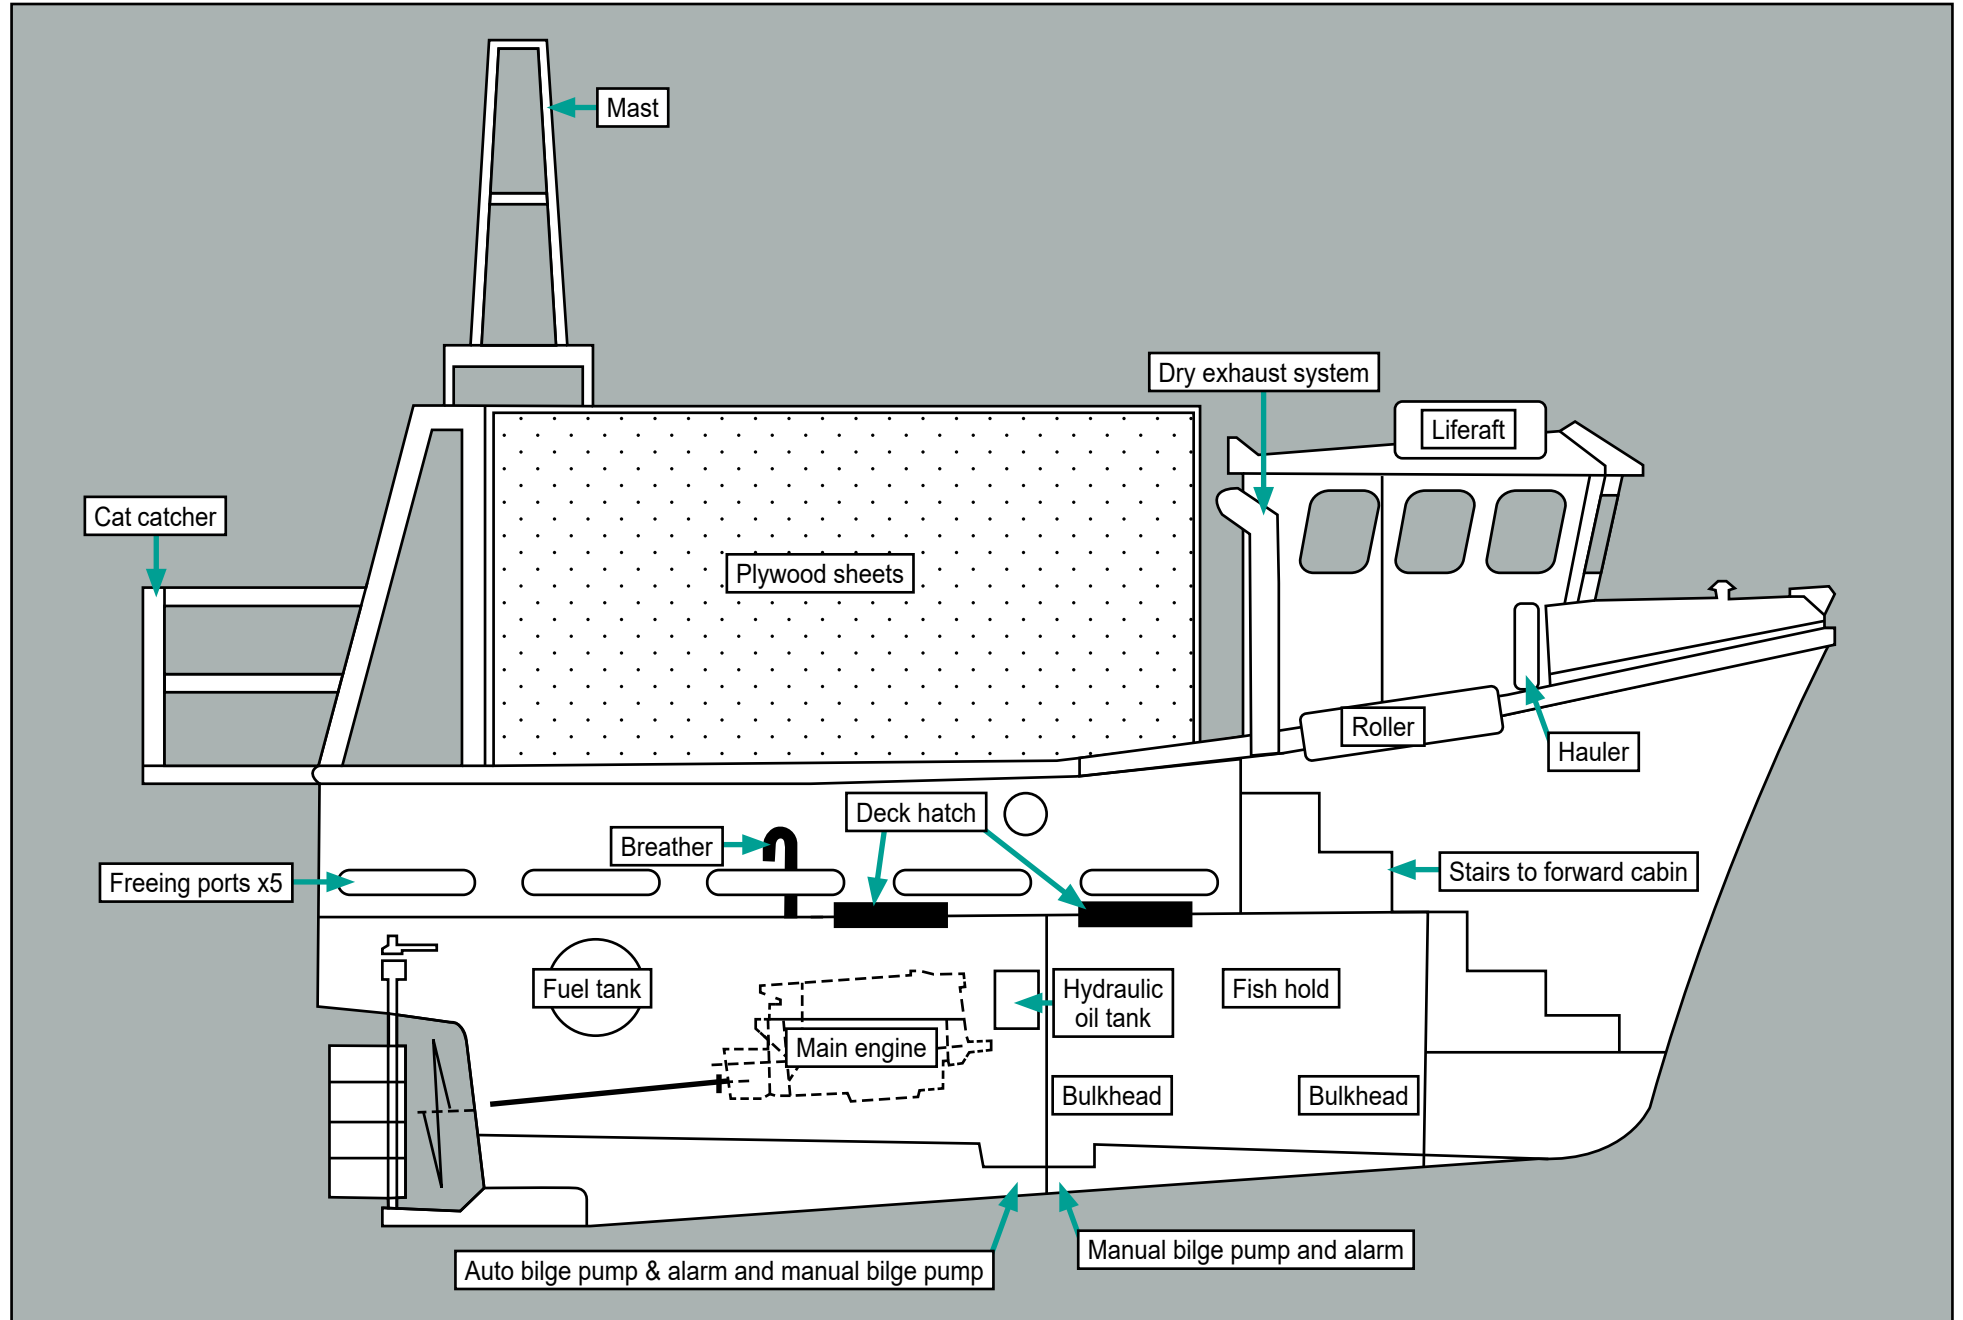
*Nicola Faith* was a 9.81m steel-hulled potter built in 1987 (**Figure 5a**). During its life it was modified to operate as a stern trawler, but later converted back for use as a potter (**Figure 5b**). It had a forward wheelhouse that was enclosed from the centreline to the port side of the vessel only. Forward of the wheelhouse, below the main deck, was a cabin that extended across the full width of the bow and was accessed from inside the enclosed wheelhouse. This cabin was used for storing equipment and tools.

Figure 6: General arrangement of *Nicola Faith*

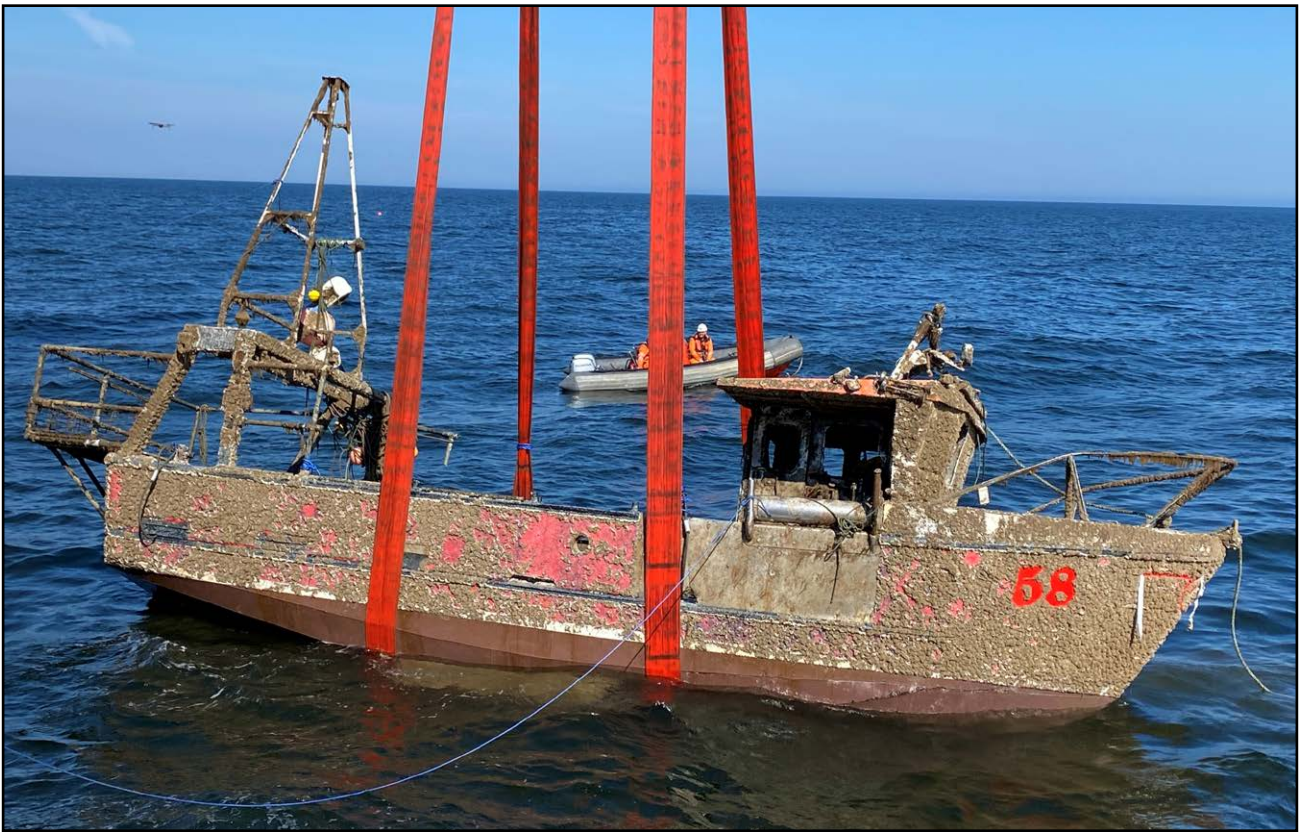
On 31 May, *Nicola Faith* was recovered from the seabed (**Figure 12**) and on the following day it was landed ashore into a local boatyard (**Figure 13**).

**Figure 12:** *Nicola Faith* being recovered from the seabed

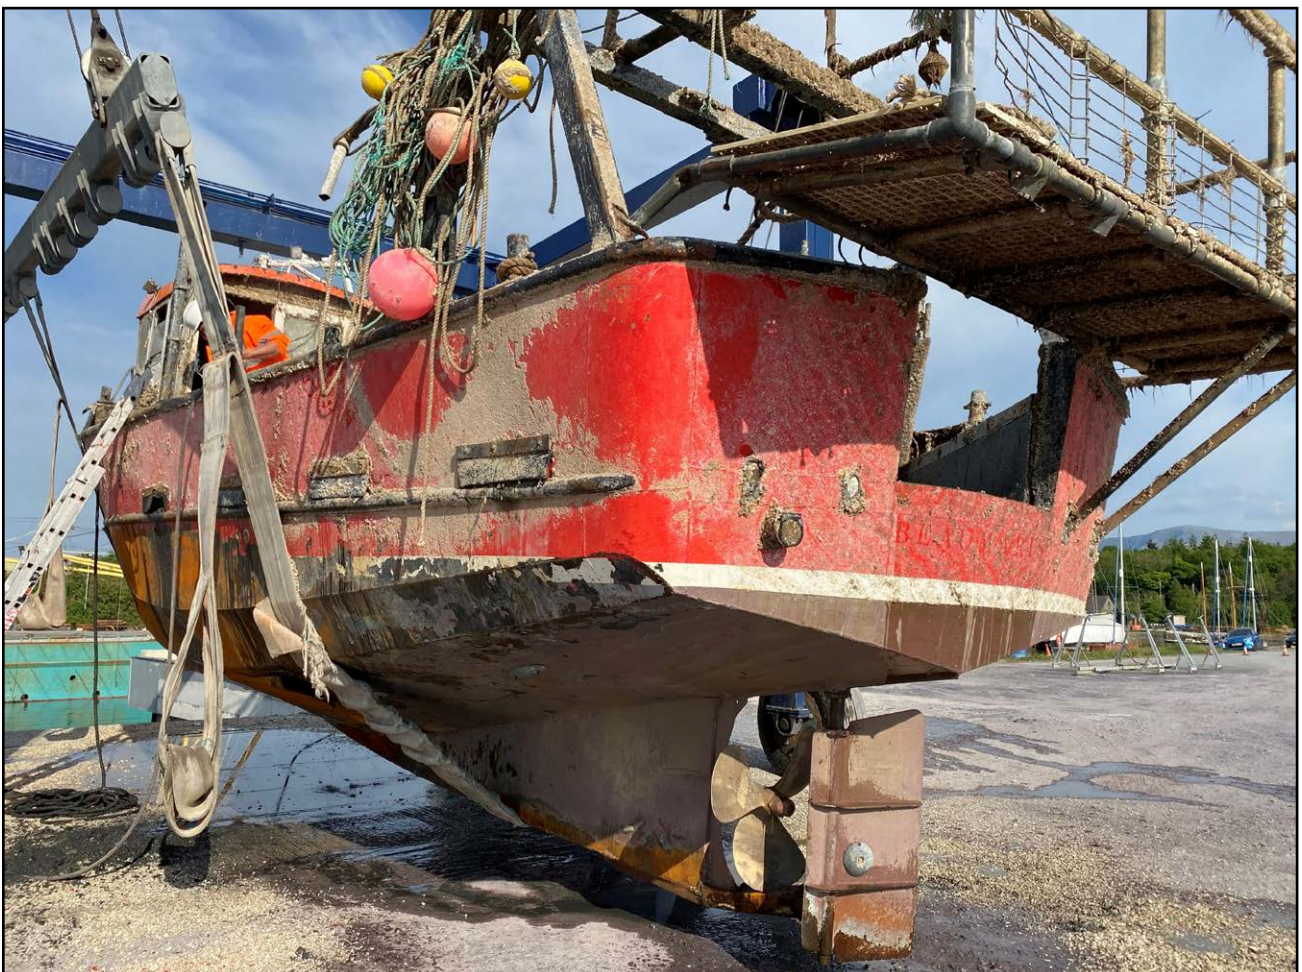
A calibrated load cell was used to weigh the equipment: the pots, rope and anchors weighed 2436kg; a large quantity of tools and spare gear found in the forward cabin area weighed 1100kg.

**Figure 13:** *Nicola Faith* being landed ashore

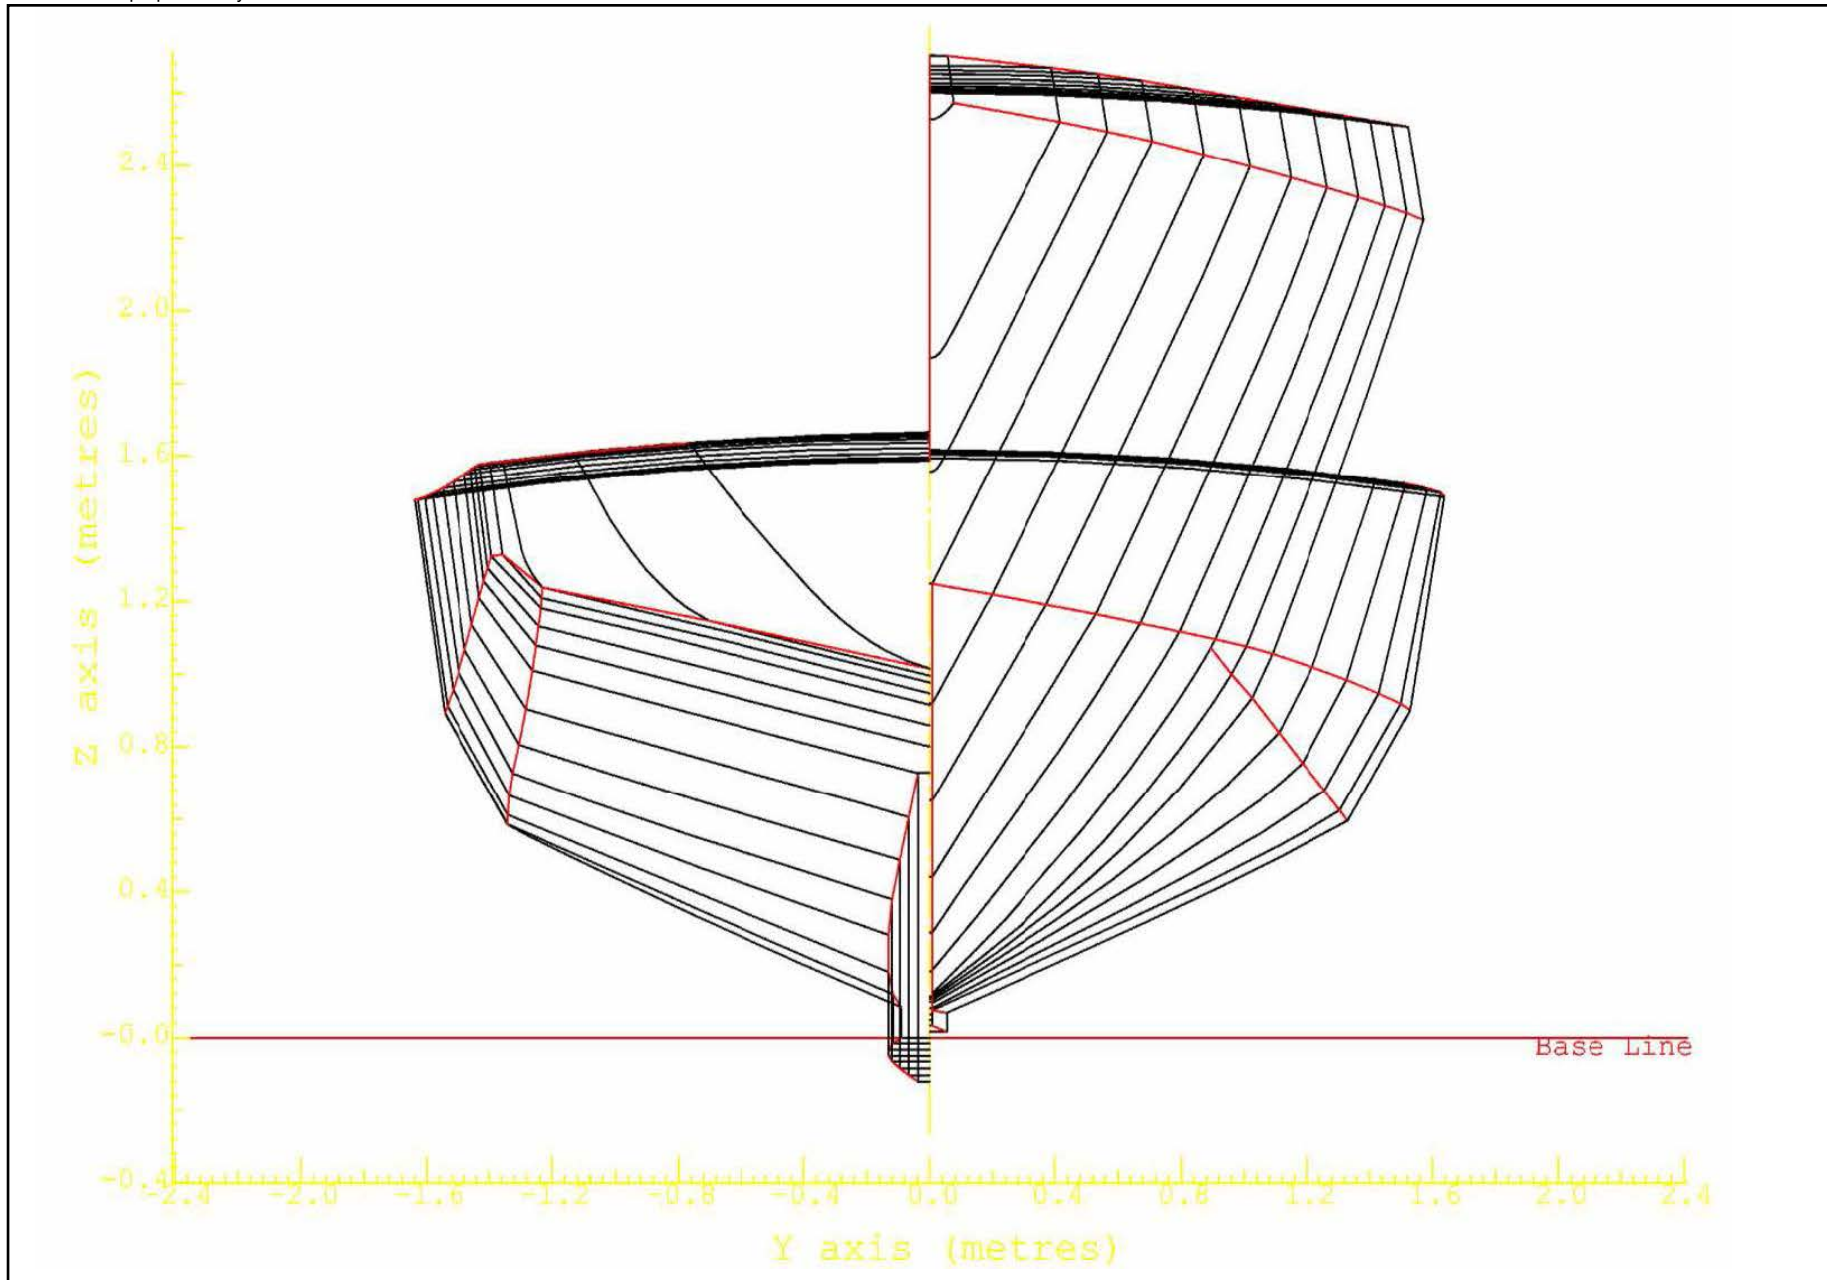
Once *Nicola Faith* had been recovered ashore, the hull shape was accurately measured by a naval architect; the decks, interior spaces, and tanks were also measured. The collected data was used to create a digital model of the vessel (**Figures 16 and 17**).

**Figure 16:** Naval architect's lines plan of *Nicola Faith*

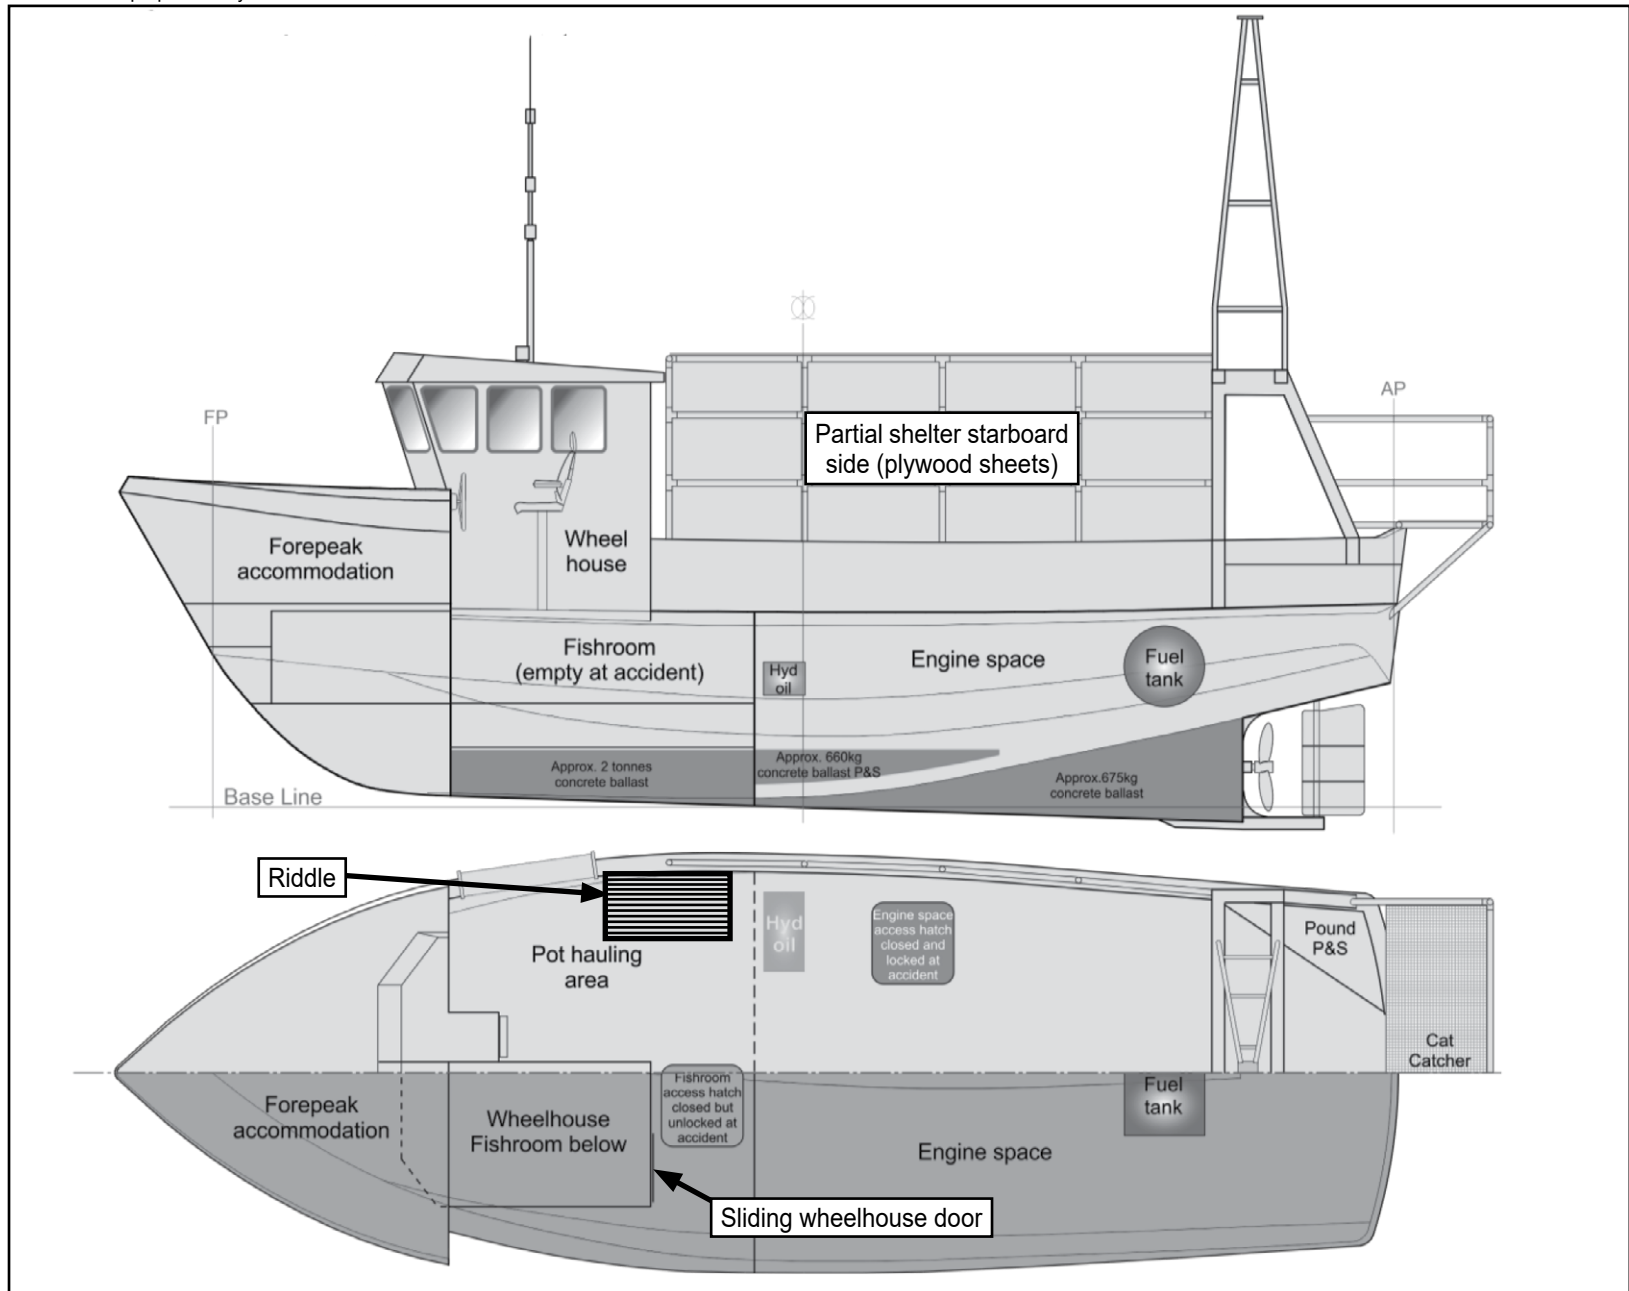
Before the modifications, when the original wheelhouse door on the centreline of *Nicola Faith* was in use, down-flooding into *Nicola Faith's* forward spaces would occur at a 90° angle of heel or list. The minimum down-flooding angle when heeled to port reduced to 29° when the new plastic sliding door was fitted in the aft bulkhead of the wheelhouse (**Figure 17**).

Figure 17: Naval architect's drawing of *Nicola Faith*
