2021 Annual Report

June 2022

Marine casualty investigation¹

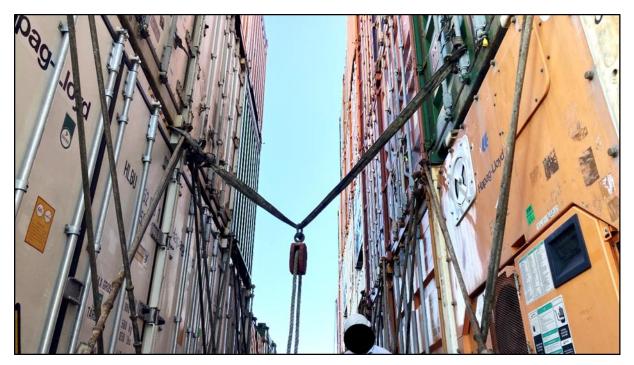
Figure 5: Rope and pulley system for evacuation via the access hatch (reproduced)¹⁰

Shortly afterwards, the unconscious person was secured at the scene with a rescue strop and evacuated to the top deck, where he was placed on a spineboard (type of rescue stretcher). A rope and pulley system suspended between containers on the top deck was used for the evacuation. A more detailed examination and first aid were carried out on the top deck. However, the casualty did not display any vital signs there, either. All attempts at resuscitation, both at the scene and shortly afterwards in the ship's sick bay, were unsuccessful and discontinued 90 minutes later. A subsequent autopsy revealed that the casualty had suffered several internal injuries, including bleeding organs and a fracture in the spinal column, which were ultimately fatal.

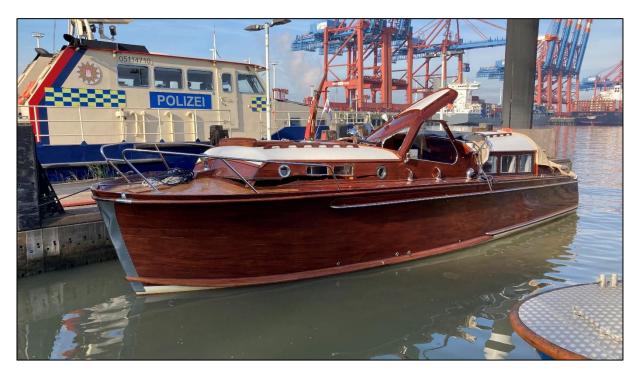
Figure 8: The heavily damaged motor yacht SANTA CECILIA after the autopilot's remote control failed¹⁶

During last year's sailing season, several similar accidents occurred while using an autopilot on different sailing grounds, some of which resulted in significant material damage and two persons were injured. One thing all the accidents had in common was that the skipper was relying on an autopilot but it did not respond as intended or as the skipper had expected. There was no time left for countermeasures.

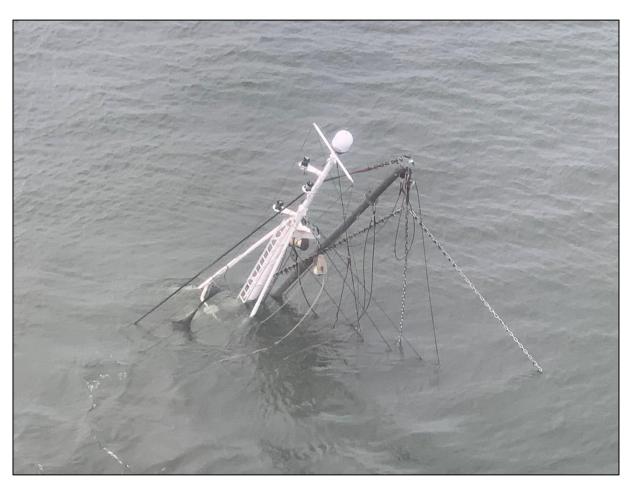
Figure 11: The mast of the foundered FREYJA still protruding from the water¹⁸

As the anchored vessel turned in the wind, the skipper noticed thick dark smoke coming from the engine room. He switched off the engines immediately and took the precaution of preparing the liferaft. This proved to be a wise decision for there was an explosion in the engine room just as they were getting ready to extinguish the fire and the entire vessel was covered in acrid smoke within seconds. The crew had no other option but to abandon the vessel immediately and board the liferaft. They were able to attract the attention of a helicopter shortly afterwards, which winched both of them up. The German Maritime Search and Rescue Service (DGzRS) monitored the fishing vessel as she burned out completely and foundered. Extinguishing work would have been too dangerous.

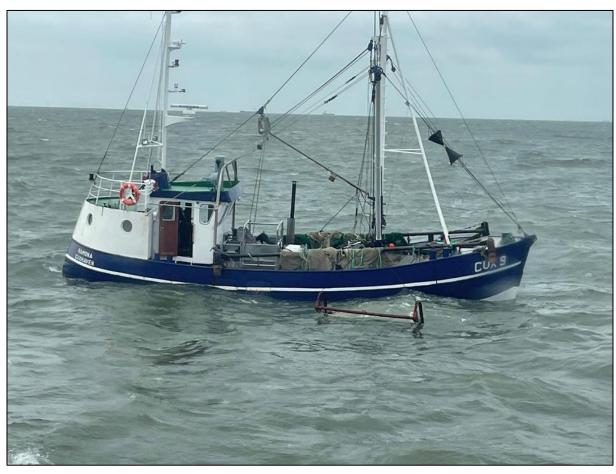
Figure 13: The RAMONA is already foundering²⁰

On 21 September 2021, the RAMONA sailed into the Heligoland Bight from Cuxhaven. Five people were on board (two crew members and three passengers). After they had already been underway for quite some time, the master noticed that planks in the fore section were coming loose and the vessel was making water. The water ingress was so severe that he immediately made an emergency call and had all persons transferred to the life raft he had brought with him. They were taken over by the FV HOFFNUNG, which was the first to come to the rescue, and brought to Cuxhaven. The rescue cruiser ANNELIESE KRAMER of the DGzRS still tried to use bilge pumps, but the RAMONA

took water too quickly and sank. The vessel foundered in the North Sea after less than 30 minutes.

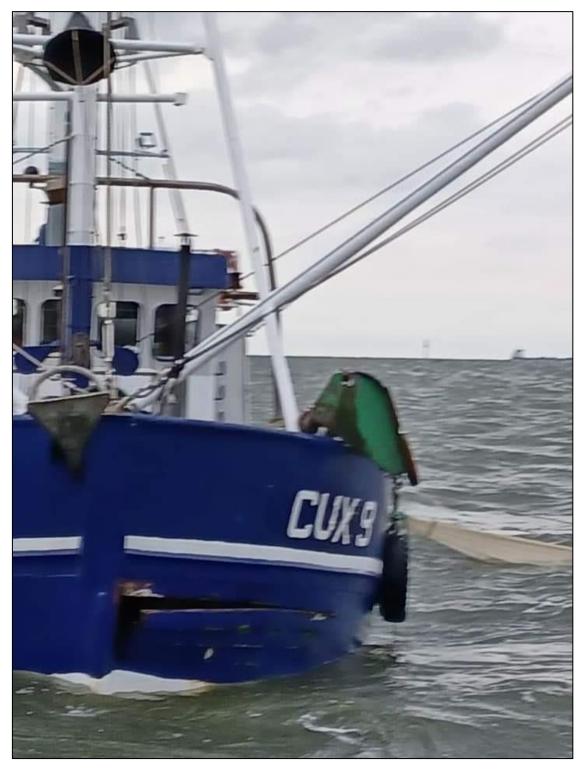
Figure 14: Loose planks at the bow of the RAMONA²¹
