Auxiliary Engine Damage

2018

How to avoid auxiliary engine damage

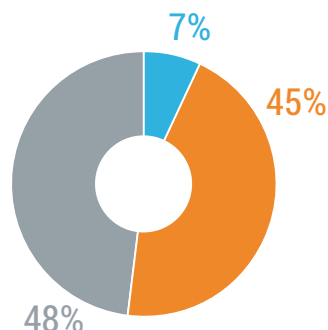
**H&M claims
by number
2010-2016**

- Auxiliary engine claims
- Machinery claims
- Other H&M claims

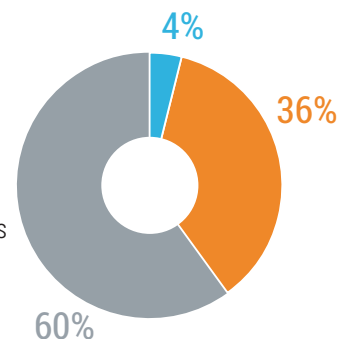
**H&M claims
by cost
2010-2016**

- Auxiliary engine claims
- Machinery claims
- Other H&M claims

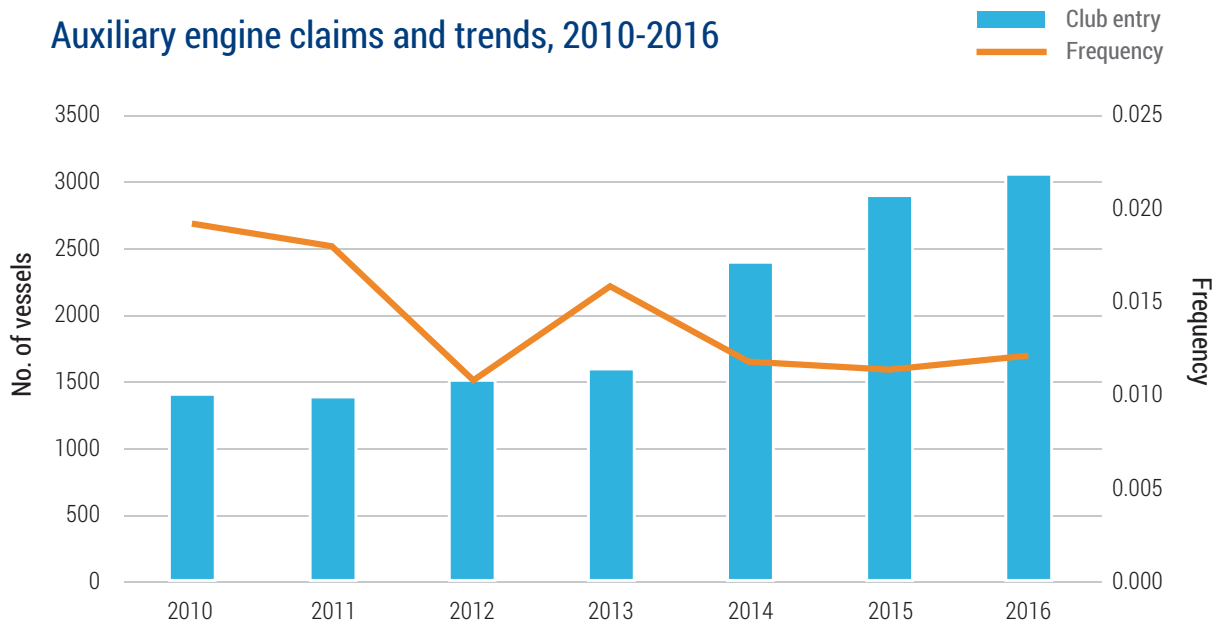
Auxiliary engine claims and trends, 2010-2016

- The frequency of auxiliary engine claims shows minor fluctuations with some reduction towards the end of the period under investigation.
- The current frequency is slightly above 0.01 claims per vessel per year (i.e. 1 claim per year for every 100 vessels entered).

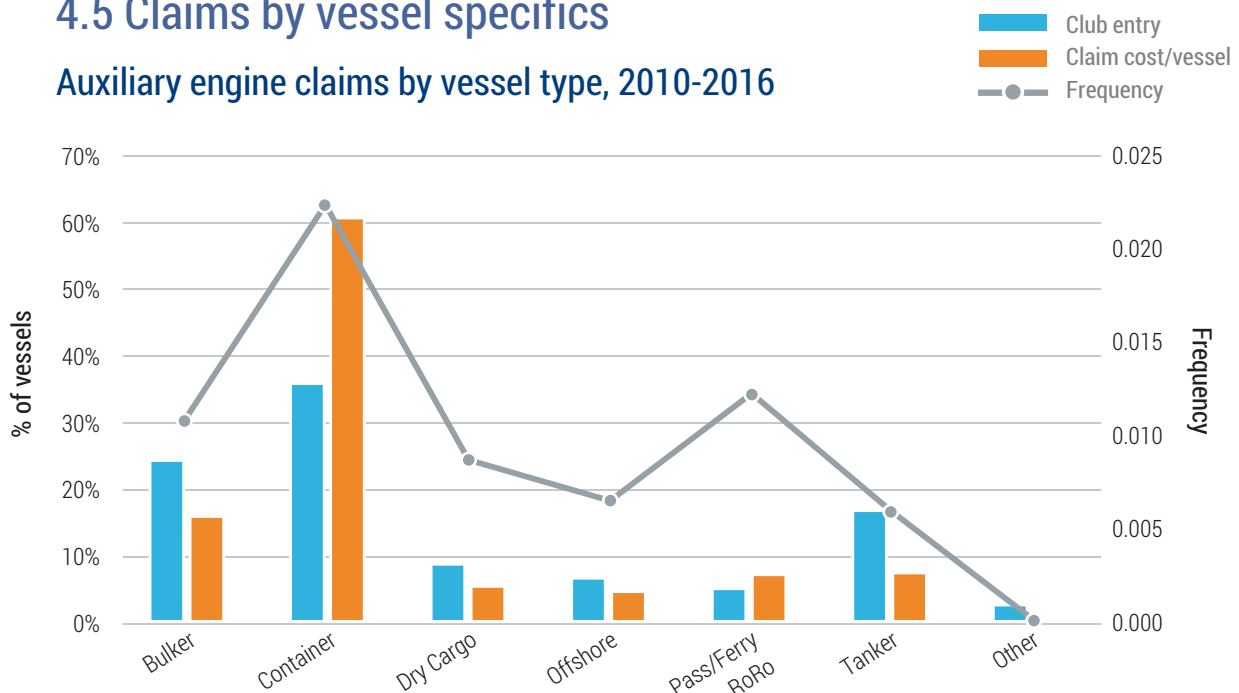
Auxiliary engine claims by vessel type, 2010-2016

- Container vessels have a significantly higher claims frequency due to the larger number of installed engines on these vessels. In addition, these engines have considerable output, hence the repair cost is greater compared with other vessels.

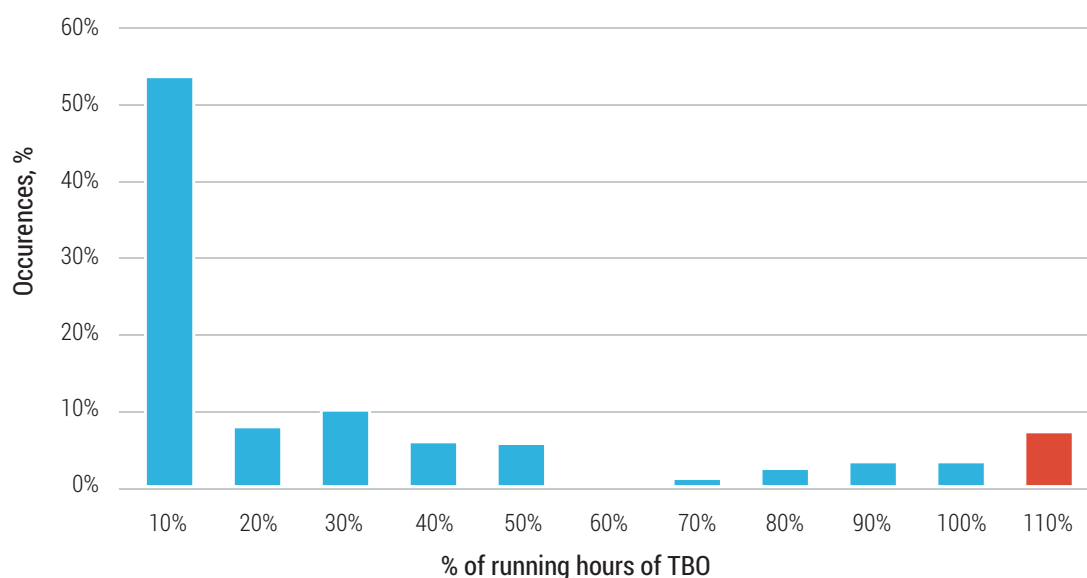
Casualties % in relation to TBO recommended by manufacturers

The chart below demonstrates the time that a casualty occurs in relation to the recommended maintenance interval (TBO) of the engine. The TBO of an auxiliary engine is normally between 12,000-16,000 hours.

Note: In addition to TBO related occurrences there are several cases where a crew member has carried out regular maintenance shortly before the breakdown. Common mistakes include replacing the oil filter but leaving rags behind, or cleaning the oil cooler and damaging a packing. These types of cases have been incorporated as TBO=0 in the analysis.

As can be seen, a majority of the casualties, 55%, occur within only 10% of the TBO, corresponding to the first 1,000 hours or so of operation after overhaul. In most cases, the damage occurs only a few hours after start up.
