MARINE SAFETY ALERT
Inspections and Compliance Directorate

Safety Alert 01-20

Danger! Improper Bonding During Gas Freeing Can Have Explosive Results!

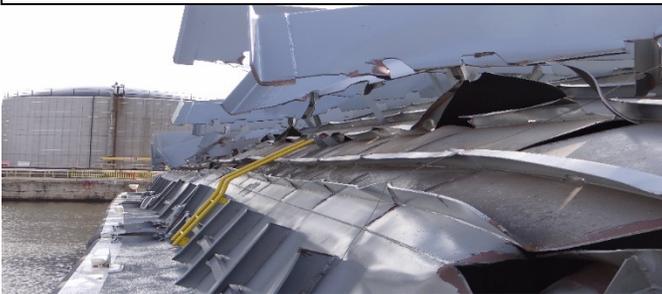
Ballooned/breached cargo tank & damaged external framing

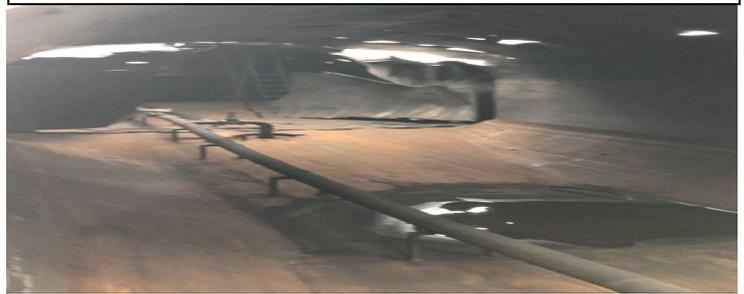
Bulkhead between the #1 from the #2 cargo tank, folded/breached

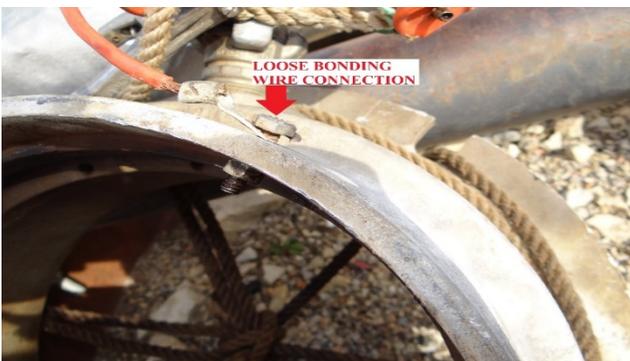
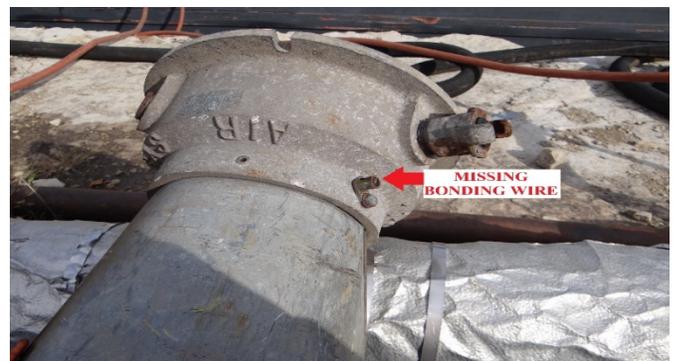
During gas freeing operations, cargo tank manway and butterworth openings are opened and the flammable vapors within the cargo tank are then removed using mechanical air moving equipment. As outside air is introduced into the cargo tank, the vapor/air mixture within the tank, and near the tank openings, will fall into the flammable range. During this time, if the air moving equipment used to gas free the cargo tank is not the proper type, is not properly maintained, or is not properly electrically bonded and secured to the vessel's structure, static electricity generated by the air moving equipment can discharge as an electric arc and ignite the flammable vapor/air mixture.

The following photos are of pneumatic blowers that were recovered on board a recently exploded tank barge. All blowers recovered on scene had either missing or improperly maintained bonding wires.

- Ensure all personnel are educated on the critical importance of the bonding wire/strap on air moving equipment (blowers/fans). All personnel should understand that the proper bonding of blowers/fans used in cargo tank cleaning and gas freeing operations is a federal requirement under 29 CFR § 1915.13(b)(11).

- Ensure all personnel are specifically trained on how to properly secure blowers/fans in place to prevent movement/rattling due to vibration and how to properly bond blowers/fans to the vessel/barge structure (e.g., ensure bonding wire/strap is tightly secured to the fan/blower housing and that the clamp for the bonding wire/strap is secured to the vessel structure on bare metal, penetrating any paint coatings). Simply touching/resting the blower/fan to bare metal is **NOT** an adequate means of bonding.

- Implement policy/procedures to require inspection of all air moving equipment, such as portable blowers/fans, prior to first use on each workday. Particular emphasis should be focused upon ensuring that all attached accessories (cones, ducting, etc.) are tightly connected to the blower/fan, and that each blower/fan has a bonding wire/strap that is undamaged, free of corrosion, and securely fastened to the housing of the blower/fan. Clamps used with the bonding wire/strap should also be free of corrosion, with adequate tension to ensure a tight grip/connection when clamped to the vessel/barge structure. Loose, poor, and corroded connections greatly increase the risk of an electric arc due to static discharge.

- Implement a policy that requires the site Safety Supervisor, SCP or PIC of the cleaning/gas freeing operation to visually inspect each blower/fan to ensure that they are properly secured to prevent movement/rattling and that they have been securely bonded to bare metal on the vessel structure by use of a bonding wire/strap with clamp (or other mechanical means to provide a secure connection). These checks should be completed before blowers and fans are activated.
